**BRUCEJACK GOLD MINE PROJECT**  
Application for an Environmental Assessment Certificate /  
Environmental Impact Statement

Brucejack Project: 2012 Fish and Fish Habitat  
Baseline Report

# BRUCEJACK GOLD MINE PROJECT 2012 Fish and Fish Habitat Baseline Report

May 2013  
Project #1042-008-09

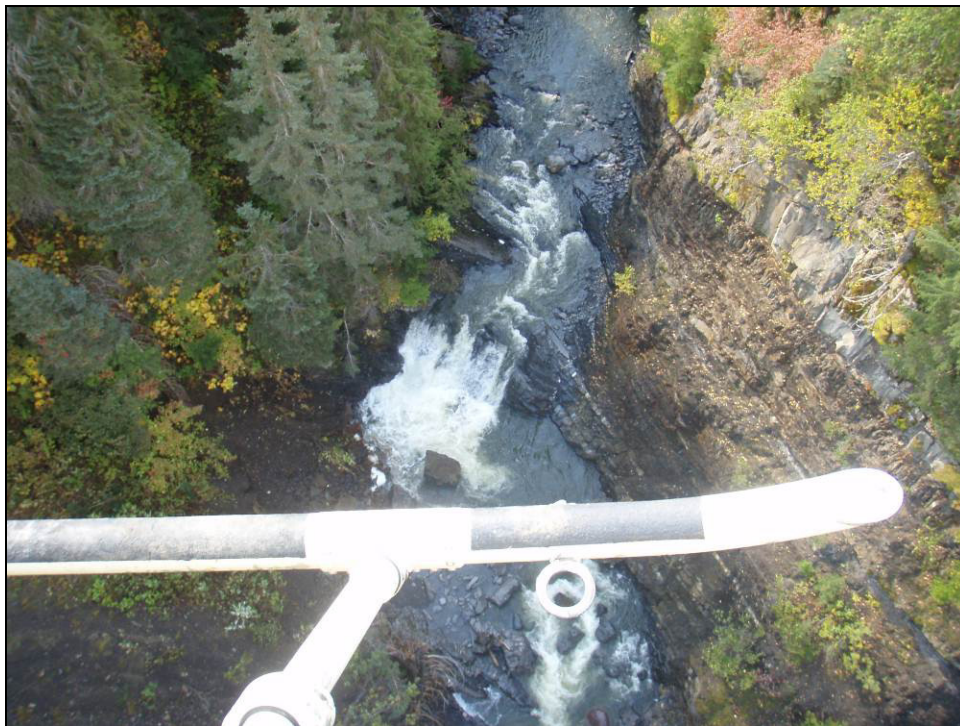
*Plate 7.1-1. Fish migration barrier on McInnes Creek.*

A barrier to fish migration is located in McInnes Creek, a small tributary that runs east into the Bell-Irving River near Wildfire Creek (Figure 7.1-1). While several small waterfalls and cascades were observed farther downstream, an approximately 2 m high waterfall 1 km from the creek mouth was determined to be the barrier nearest to the creek mouth that could be definitively labelled an impassable obstruction to fish passage (Plate 7.1-1). No fish sampling has been undertaken above the barrier, so the fish-bearing status of the upstream reaches of McInnes Creek is not known.

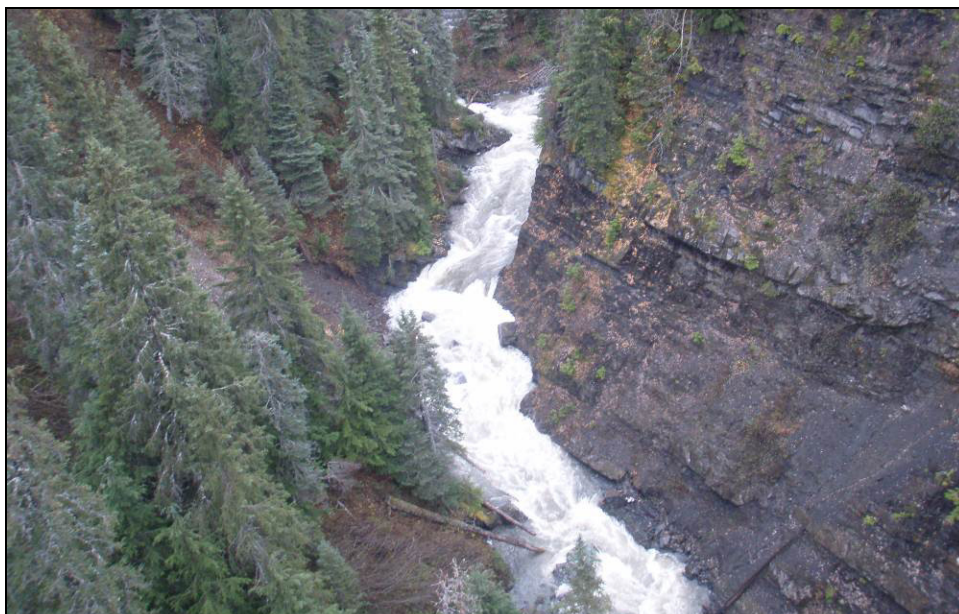
*Plate 7.1-4. Cascades and small waterfalls on Wildfire Creek approximately 2 km upstream of the confluence with the Bell-Irving River.*

Approximately 1.5 km upstream of the mouth of Wildfire Creek, a series of waterfalls, steps, and cascades was observed below the confluence of the two branches of Wildfire Creek (Plates 7.1-4 and 7.1-5). While none of the features are sufficient to stop fish passage, no fish have been captured above this stretch, despite 3,707 electrofishing seconds and 1,154 hours of minnow trapping effort and 123 hours of gillnetting effort over the course of three years from 2010 to 2012 (see Section 7.4.2). In light of the lack of fish capture despite substantial effort, the sections of Wildfire Creek and the large tributary above this barrier are considered non-fish bearing.

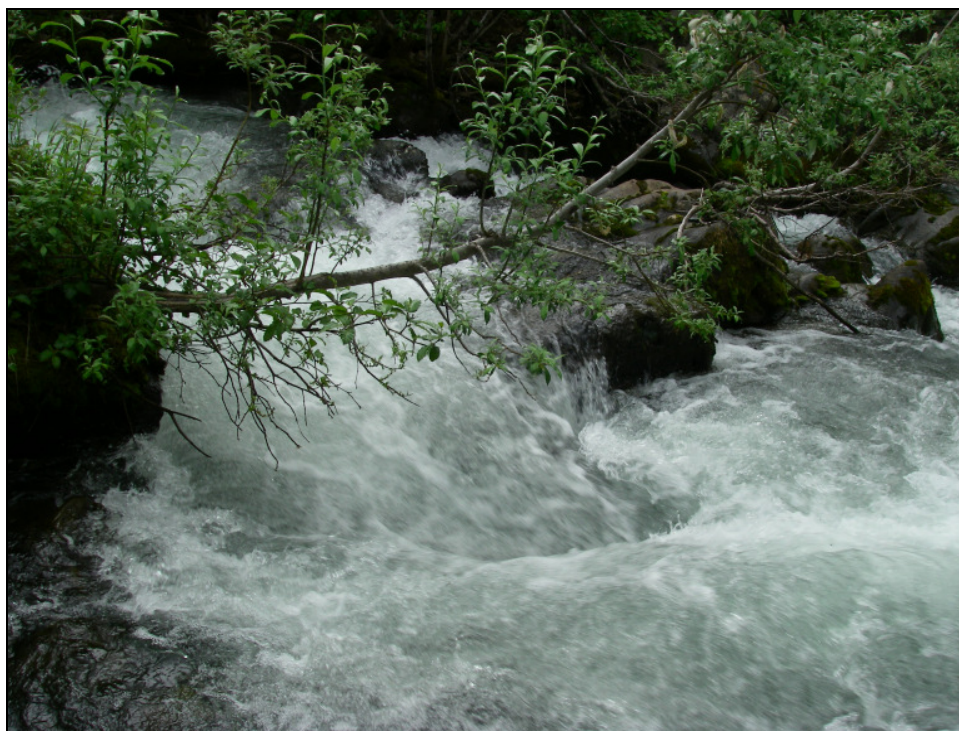
*Plate 7.2-3. High water velocity habitat in Reach 2 of Scott Creek.*

Reach 2 of the Scott Creek mainstem is higher gradient than Reach 1 and contains less instream cover and more riffle habitat (Plate 7.2-3). Substrate in Reach 2 is larger, and more cover is provided by boulders. Rearing habitat in Reach 2 is limited to small areas where boulders or large woody debris blocked water flow and created pools. The upstream end of the reach is marked by a section where the creek is confined in a narrow channel, creating a series of cascades interspersed with microhabitats of fast flowing water. Although there is no distinct barrier to fish passage such as a waterfall, this constriction likely provides an obstacle to upstream migration and may mark the end of fish use in the watershed. No fish have been captured upstream of this point during these baseline studies or in historical studies (Rescan 2010).

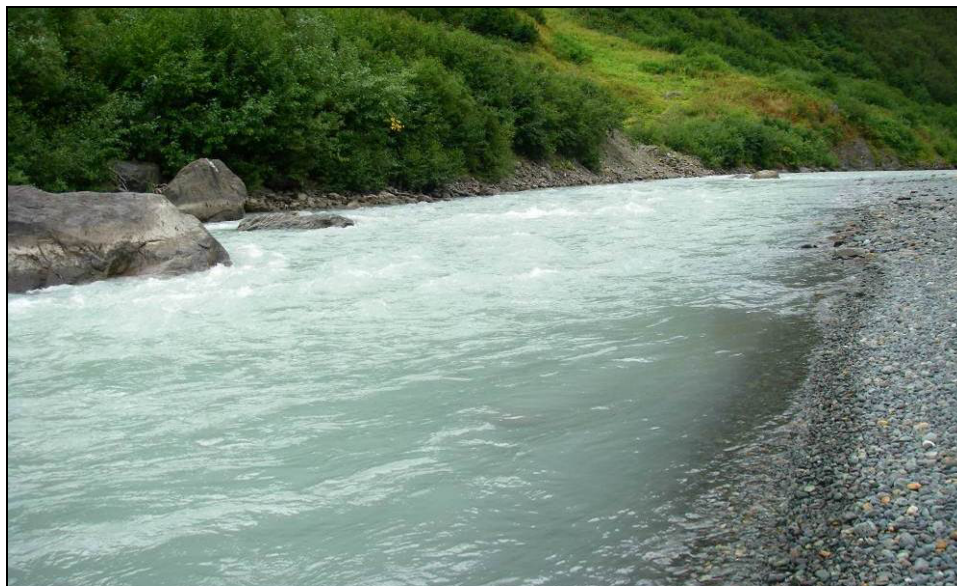
Plate 7.2-4. Todd Creek Watershed Reach 1.

Todd Creek flows north from its headwaters in the mountains to the Bowser River directly upstream of Bowser Lake. Todd Creek and its tributaries are primarily steep and glacial in origin. As a result, water clarity in the watershed is generally low (Plate 7.2-4). There are no significant lakes or wetlands in the watershed.

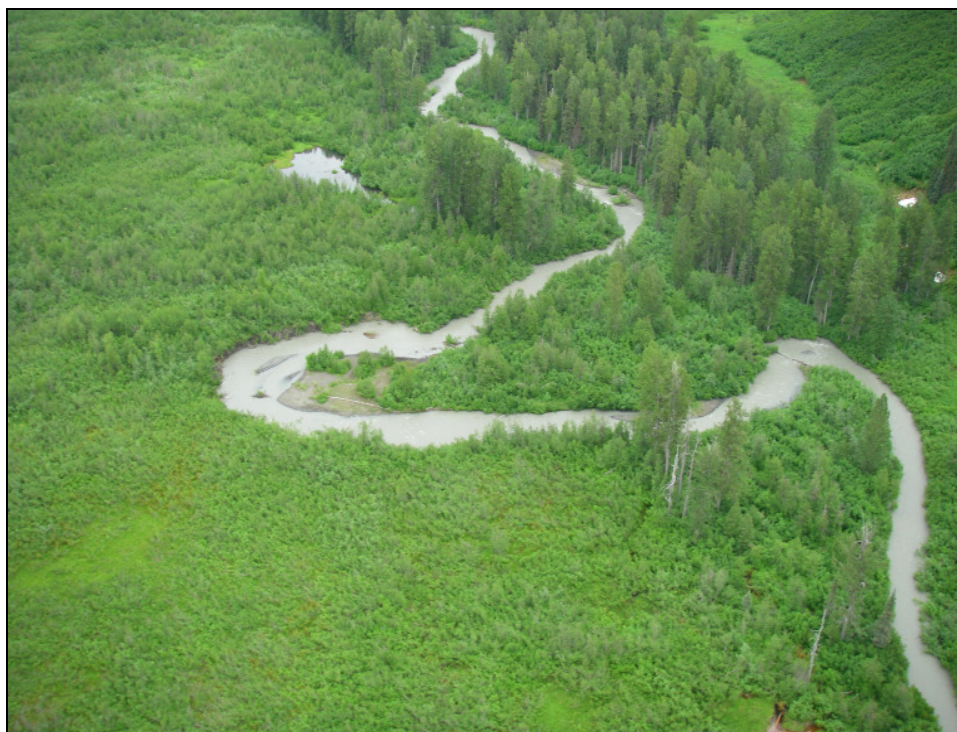
*Plate 7.2-5. Reach 2 of Todedada Creek flowing through wetland.*

Reach 2 of Todedada Creek runs through a large wetland area (Plate 7.2-5). The creek mainstem forms a distinct, flowing channel through the wetland, but the surrounding area is flooded, filled with small permanent and temporary wetted channels, and influenced by substantial overland water flow. The substrate in the mainstem is primarily fines and gravel with trace amounts of larger substrates (Tables 7.2-15 and 7.2-16). Good quality fish habitat is available for rearing, spawning, and overwintering purposes. Habitat in Reach 2 is heterogenous, as the reach contains riffle, glide and pool habitat types.

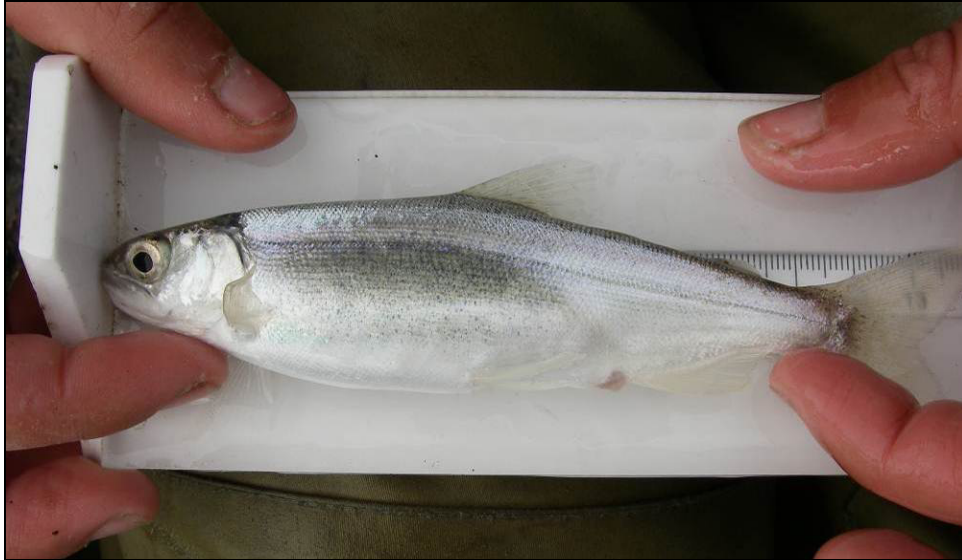
*Plate 7.3-1. Mature kokanee salmon captured in Bowser Lake.*

Gillnets set in Bowser Lake captured small kokanee salmon with nearly mature gonads (Plate 7.3-1). Kokanee salmon are a small, landlocked form of sockeye salmon and may spawn and rear in Bowser Lake.

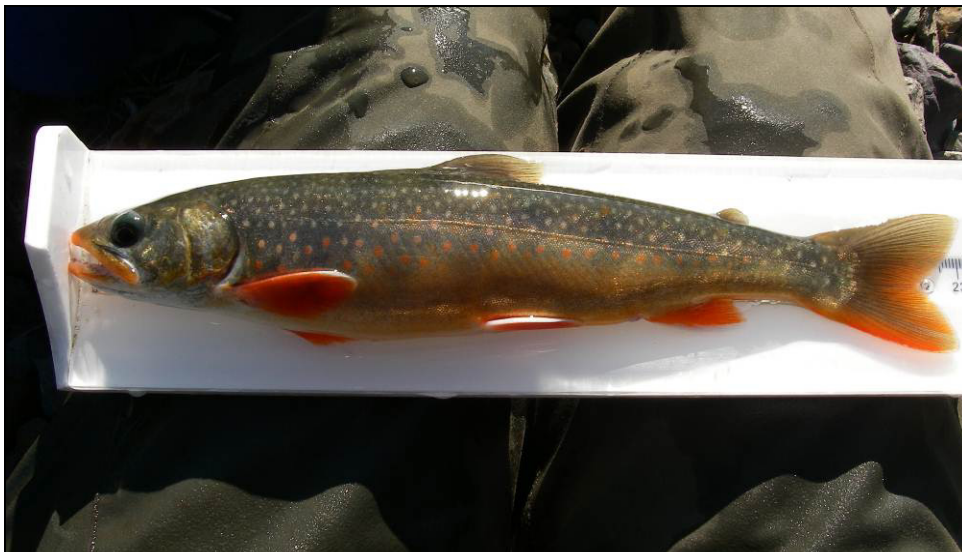
*Plate 7.3-2. Dolly Varden/bull trout with spawning colours captured in Todedada Lake.*

Dolly Varden/bull trout captured in Todedada Lake and Unnamed Lake 3 appeared to be nearing spawning condition. Many had developed spawning colouration and their gonads had begun to mature (Plate 7.3-2). In both lakes areas of possible spawning were identified along the shoreline. Areas of disturbed gravel and coarse sand suggested possible spawning areas, although Dolly Varden/bull trout are not generally considered to be shoreline spawning species.

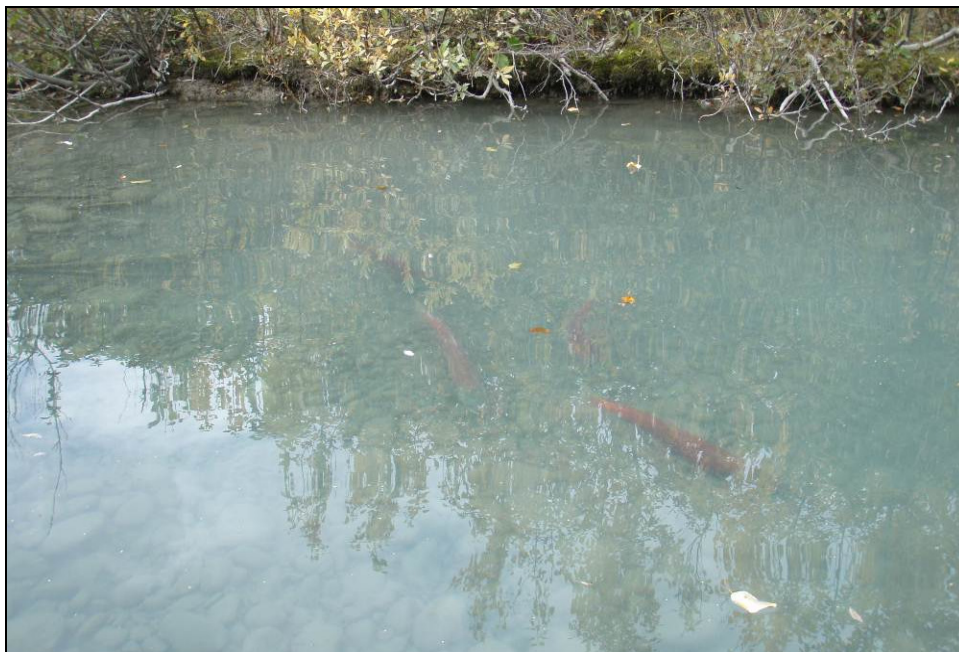
*Plate 7.3-3. Sockeye salmon spawning in a groundwater-fed inlet to Bowser Lake.*

Adult sockeye salmon were observed in a branch of Todedada Creek (Plate 7.3-3), in a small tributary of the Bowser River, and in two groundwater-fed channels near the outlets of the Bowser River and Scott Creek to Bowser Lake (Figure 7.3-2). They were observed engaging in courtship behaviour and holding over redds, indicating that the locations in which they were observed are spawning grounds.

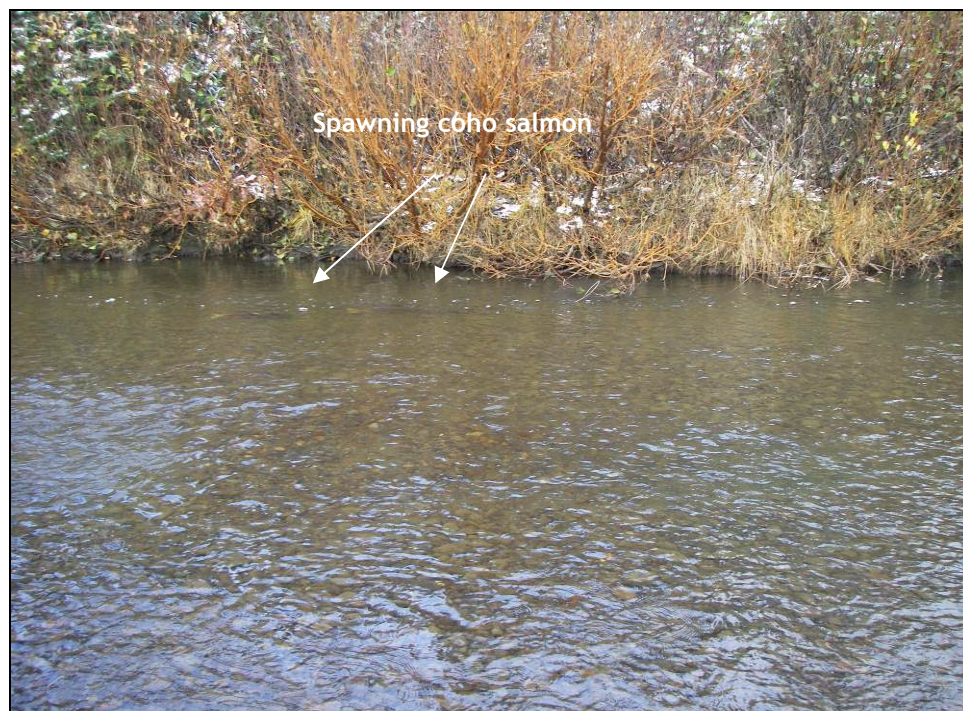
Plate 7.3-4. Coho salmon spawning in Todedada Creek.

Ninety nine coho salmon spawners and approximately twenty redds were found in a tributary to Todedada Creek near the wetland reach of the stream (Plate 7.3-4). Six coho spawners were also found in the mainstem of Todedada Creek nearby. The adult coho observed in the Todedada Creek watershed were displaying active spawning behaviour. Many were paired up and holding near redds. Only a single female coho was observed in the Bowser River system in a groundwater channel near the Scott Creek outlet to Bowser Lake.

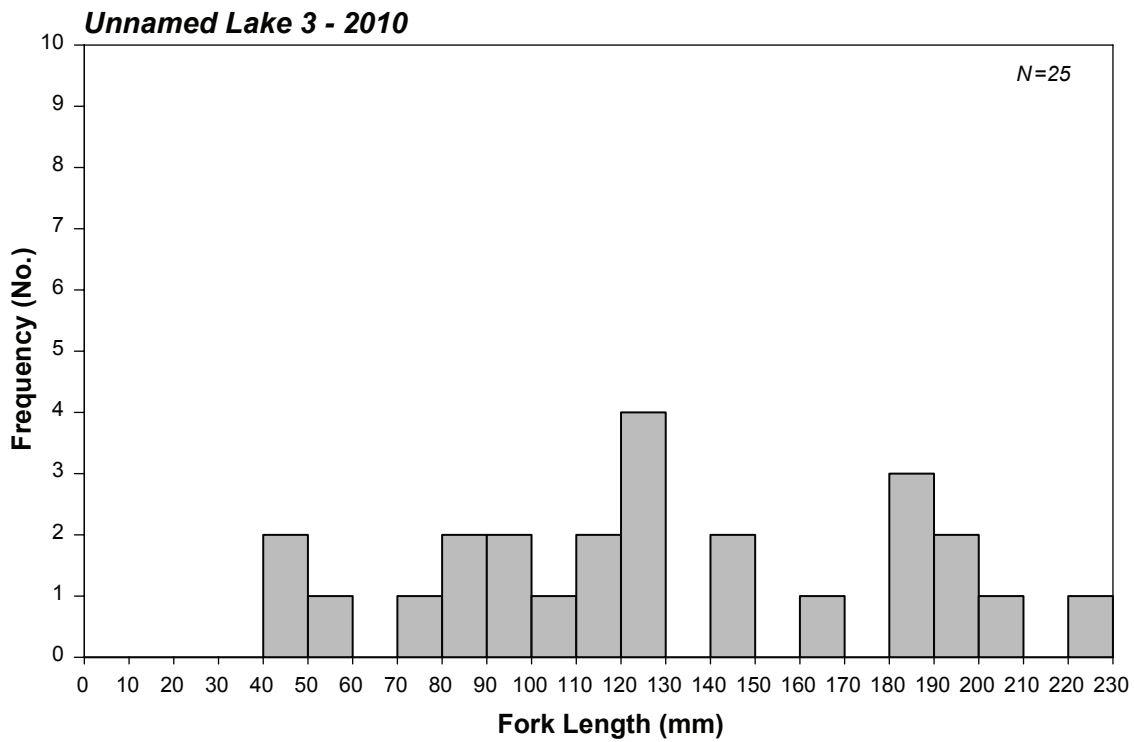
Length-Frequency Distribution for Dolly Varden/Bull Trout Captured by Minnow Trap in Lakes

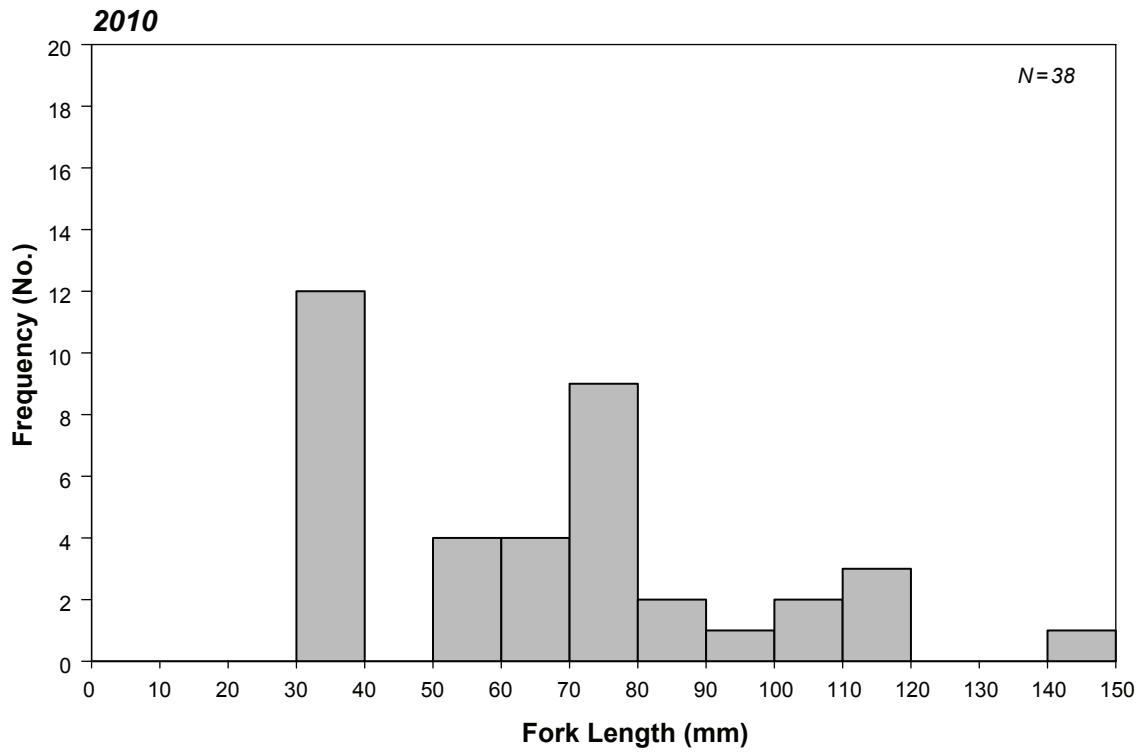
**Length-Frequency Distribution for Fish  
Captured by Electrofishing in WL1**

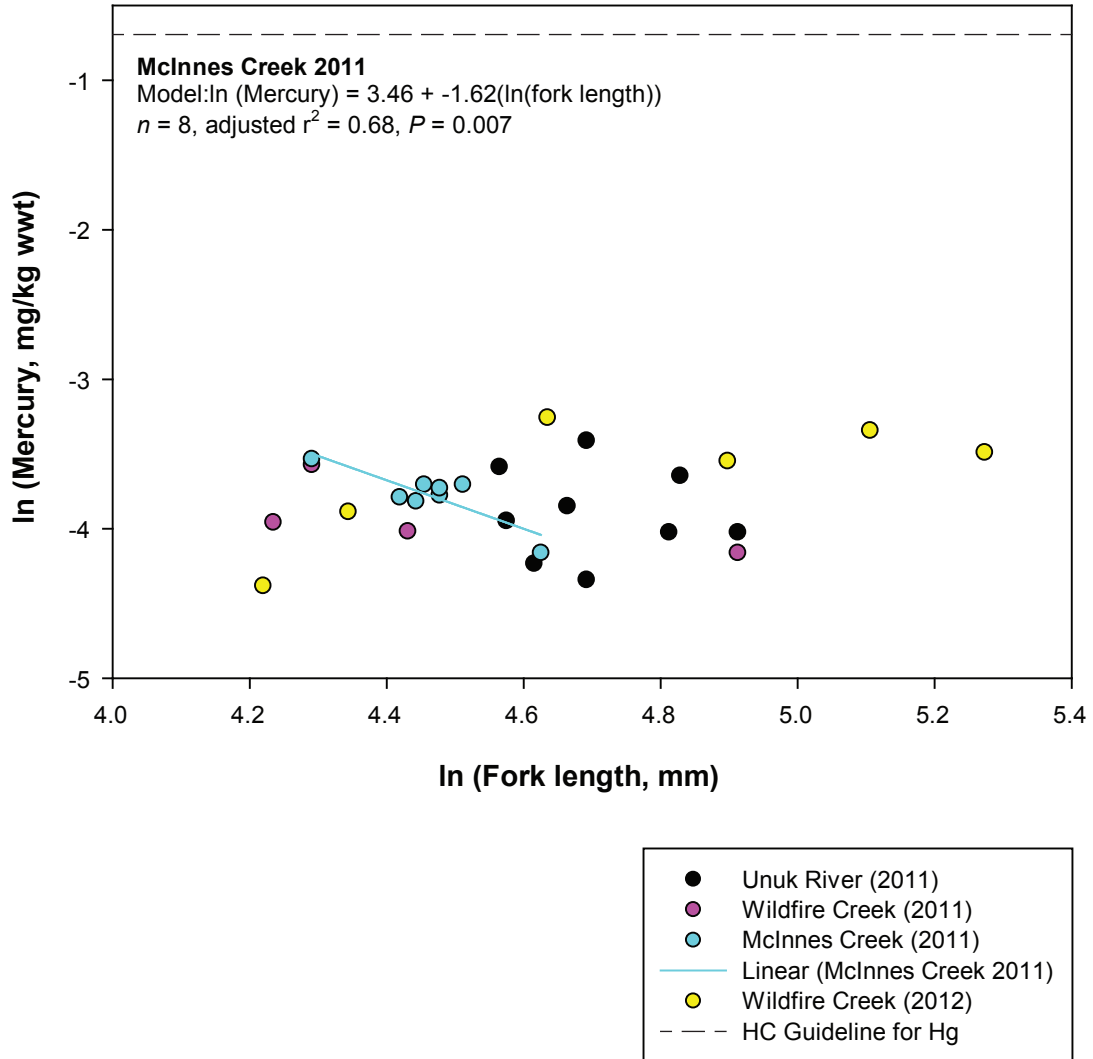
Mercury Concentrations on Fork Length of Dolly Varden/Bull Trout Sampled for Metals

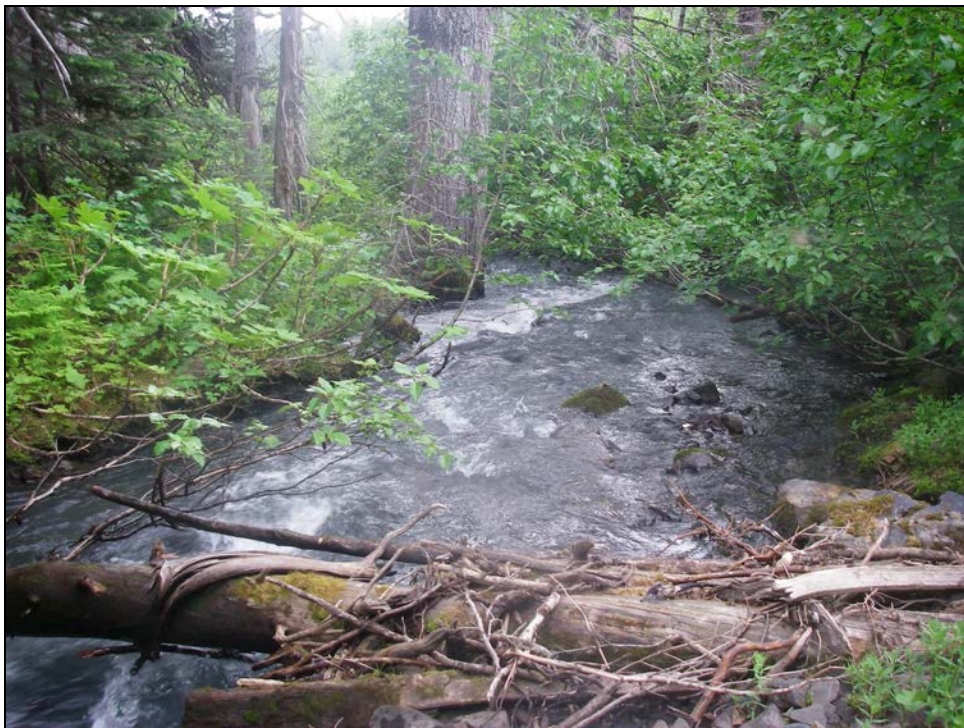
*Site # 505 Photo: IMG8823*  
*Site 505 - A view of the avulsion at the bottom end of the site.*

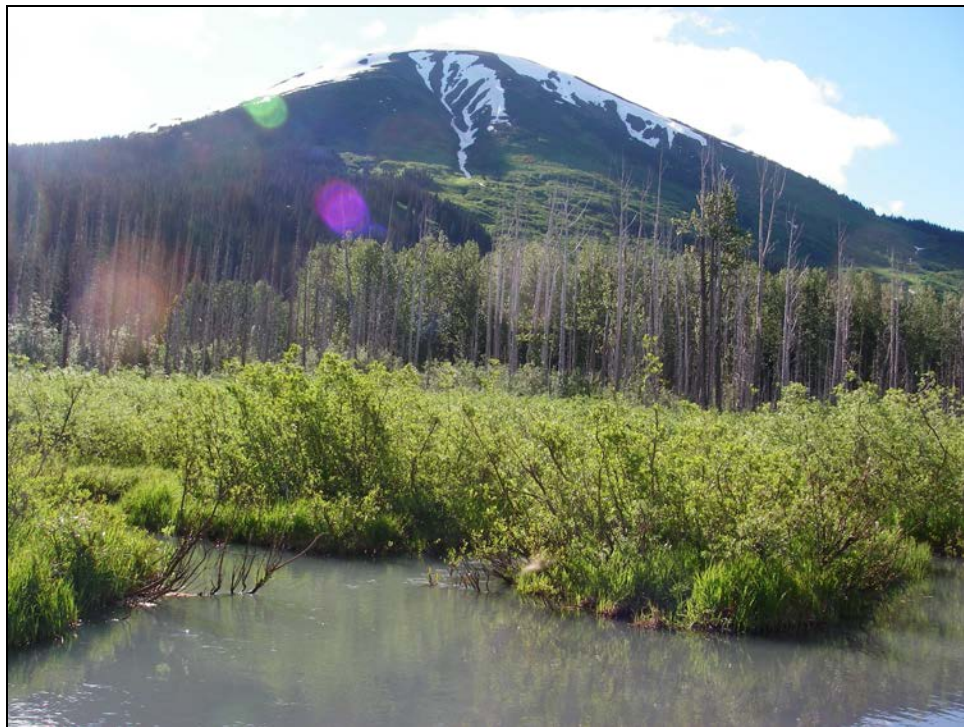
*Site # 506 Photo: IMG8828  
Site 506 - A view of the braided wetland area.*

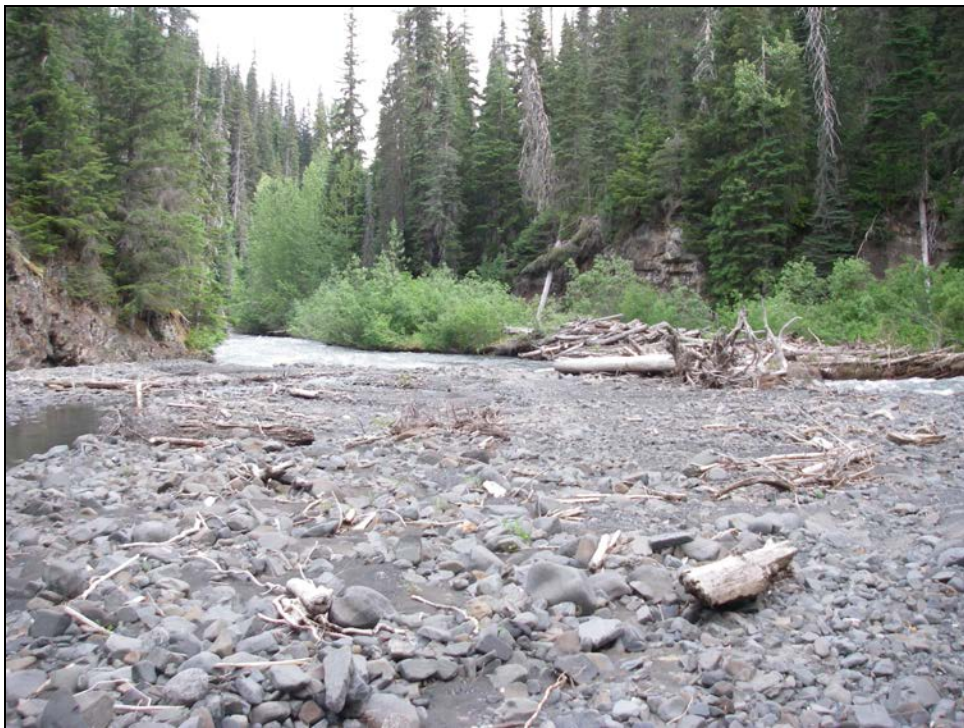
*Site # 511 Photo: IMG8859  
Site 511 - A view downstream of the site with mid-channel bar.*

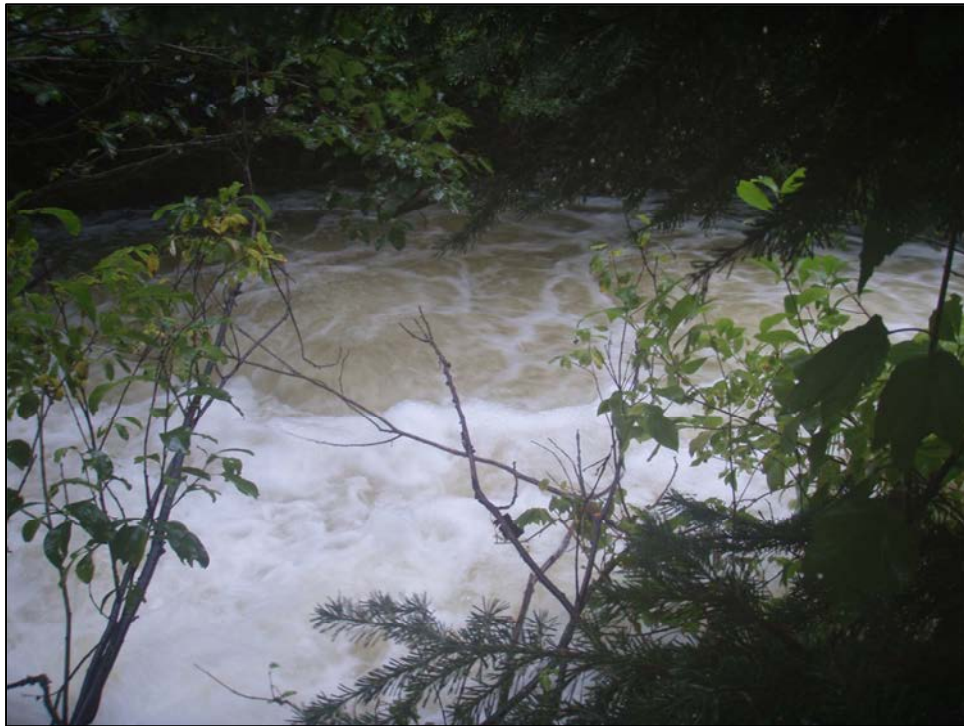
*WC-2 P9086305*  
*WC-2 Pool below cascade at downstream end of site*
