Springbank Off-stream Reservoir Project

Impact Assessment Agency
of Canada
Annual Report - 2021/2022
Reporting Year

Prepared for:
Alberta Transportation

Prepared by:
Stantec Consulting Ltd.

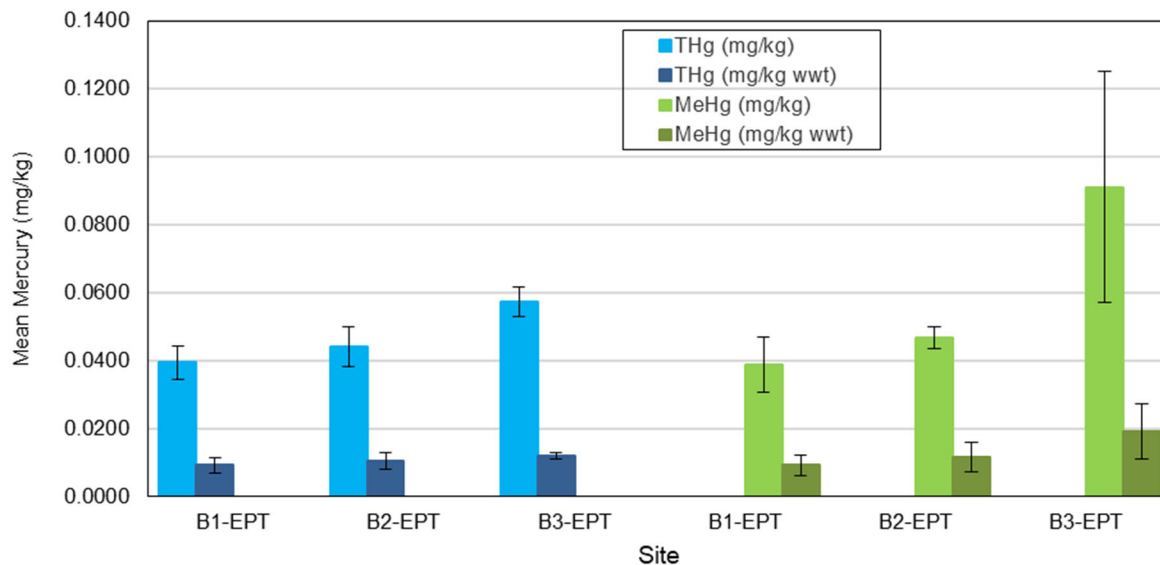
Mean THg concentrations in invertebrate tissue at the three sites ranged from 0.0393 to 0.0573 mg/kg and from 0.0091 to 0.0120 mg/kg wet weight (wwt) (Figure 3.1). MeHg concentrations at the three sites ranged from 0.0387 to 0.0910 mg/kg and from 0.0091 to 0.0191 mg/kg wwt (Figure 3.1). There was a slight increase in both THg and MeHg in invertebrates in a downstream direction on the Elbow River.

Figure 3.1 Mean THg and MeHg concentrations with SD in benthic invertebrates at Elbow River sites, 2021

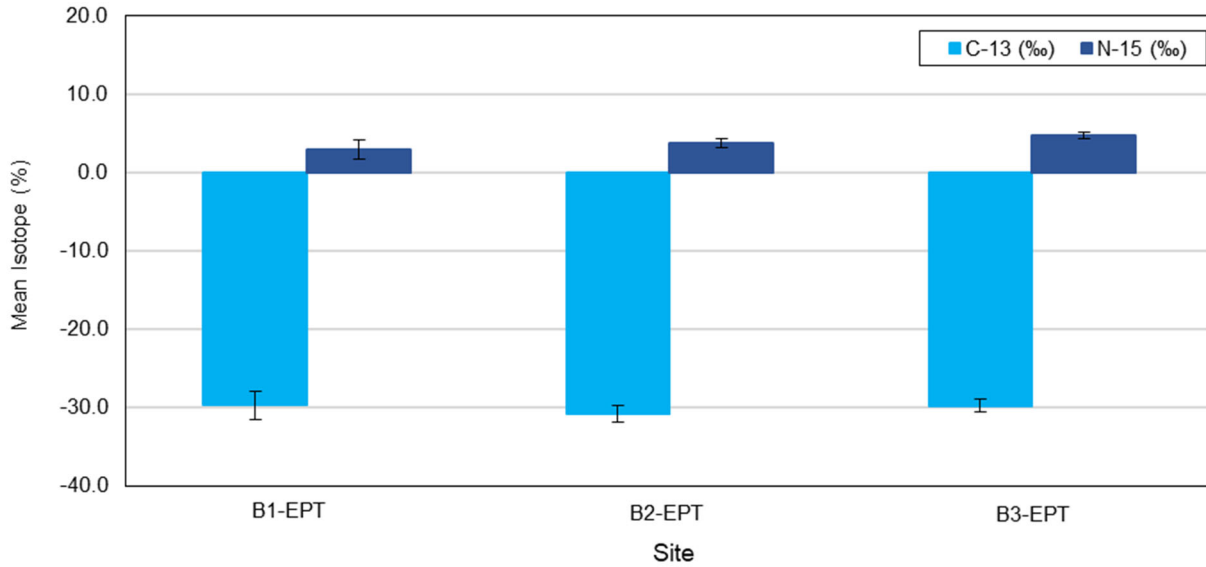
Mean C-13 in invertebrate tissue at the three sites ranged from -29.7 to -30.8‰ and N-15 from 2.9 to 4.7‰ (Figure 3.2). C-13 values in invertebrates were similar between sites, while N-15 increased slightly in a downstream direction on the Elbow River. Mean C content at the three sites ranged from 48.1 to 53.8% and N content from 10.3 to 11.8% (Figure 3.3). N content in invertebrates was similar between sites, while C content was slightly lower at site B2-EPT compared to the other two sites.

Figure 3.2 Mean C-13 and N-15 with SD in benthic invertebrates at Elbow River sites, 2021

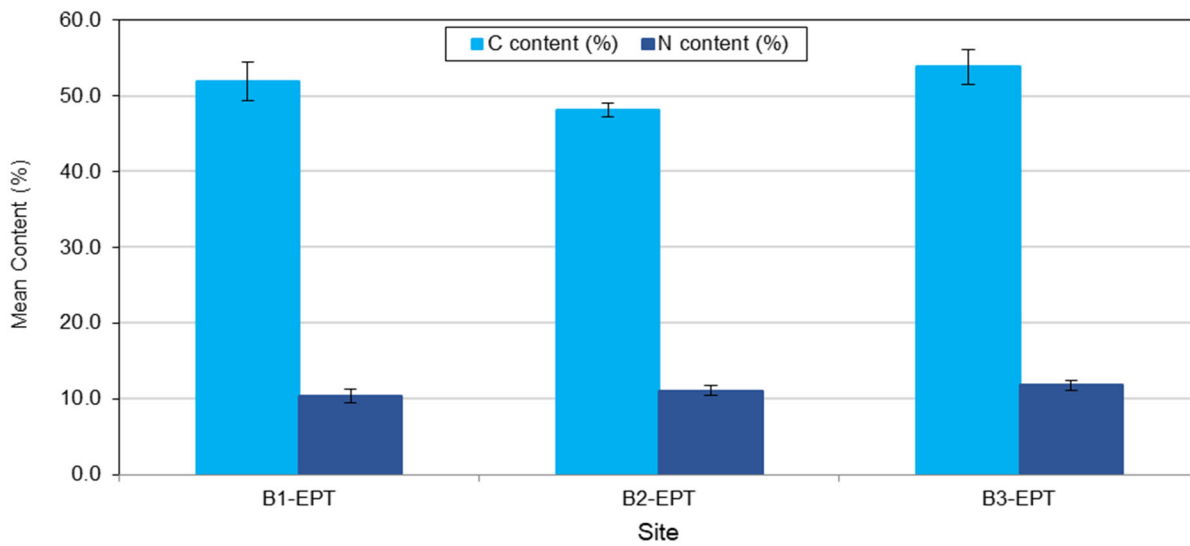
Figure 3.3 Mean C content and N content with SD in benthic invertebrates at Elbow River sites, 2021

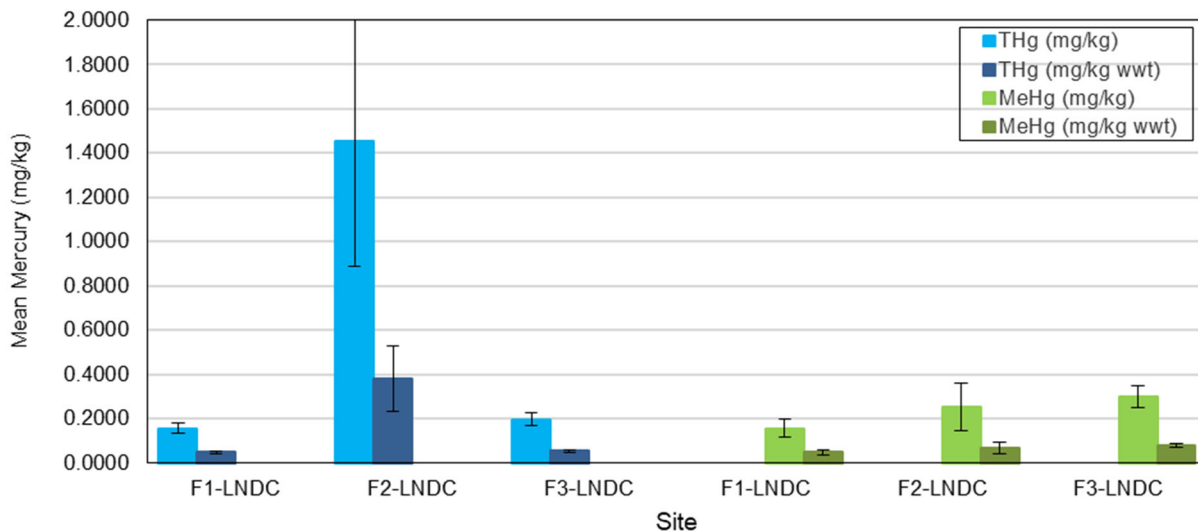
Mean THg concentrations in longnose dace at the three sites ranged from 0.1561 to 1.4517 mg/kg and from 0.0469 to 0.3825 mg/kg wet weight (wwt) (Figure 3.4). MeHg concentrations at the three sites ranged from 0.1559 to 0.2988 mg/kg and from 0.0468 to 0.0807 mg/kg wwt (Figure 3.4). There was a slight increase in MeHg in longnose dace in a downstream direction on the Elbow River, while THg was considerably higher at site F2-LNDC compared to the other two sites.

Figure 3.4 Mean THg and MeHg concentrations with SD in longnose dace at Elbow River sites, 2021

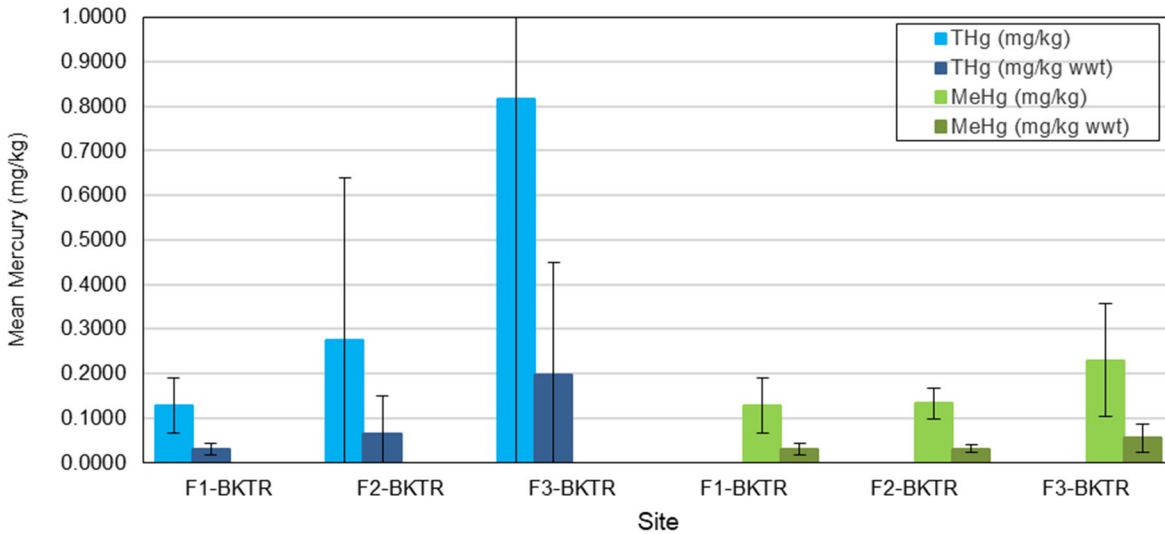
Mean THg concentrations in brook trout at the three sites ranged from 0.1274 to 0.8167 mg/kg and from 0.0302 to 0.1983 mg/kg wet weight (wwt) (Figure 3.5). MeHg concentrations at the three sites ranged from 0.1292 to 0.2302 mg/kg and from 0.0306 to 0.0552 mg/kg wwt (Figure 3.5). There was an increase in both THg and MeHg in brook trout in a downstream direction on the Elbow River.

Figure 3.5 Mean THg and MeHg concentrations with SD in brook trout at Elbow River sites, 2021

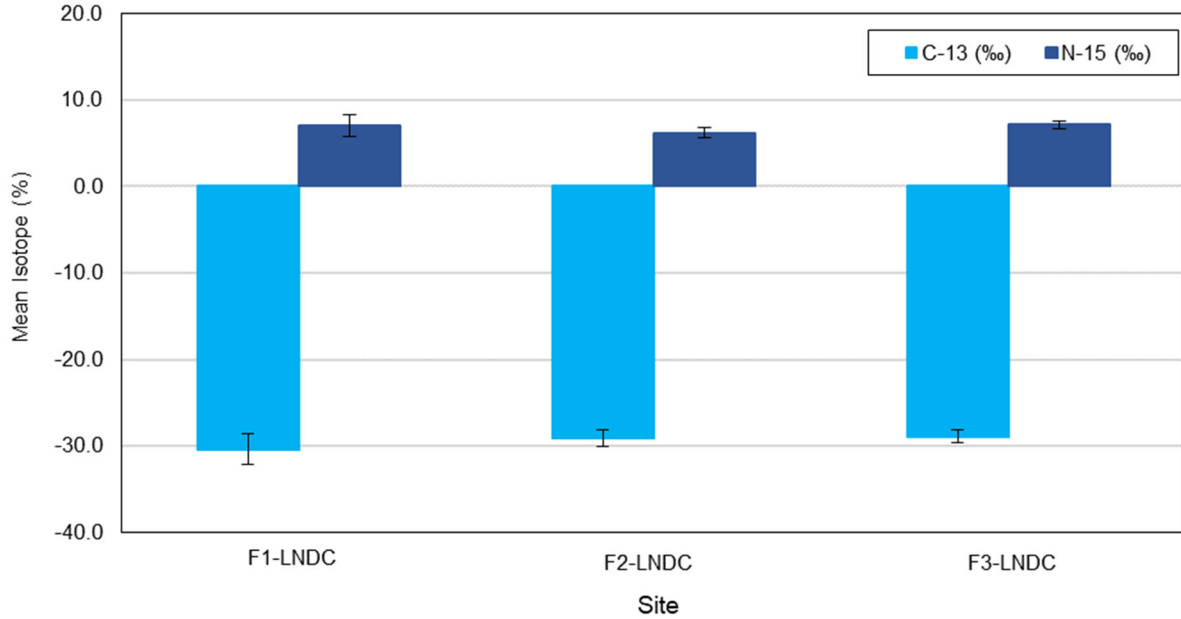
Mean C-13 in longnose dace tissue at the three sites ranged from -28.9 to -30.4‰ and N-15 from 6.2 to 7.1‰ (Figure 3.6). C-13 values in longnose dace decreased slightly in a downstream direction on the Elbow River, while N-15 was slightly lower at site F2-LNDC compared to the other two sites. Mean C content at the three sites ranged from 47.8 to 50.4% and N content from 12.2 to 13.7% (Figure 3.7). N content in longnose dace increased slightly in a downstream direction on the Elbow River, while C content was slightly lower at site F2-LNDC compared to the other two sites.

Figure 3.6 Mean C-13 and N-15 with SD in longnose dace at Elbow River sites, 2021

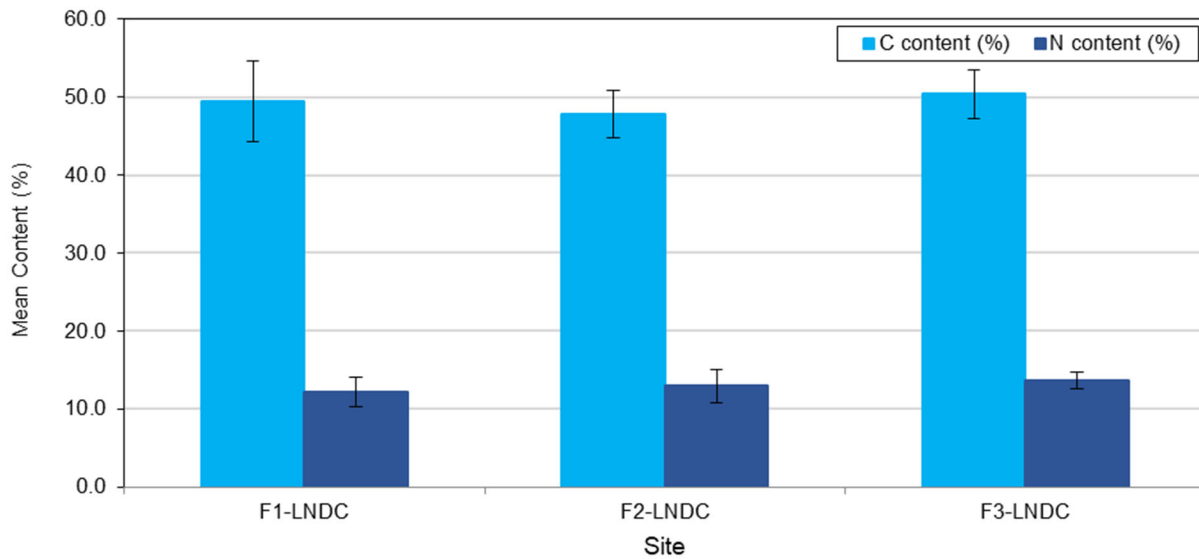
Figure 3.7 Mean C content and N content with SD in longnose dace at Elbow River sites, 2021

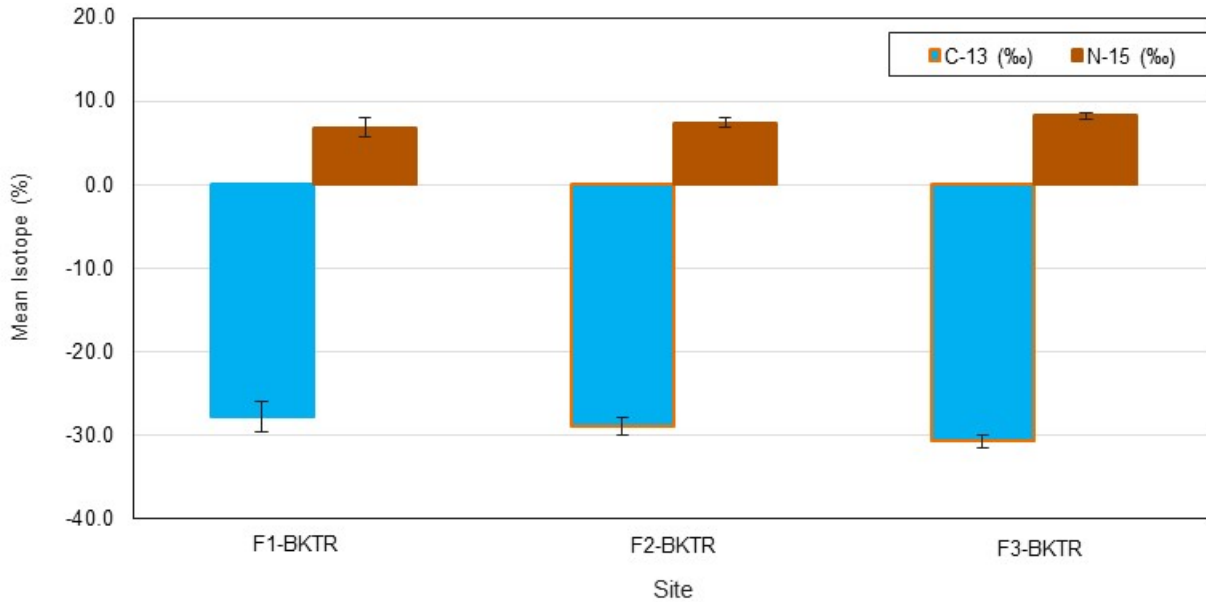
Mean C-13 in brook trout tissue at the three sites ranged from -27.8 to -30.7% and N-15 from 6.8 to 8.3% (Figure 3.8). C-13 and N-15 values in brook trout increased slightly in a downstream direction on the Elbow River. Mean C content at the three sites ranged from 47.6 to 48.8% and N content from 14.6 to 15.3% (Figure 3.9). C content and N content in brook trout decreased slightly in a downstream direction on the Elbow River.

Figure 3.8 Mean C-13 and N-15 with SD in brook trout at Elbow River sites, 2021

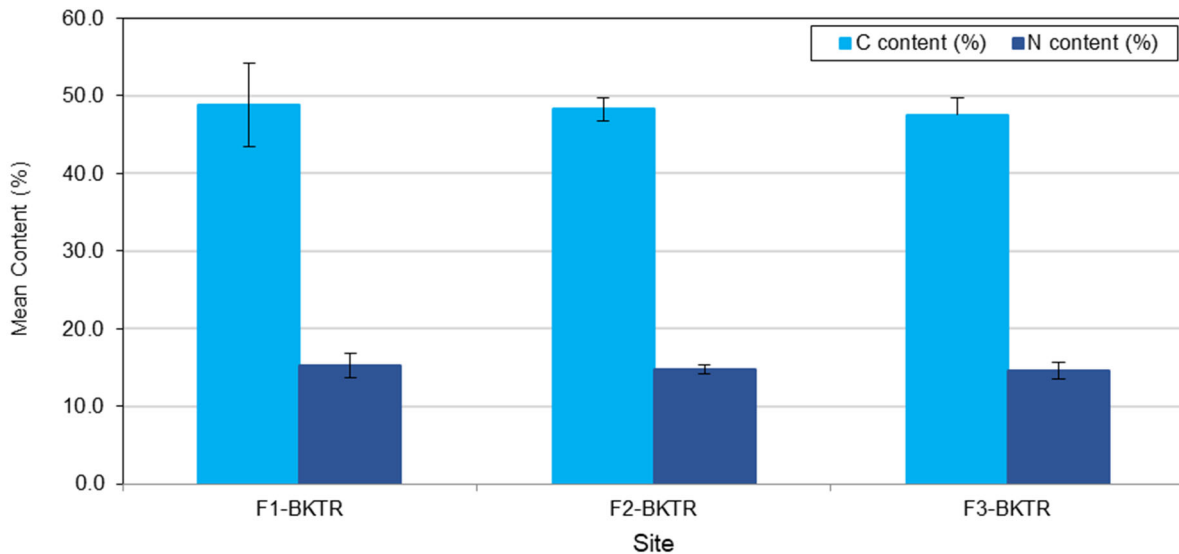
Figure 3.9 Mean C content and N content with SD in brook trout at Elbow River sites, 2021

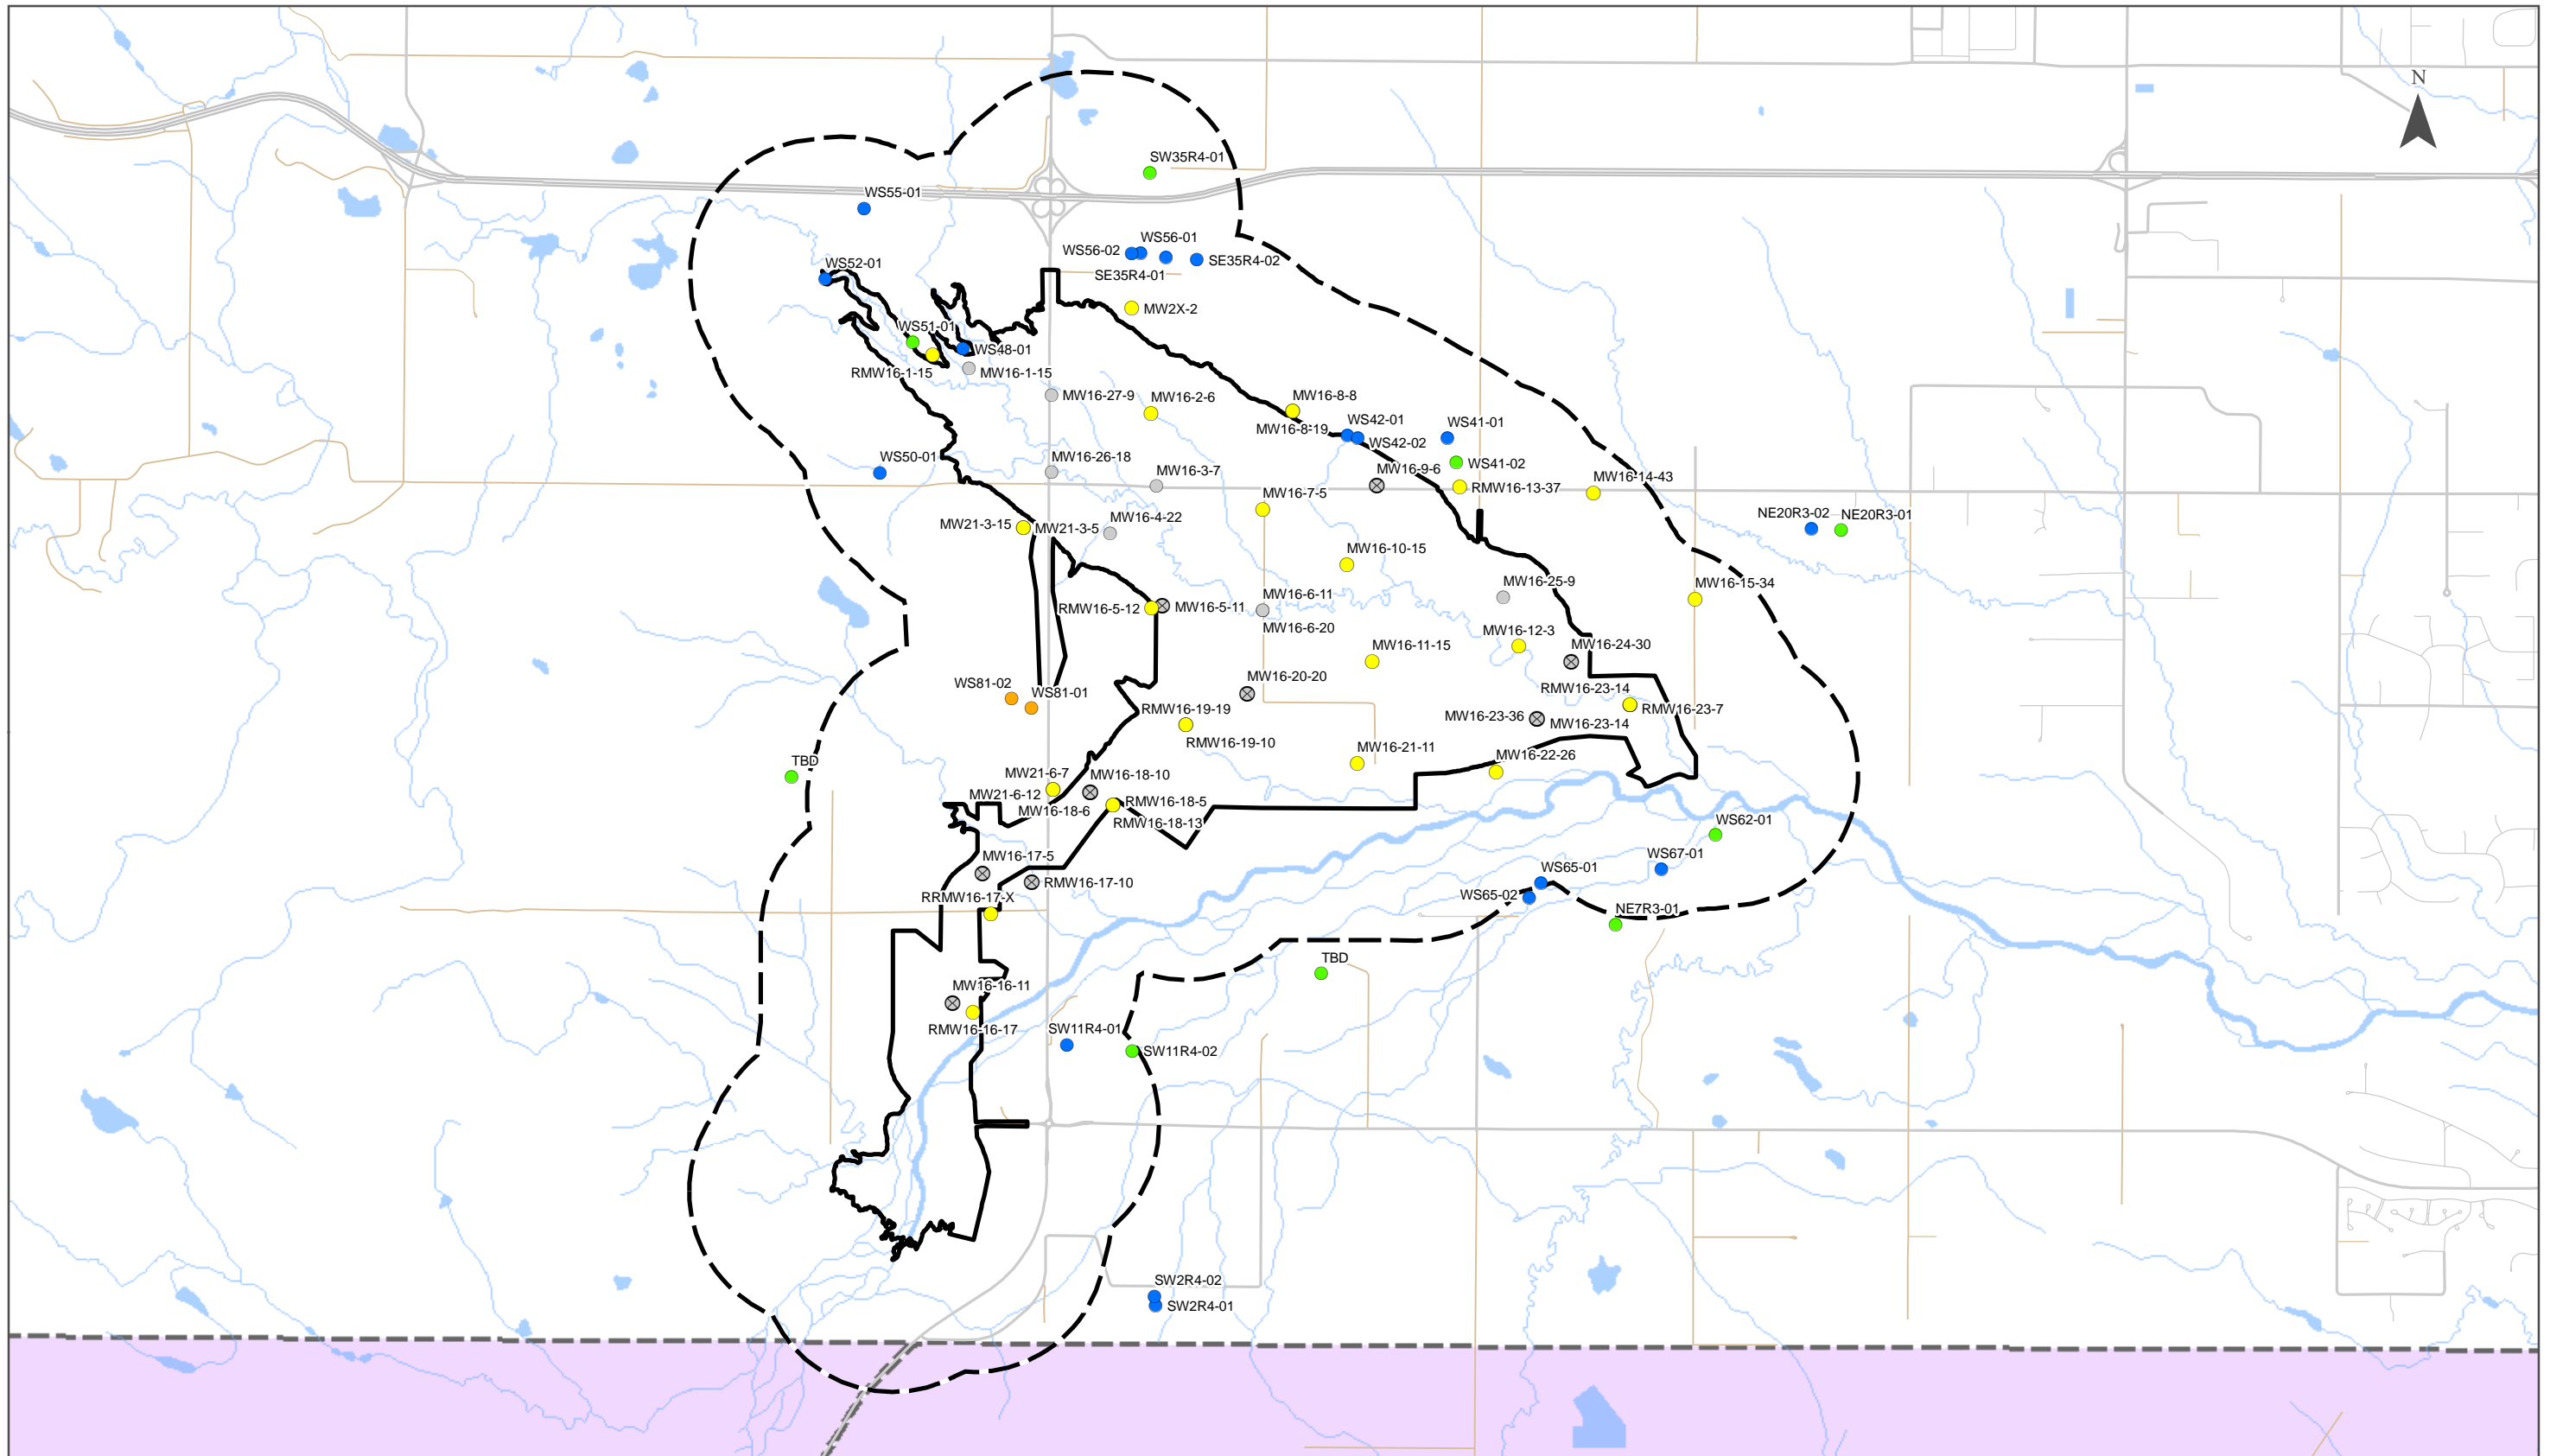
Figure 2.1 presents the layout of the current groundwater monitoring network. The density and distribution of groundwater monitoring wells is based on the need to detect potential changes to groundwater levels and quality that could arise from interactions between the Project and groundwater resources. The siting of monitoring wells considered the expected extent of effects on groundwater for construction as well as dry and flood operations.

The new and replacement monitoring well locations are presented in Figure 2.1. Borehole logs including lithological descriptions and monitoring well completion details are included in Appendix B.

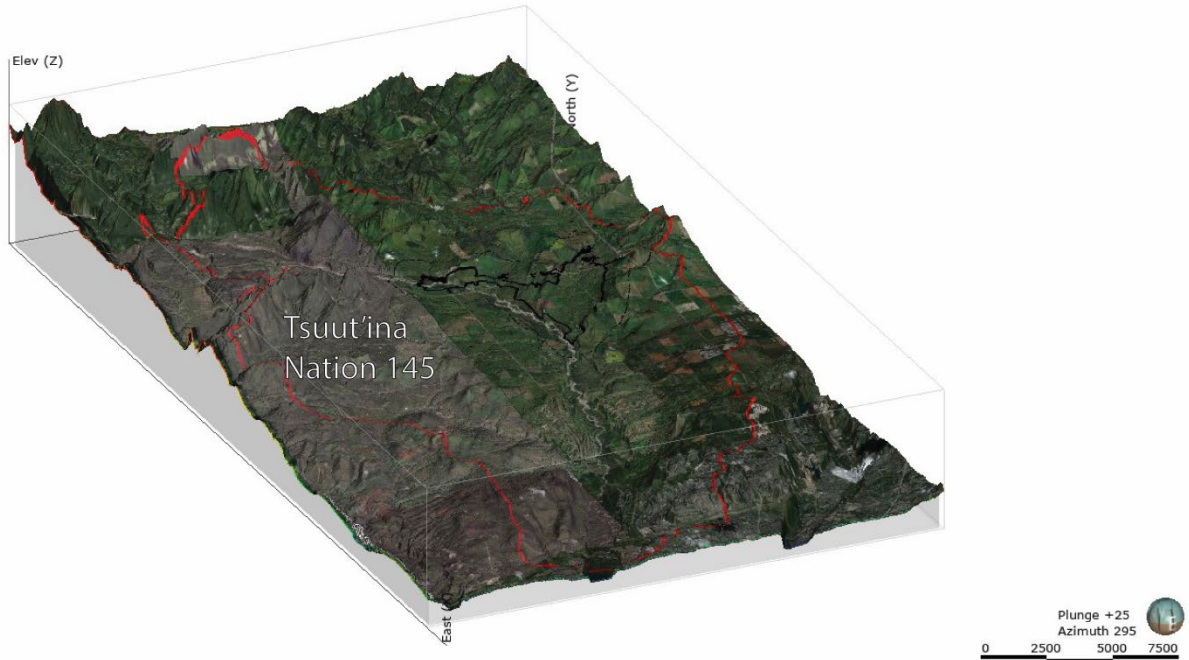
Figure A.2 Oblique Angle Overview of 3D CSM

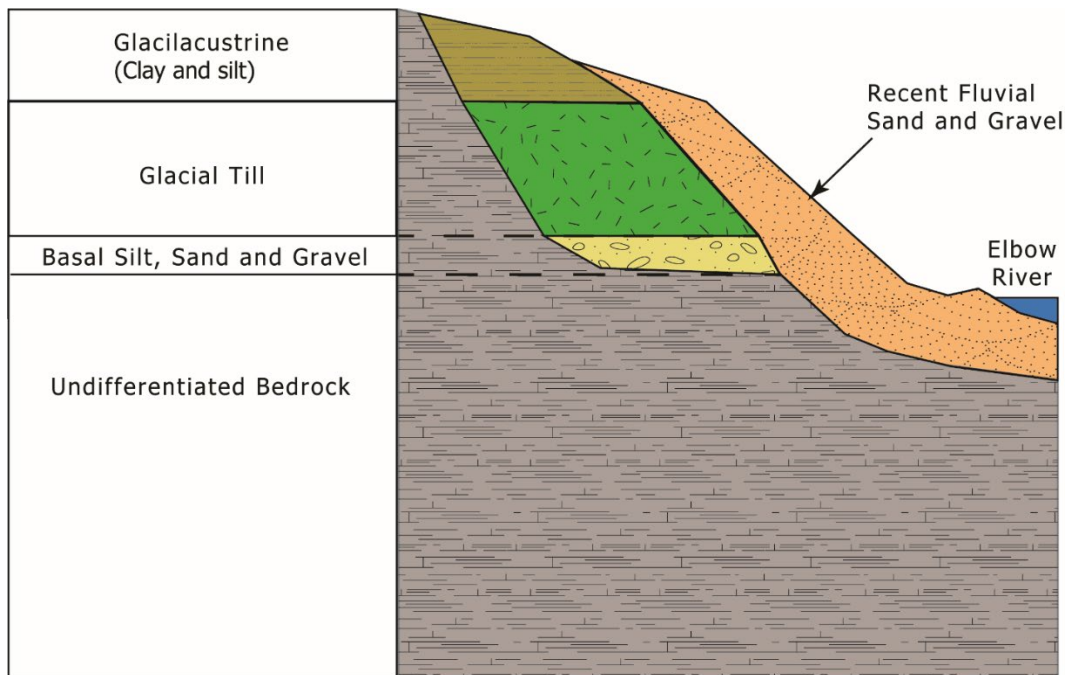
Figure A.3 Conceptual Regional Stratigraphic Column

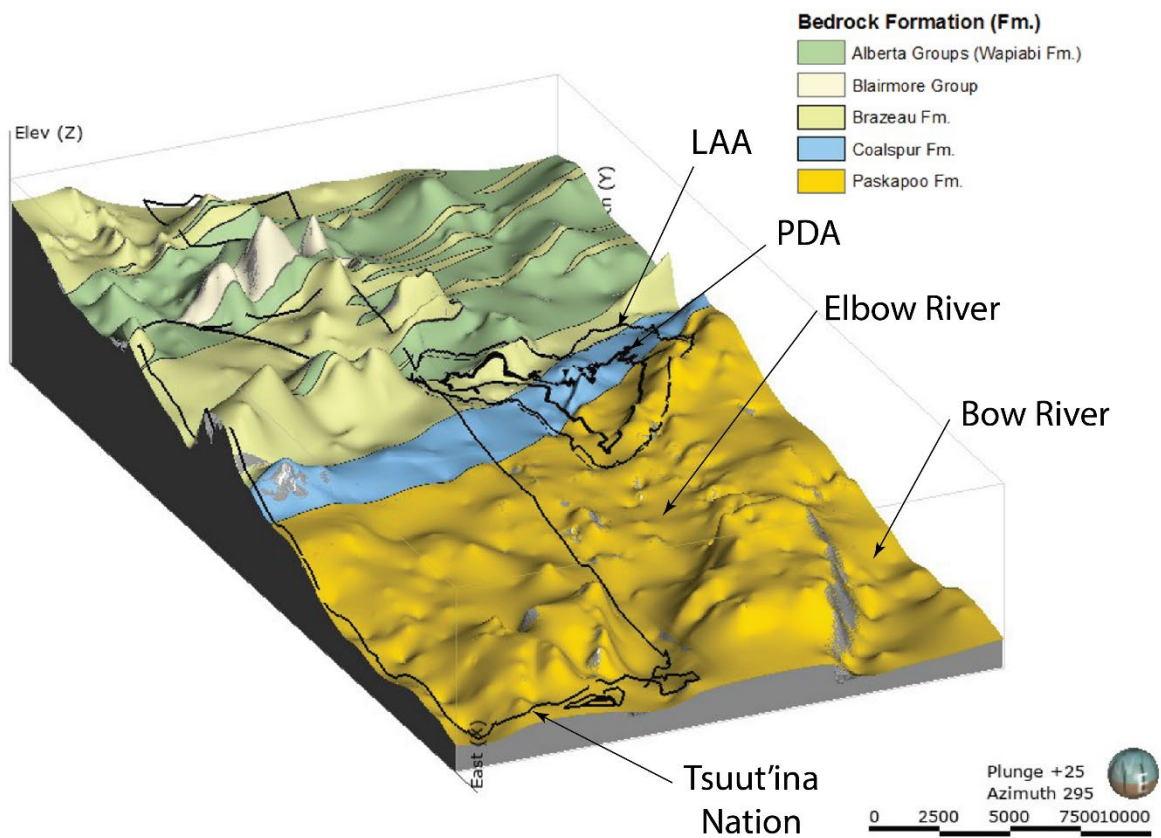
The bedrock surface within the RAA was shaped by tectonism and associated formation of the Rocky Mountains to the west, glacial erosion/deposition, and erosional incision of modern-day river channels. The RAA is in the disturbed belt which forms a transitional zone (foothills) between the Rocky Mountains to the west and prairie to the east. Bedrock topography is depicted in Figure A.4.

Figure A.4 Bedrock Topography and Subcrop Formations

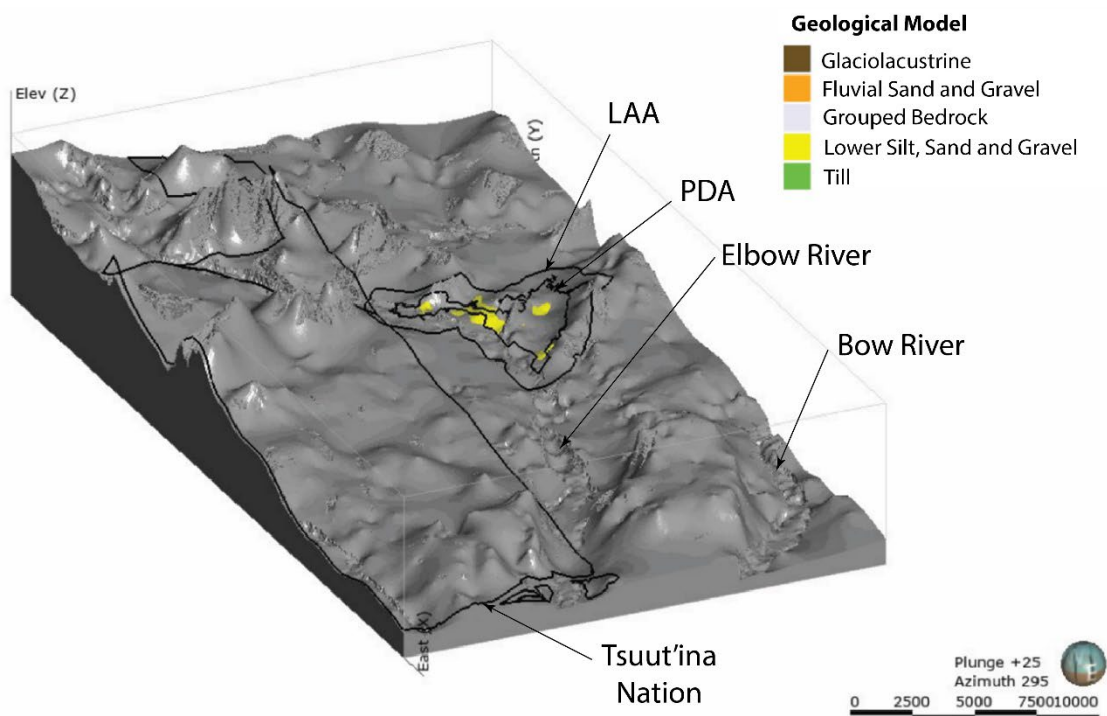
Figure A.5 Distribution of Basal Silt, Sand and Gravel

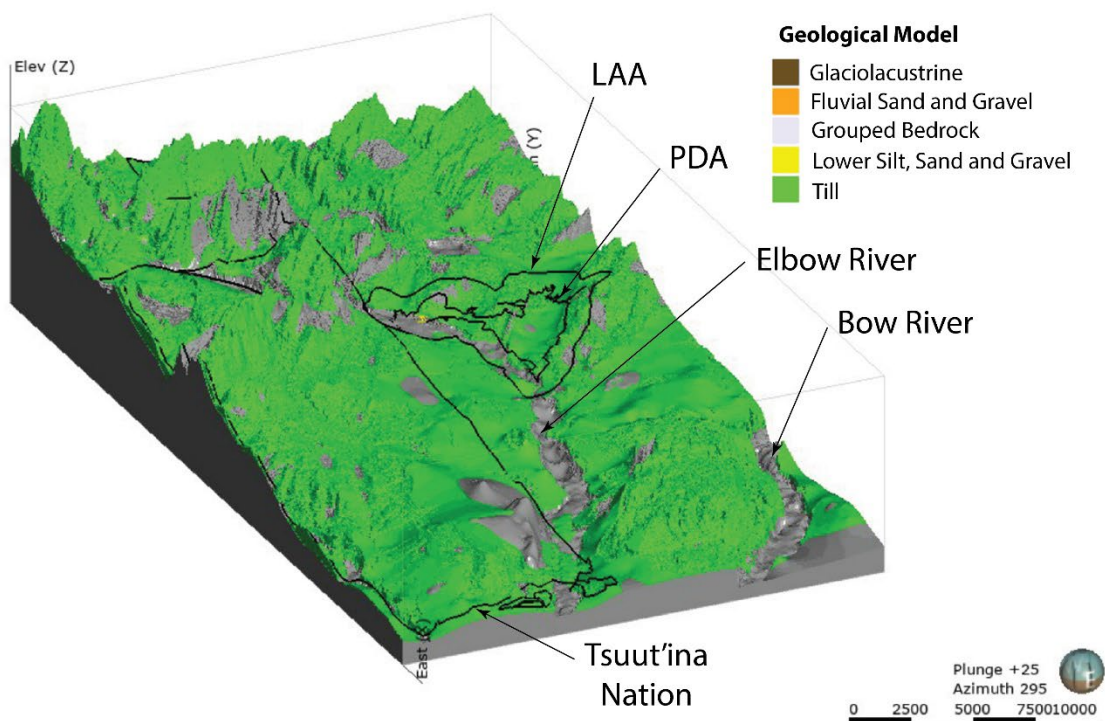
The unconsolidated deposits present beneath the majority of the RAA consist of Pleistocene Age glaciolacustrine clay and till (Fenton et al. 2013; Moran 1986). In the RAA, the till material was deposited by glacial ice as basal or lateral moraines. Based on the field observations and laboratory grain size analyses completed as part of the geotechnical drilling program, the till in the LAA is composed of a heterogeneous mixture of approximately equal parts clay and silt, a lower proportion of sand, and minor gravel. Silt and sand lenses are also present within the heterogeneous matrix. The till is described as generally stiff to very stiff or hard, medium to high plastic clay with silt and more minor sand. Where present, the till ranges in thickness from 0.2 m to greater than 50 m with an average thickness of 10 m across the RAA.

Figure A.6 Distribution of Till

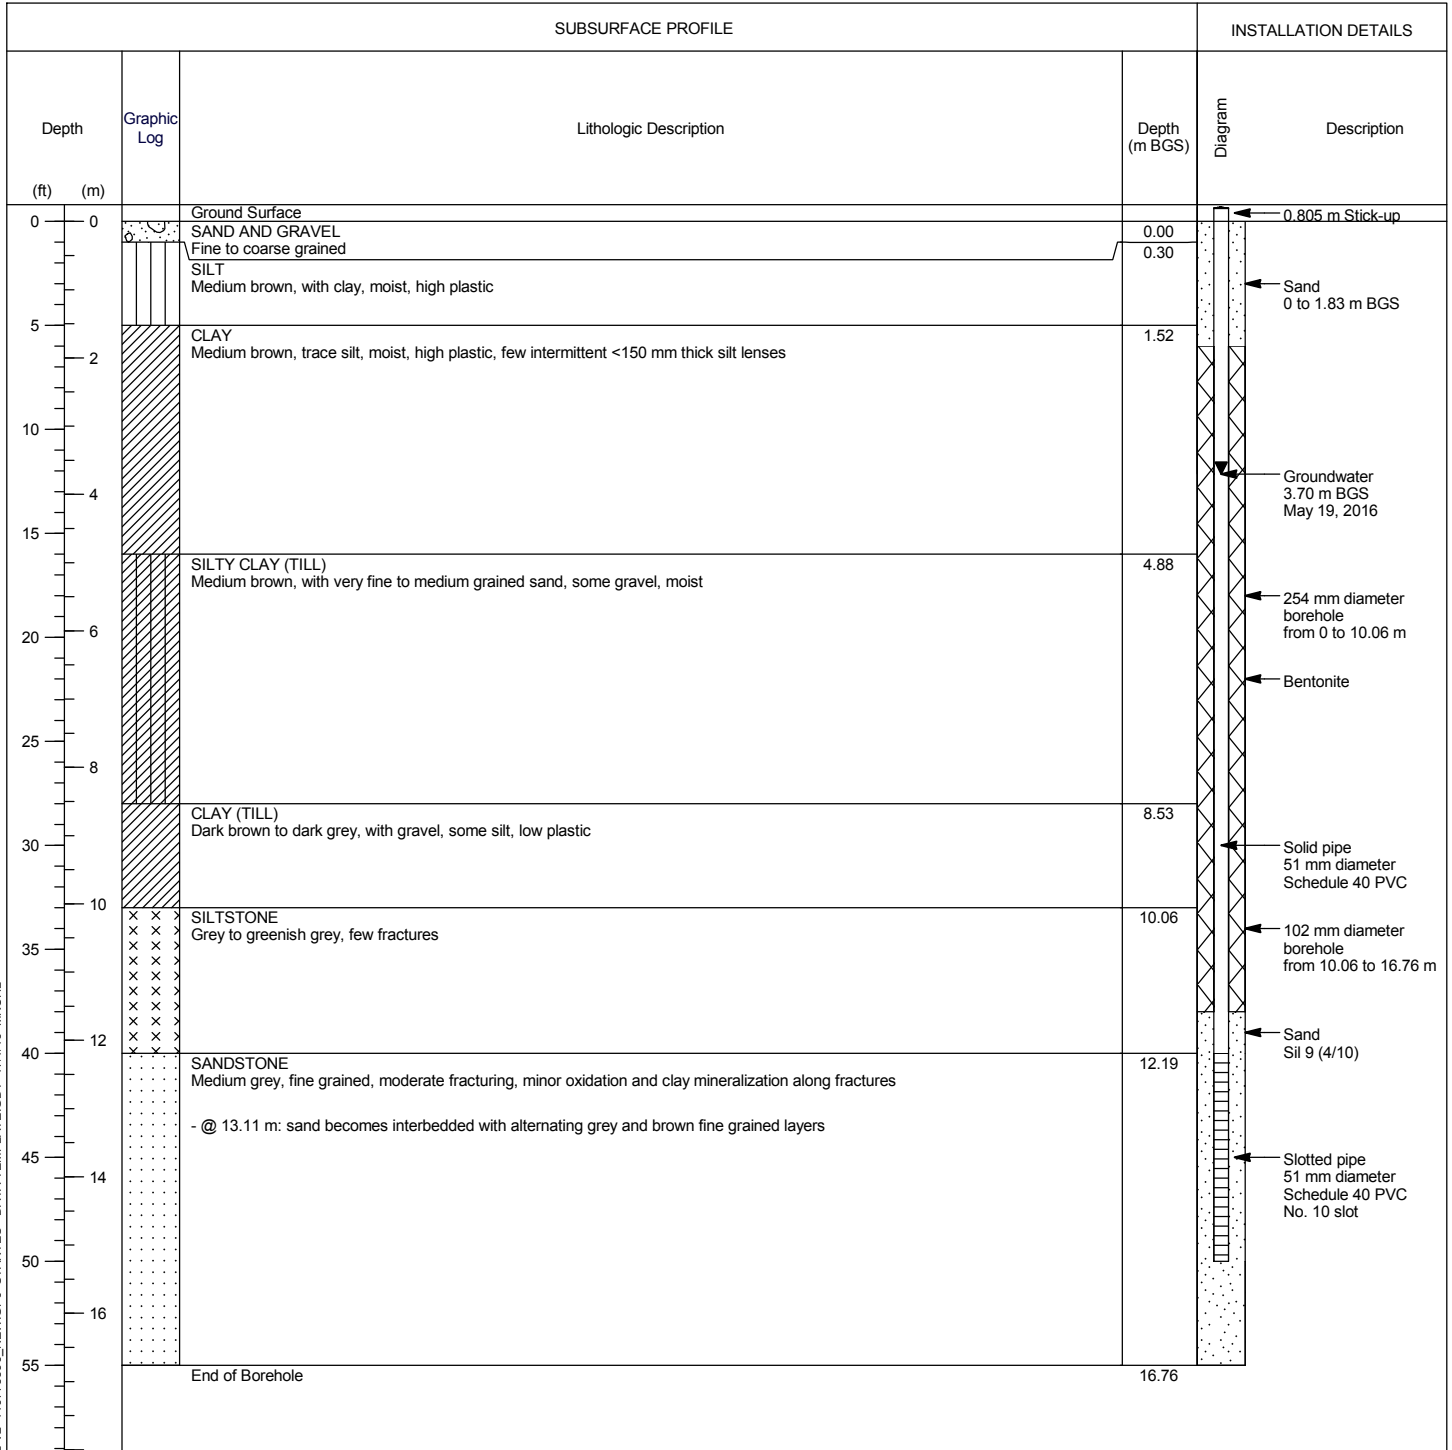
Project: Springbank Off-Stream Reservoir Project (SR1) Client: Alberta Transportation Location: Rocky View County, Alberta Number: 110773396 Field investigator: D. Nisbet Contractor: All Service Drilling Inc.	Drilling method: Hollow-stem auger (Track mounted)/ Coring Date started/completed: 19-May-2016 Ground surface elevation: n/a Top of casing elevation: n/a Easting: -33327.478 Northing: 5659967.274
---	--

Screen Interval: 12.19 - 15.24 m BGS
 Sand Pack Interval: 11.58 - 16.76 m BGS
 Well Seal Interval: 1.83 - 11.58 m BGS

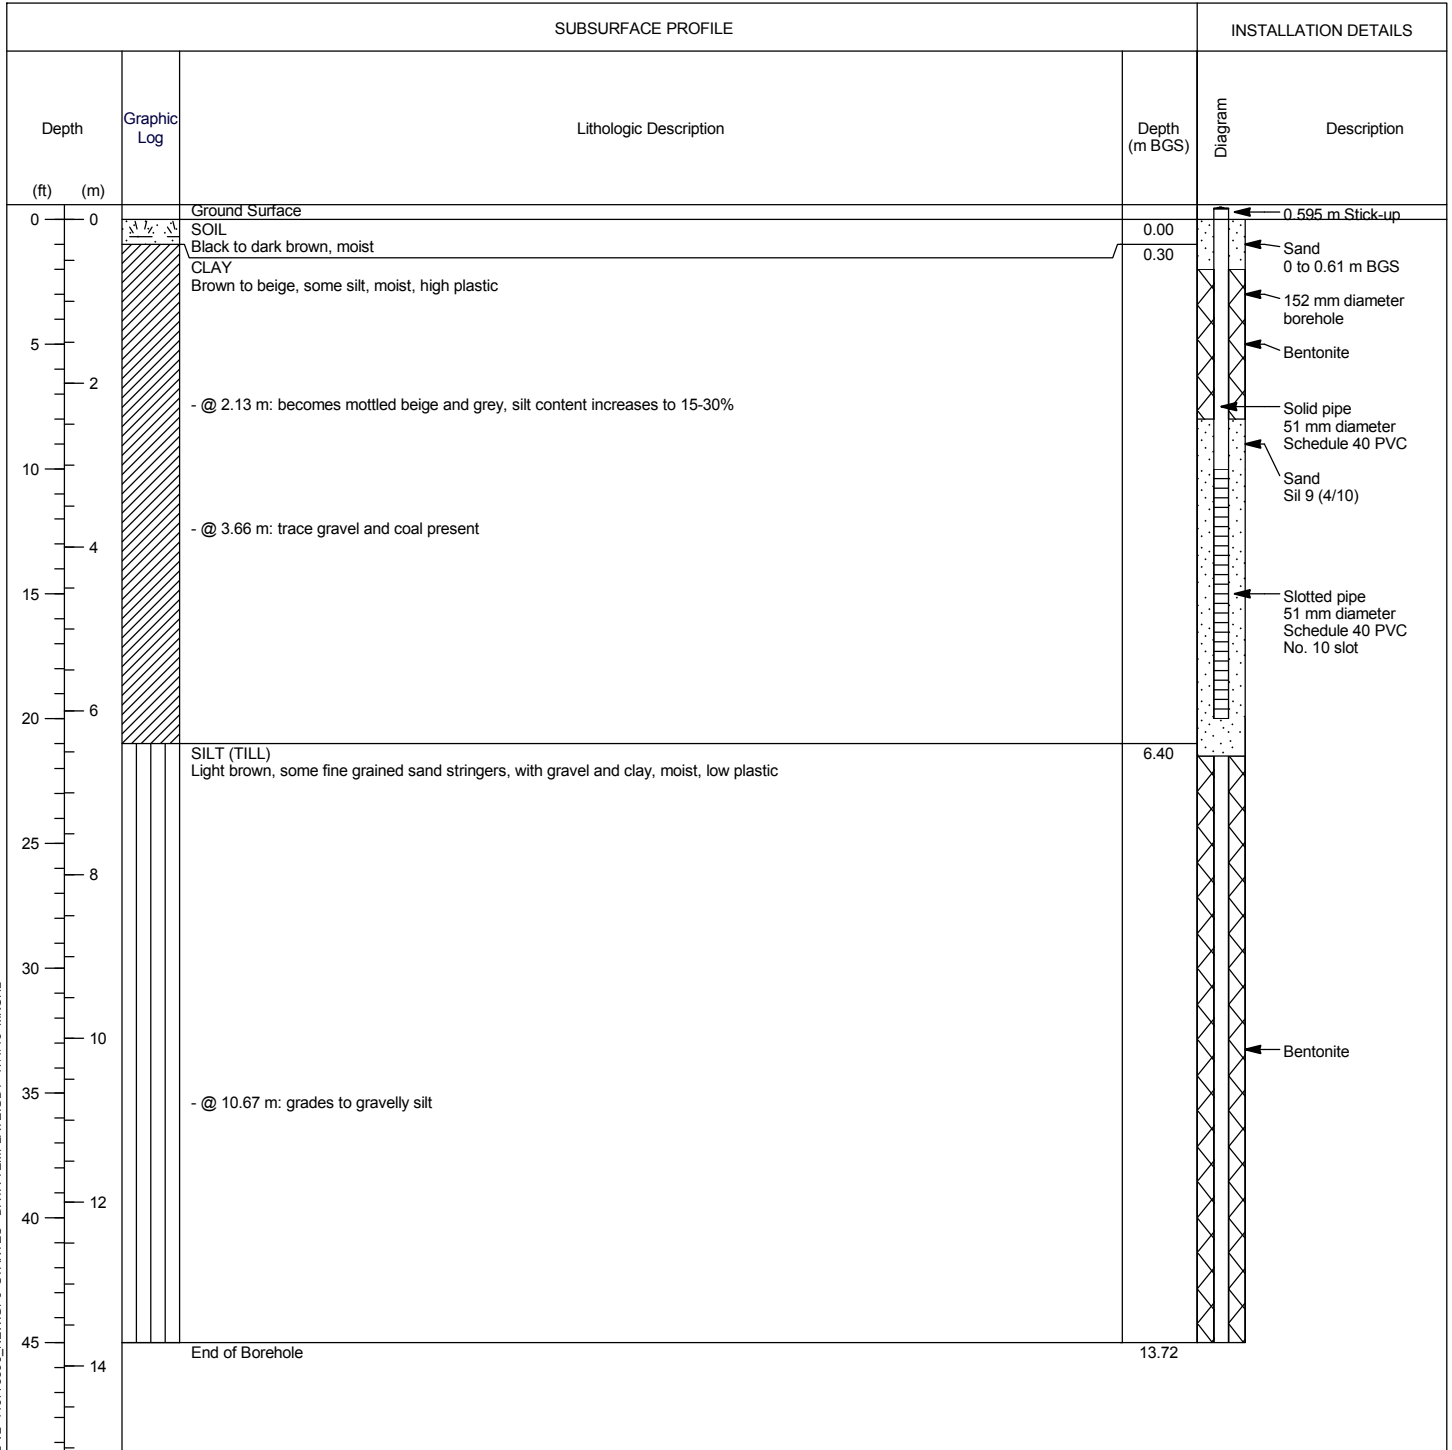
Drilling method: Solid-stem auger (Track mounted)
Date started/completed: 26-May-2016
Ground surface elevation: n/a
Top of casing elevation: n/a
Easting: -31947.274
Northing: 5659623.886

Screen Interval: 3.05 - 6.10 m BGS
 Sand Pack Interval: 2.44 - 6.55 m BGS
 Well Seal Interval: 6.55 - 13.72 m BGS

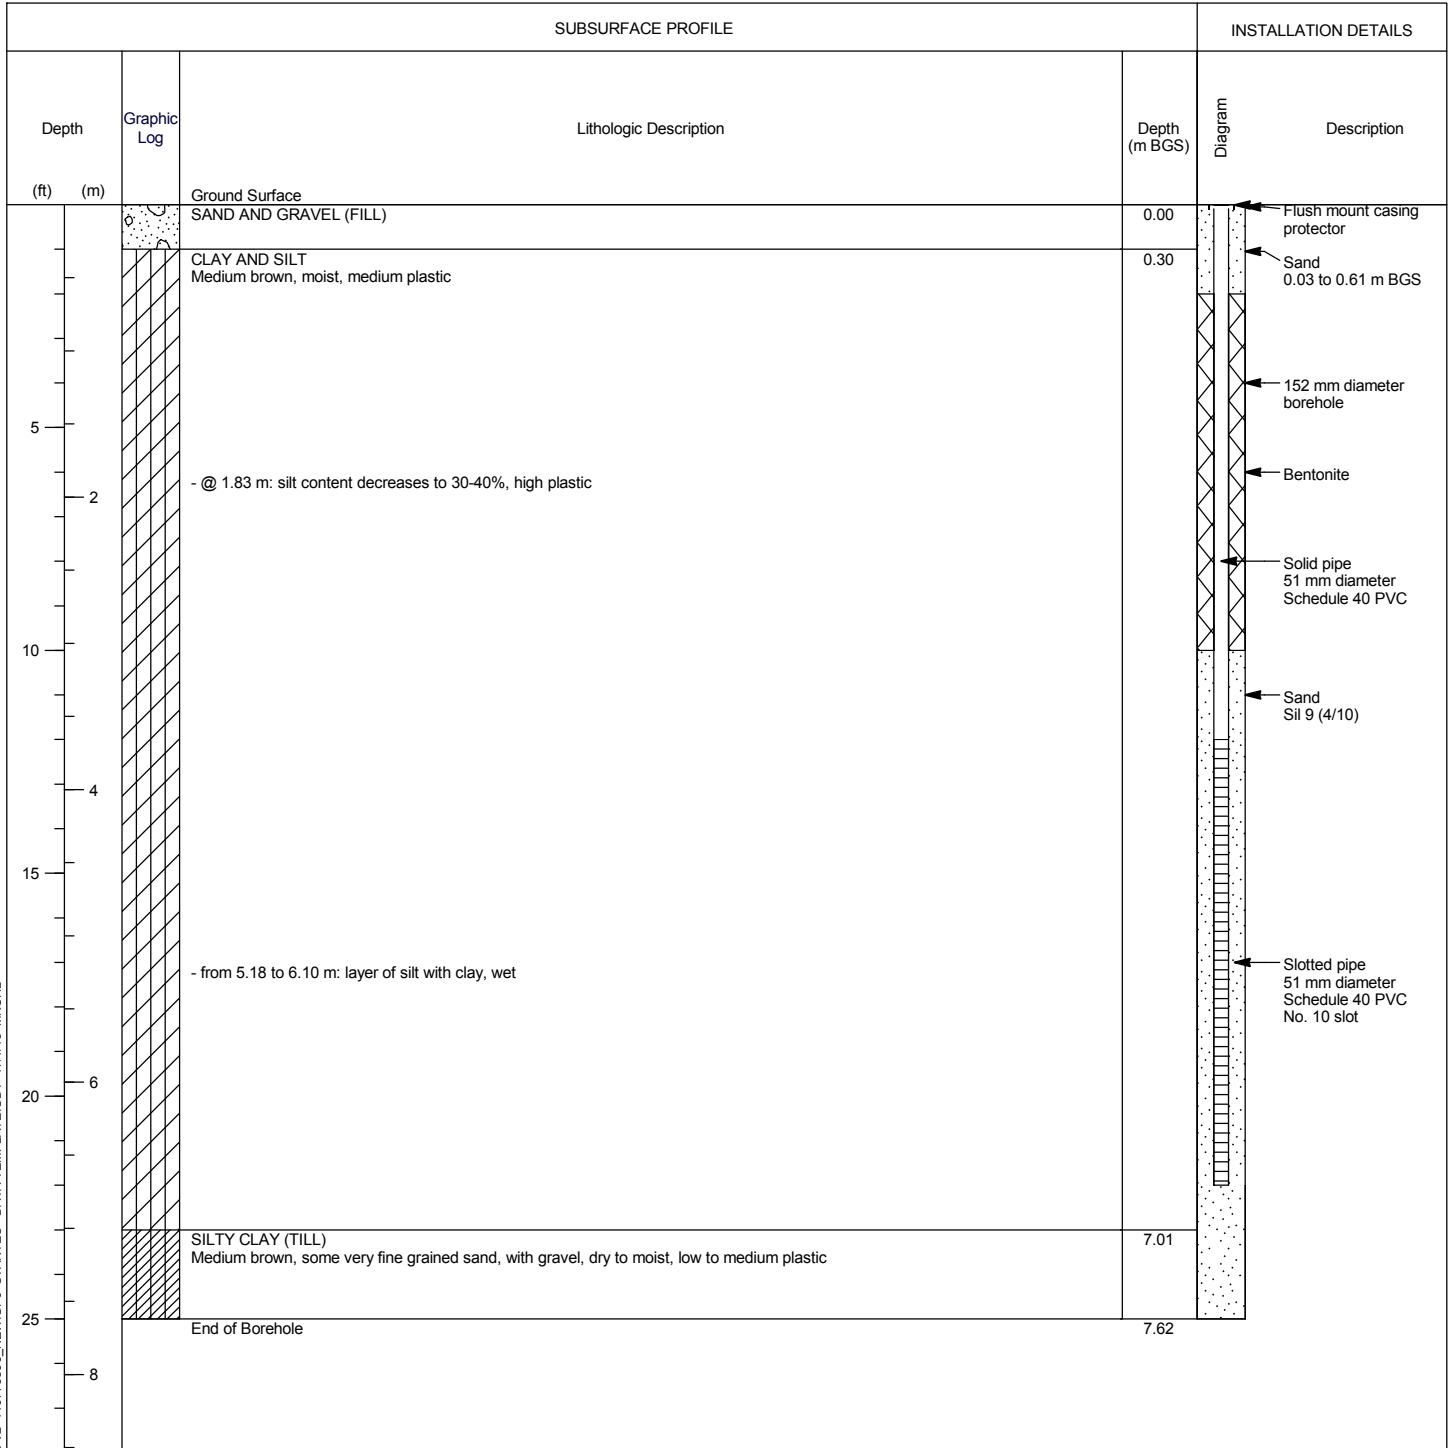
Drilling method: Solid-stem auger (Truck mounted)
Date started/completed: 29-Jul-2016
Ground surface elevation: n/a
Top of casing elevation: n/a
Easting: -31904.435
Northing: 5659073.461

Screen Interval: 3.66 - 6.71 m BGS
 Sand Pack Interval: 3.05 - 7.62 m BGS
 Well Seal Interval: 0.61 - 3.05 m BGS
