Springbank Off-stream Reservoir Project

Impact Assessment Agency
of Canada
Annual Report - 2021/2022
Reporting Year

Prepared for:
Alberta Transportation

Prepared by:
Stantec Consulting Ltd.

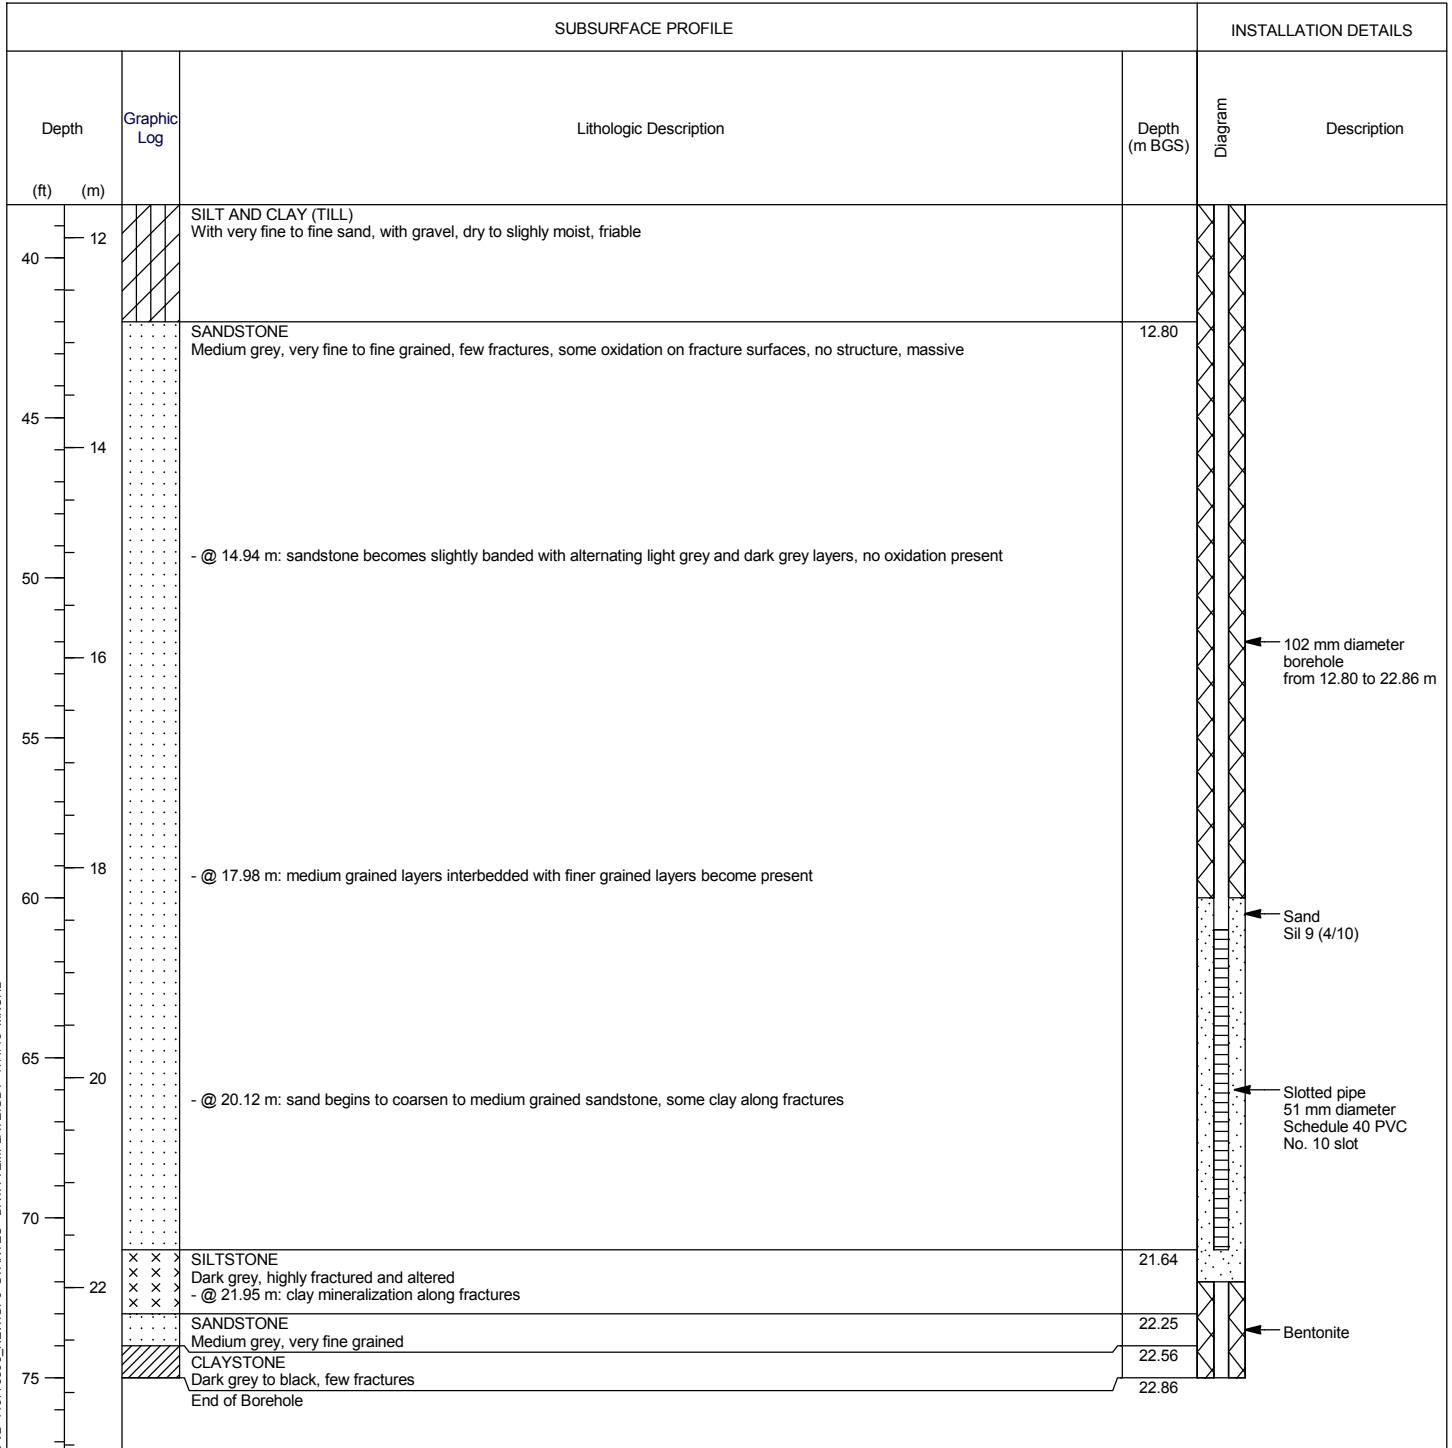
Monitoring Well: MW16-4-22 (GW4)

Project: Springbank Off-Stream Reservoir Project (SR1) Client: Alberta Transportation Location: Rocky View County, Alberta Number: 110773396 Field investigator: D. Nisbet Contractor: All Service Drilling Inc.	Drilling method: Hollow-stem auger (Track mounted)/ Coring Date started/completed: 20-May-2016 Ground surface elevation: n/a Top of casing elevation: n/a Easting: -32259.324 Northing: 5658717.399
---	--

Screen Interval: 18.59 - 21.64 m BGS
 Sand Pack Interval: 18.29 - 21.95 m BGS
 Well Seal Interval: 21.95 - 22.86 m BGS

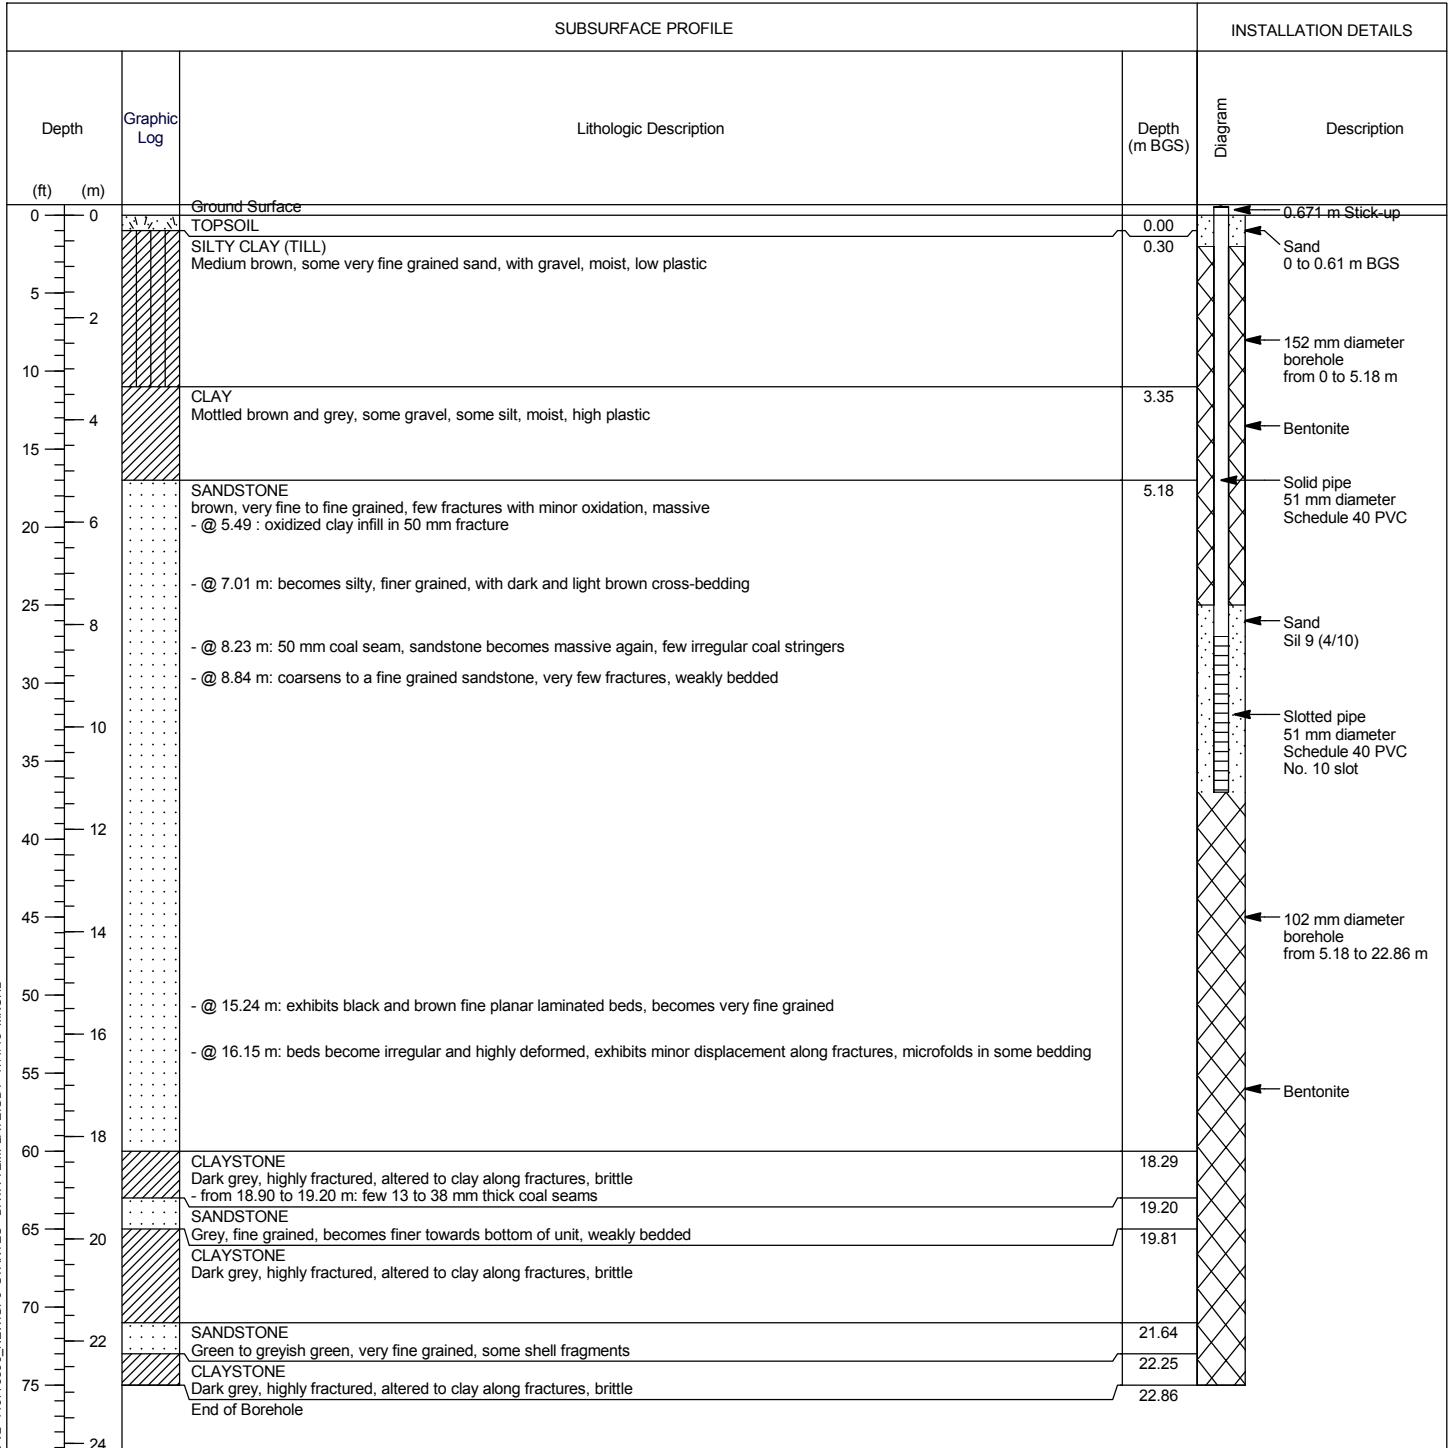
Monitoring Well: MW16-5-11 (GW5)

Project: Springbank Off-Stream Reservoir Project (SR1) Client: Alberta Transportation Location: Rocky View County, Alberta Number: 110773396 Field investigator: D. Nisbet Contractor: All Service Drilling Inc.	Drilling method: Solid-stem auger (Track mounted)/ Coring Date started/completed: 09-Jun-2016 Ground surface elevation: n/a Top of casing elevation: n/a Easting: -31863.152 Northing: 5658164.716
---	---

Screen Interval: 8.23 - 11.28 m BGS
 Sand Pack Interval: 7.62 - 11.28 m BGS
 Well Seal Interval: 0.61 - 7.62 m BGS

- installation of replacement monitoring wells RWM16-19-10 and RMW16-19-19 following removal of the original wells (MW16-19-8 and MW16-19-19) by the landowner
- decommissioning of monitoring well MW16-5-11 and replacement installation of RMW15-5-12 outside of the design flood wetted perimeter of the reservoir

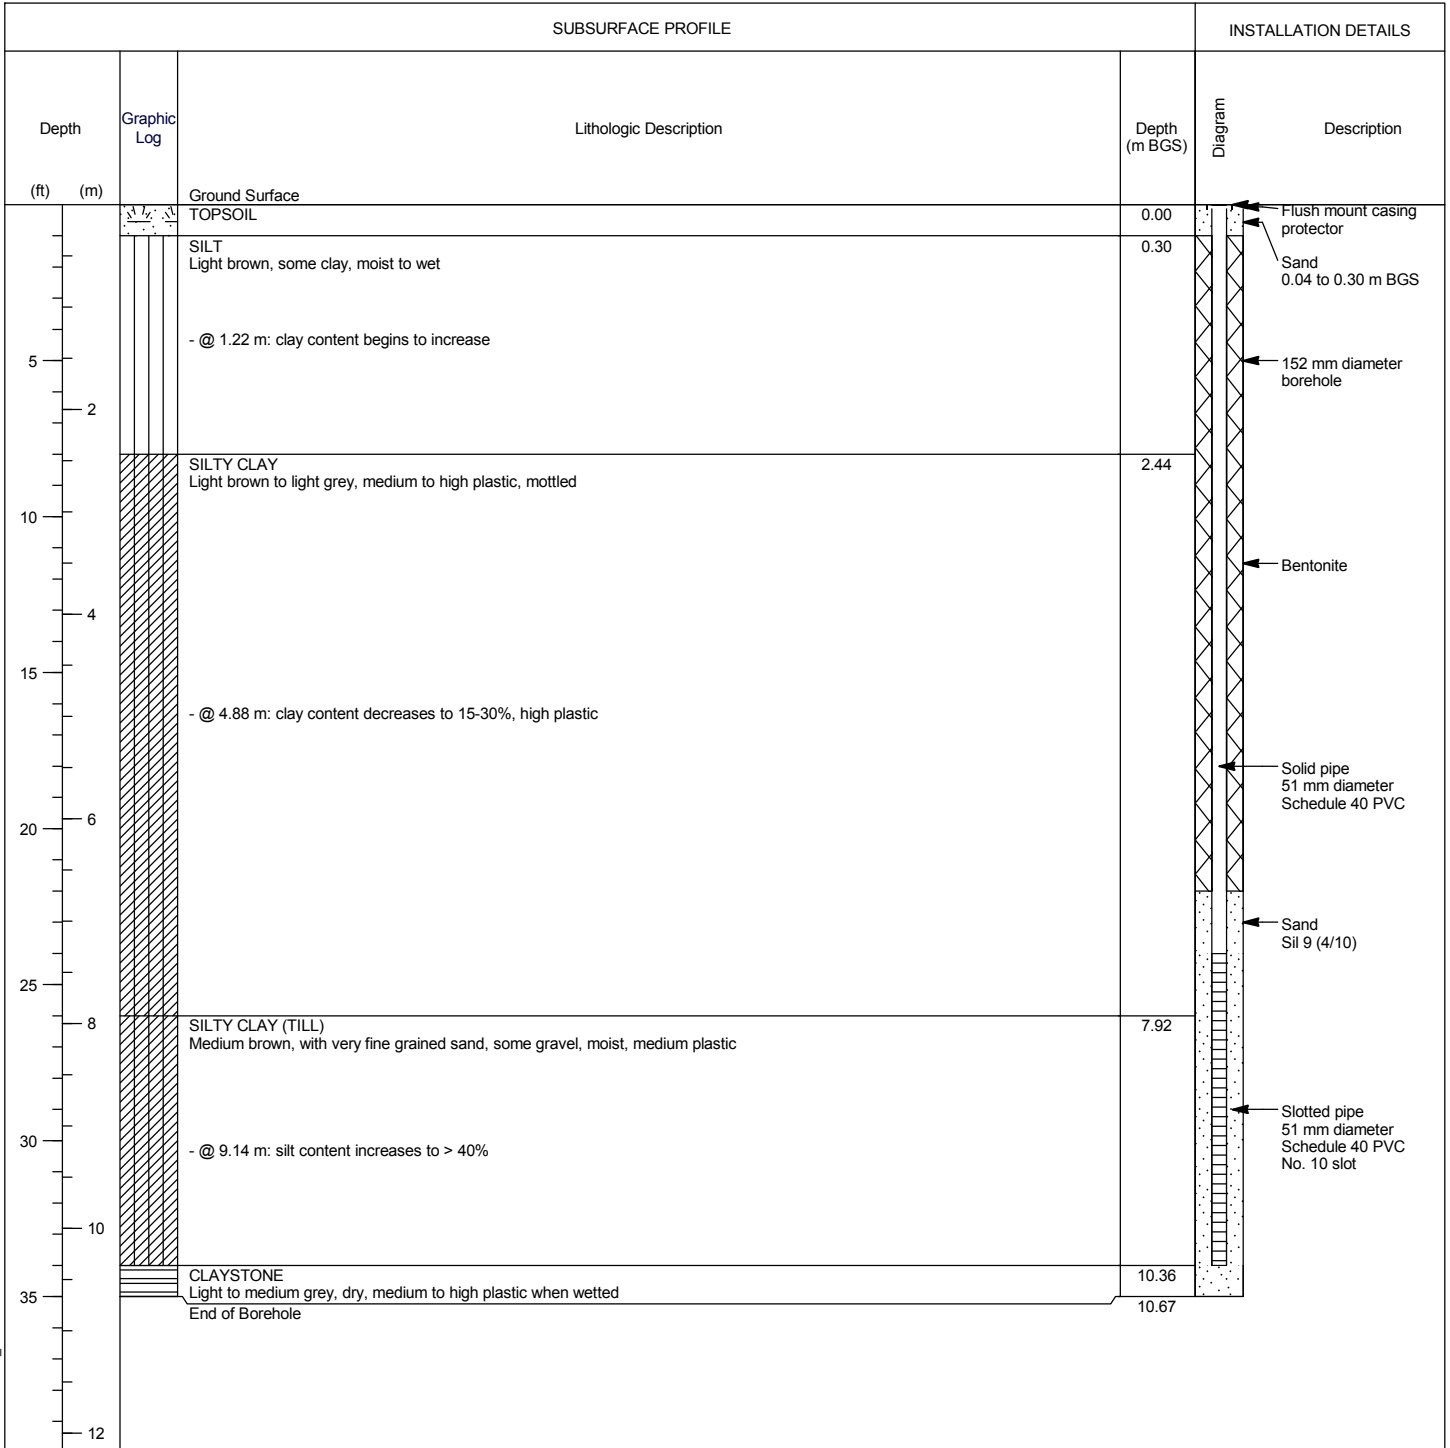
Drilling method: Solid-stem auger (Truck mounted)
Date started/completed: 26-Aug-2016
Ground surface elevation: n/a
Top of casing elevation: n/a
Easting: -31100.486
Northing: 5658135.293

Screen Interval: 7.32 - 10.36 m BGS
 Sand Pack Interval: 6.71 - 10.67 m BGS
 Well Seal Interval: 0.30 - 6.71 m BGS

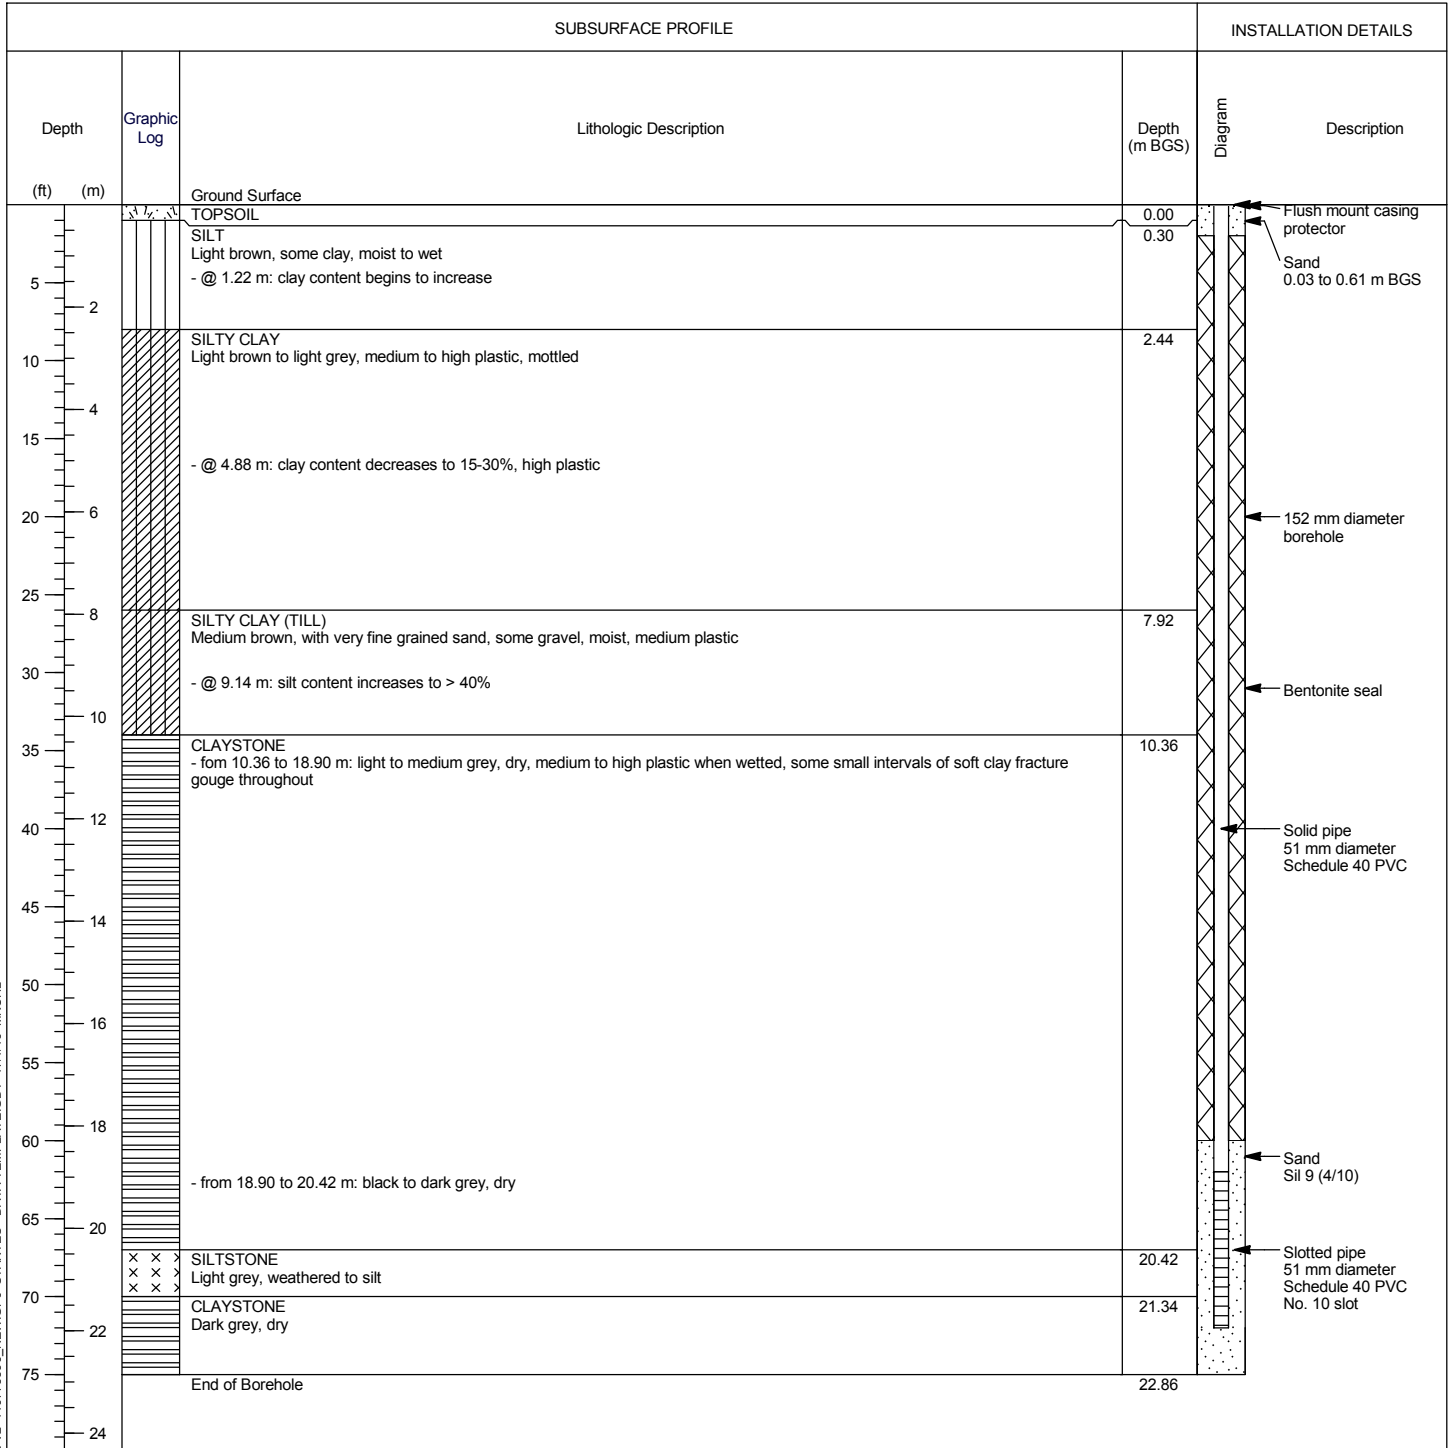
Drilling method: Solid-stem auger (Truck mounted)
Date started/completed: 26-Aug-2016
Ground surface elevation: n/a
Top of casing elevation: n/a
Easting: -31100.423
Northing: 5658133.938

Screen Interval: 18.90 - 21.95 m BGS
 Sand Pack Interval: 18.29 - 22.86 m BGS
 Well Seal Interval: 0.61 - 18.29 m BGS

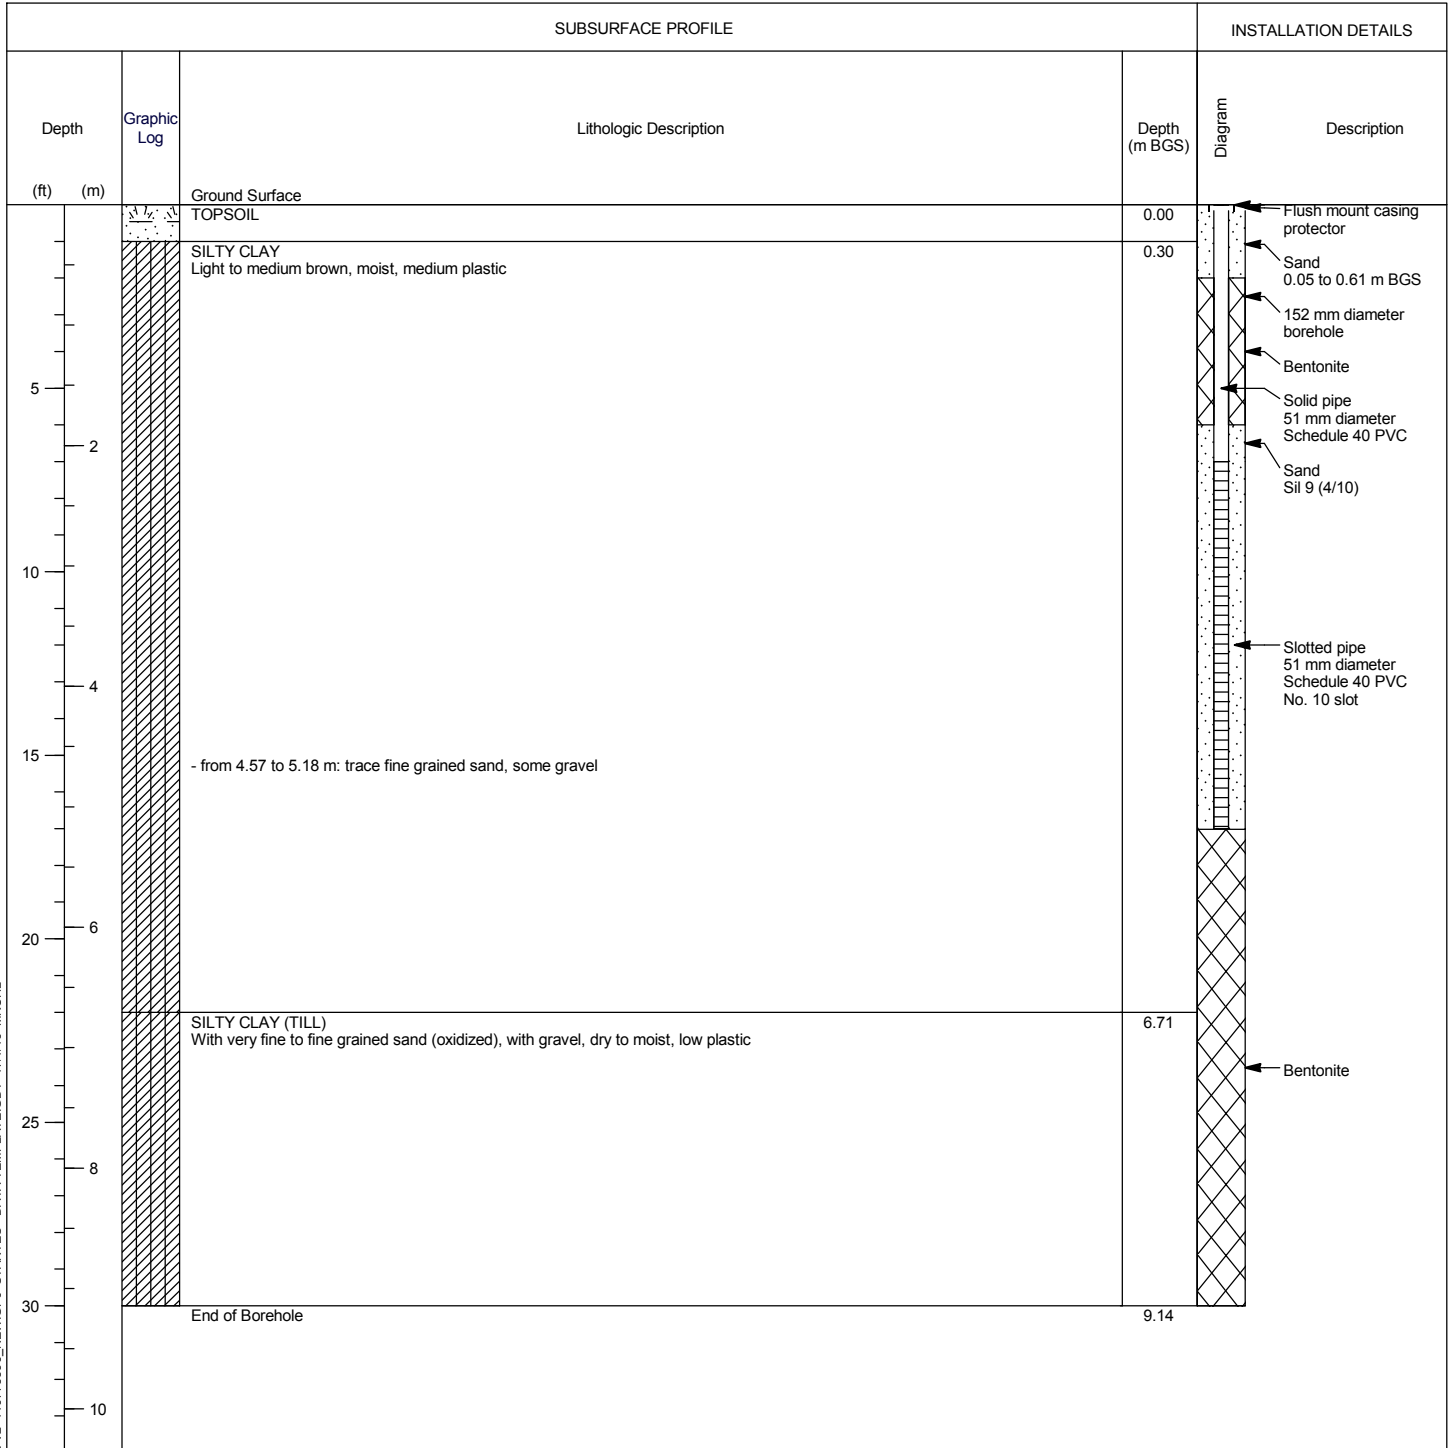
Drilling method: Solid-stem auger (Truck mounted)
Date started/completed: 28-Jul-2016
Ground surface elevation: n/a
Top of casing elevation: n/a
Easting: -31098.792
Northing: 5658895.242

Screen Interval: 2.13 - 5.18 m BGS
 Sand Pack Interval: 1.83 - 5.19 m BGS
 Well Seal Interval: 0.61 - 1.83 m BGS

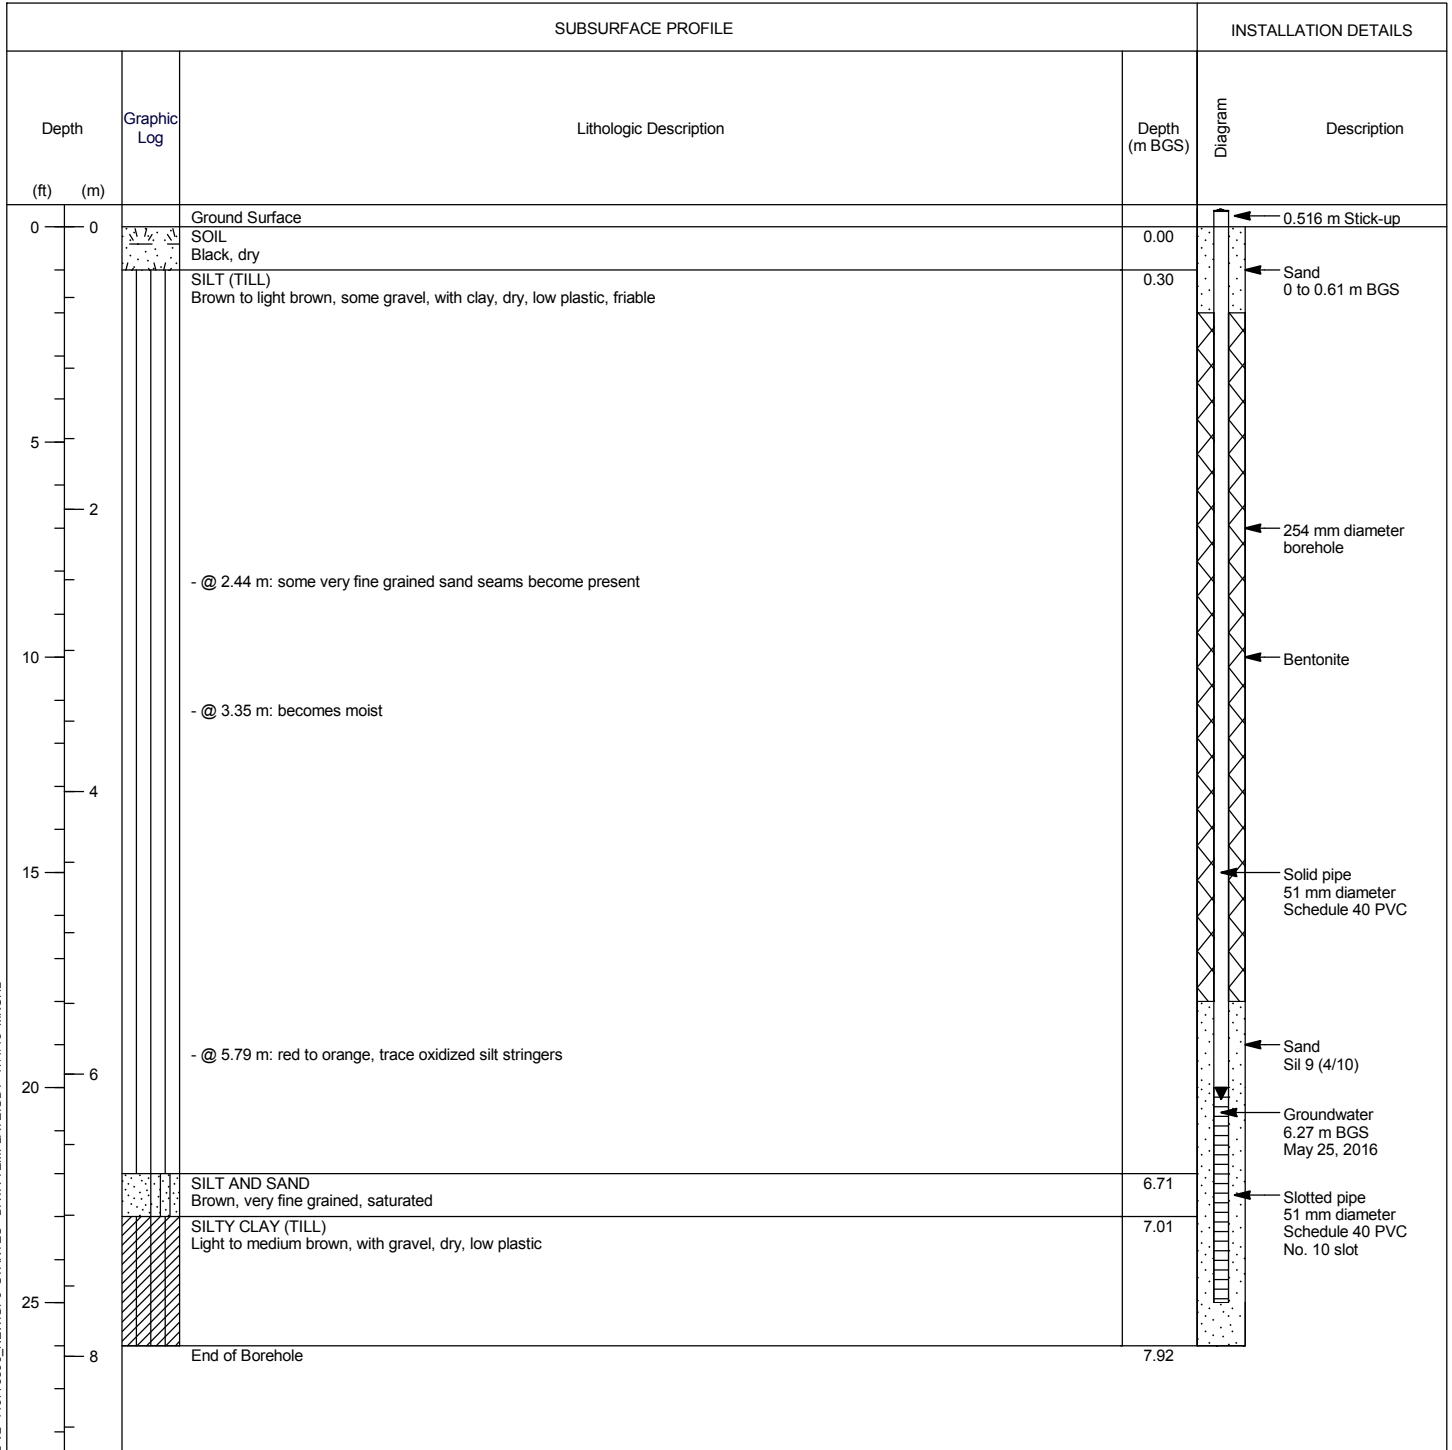
Drilling method: Hollow-stem auger (Track mounted)
Date started/completed: 25-May-2016
Ground surface elevation: n/a
Top of casing elevation: n/a
Easting: -30875.717
Northing: 5659641.119

Screen Interval: 6.10 - 7.62 m BGS
 Sand Pack Interval: 5.49 - 7.92 m BGS
 Well Seal Interval: 0.61 - 5.49 m BGS

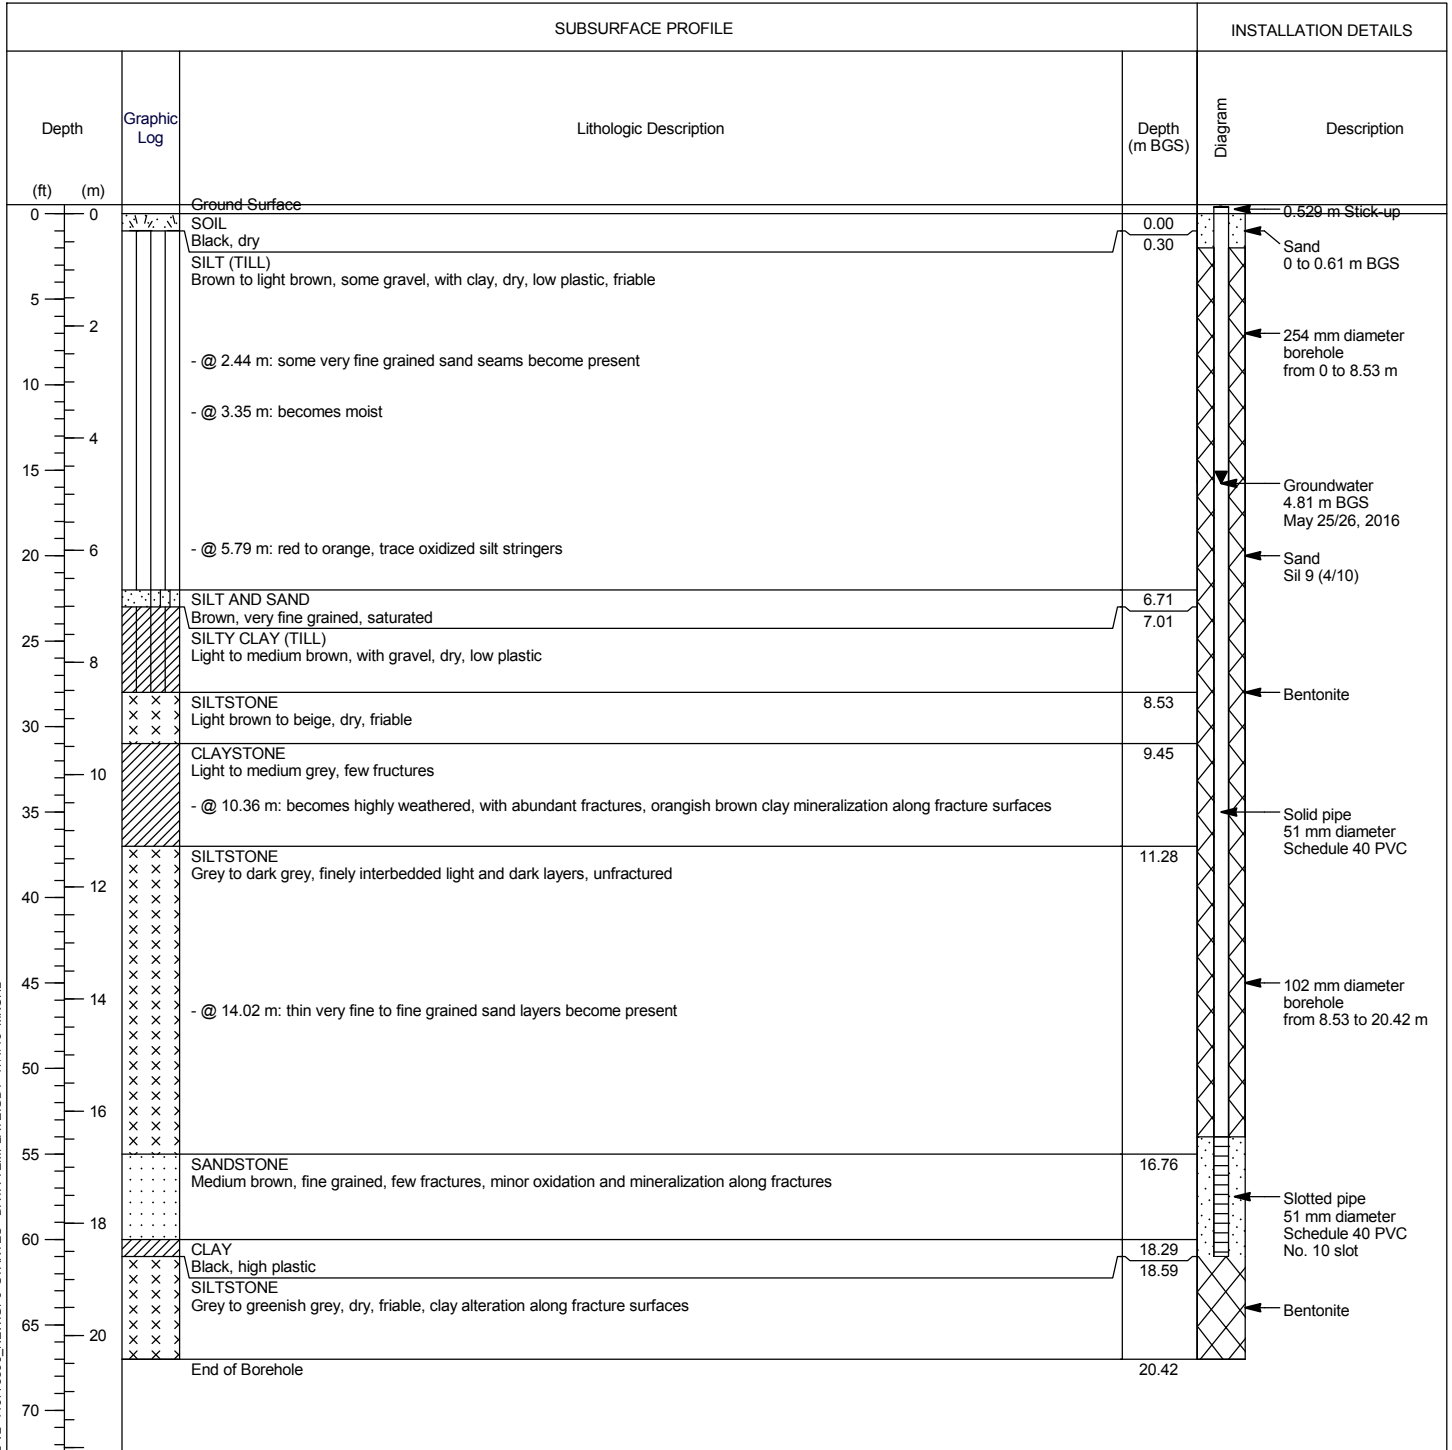
Project: Springbank Off-Stream Reservoir Project (SR1) Client: Alberta Transportation Location: Rocky View County, Alberta Number: 110773396 Field investigator: D. Nisbet Contractor: All Service Drilling Inc.	Drilling method: Hollow-stem auger (Track mounted)/ Coring Date started/completed: 25-May-2016 / 26-May-2016 Ground surface elevation: n/a Top of casing elevation: n/a Easting: -30877.454 Northing: 5659641.18
---	---

Screen Interval: 16.46 - 18.59 m BGS
 Sand Pack Interval: 16.46 - 18.59 m BGS
 Well Seal Interval: 0.61 - 16.46 m BGS

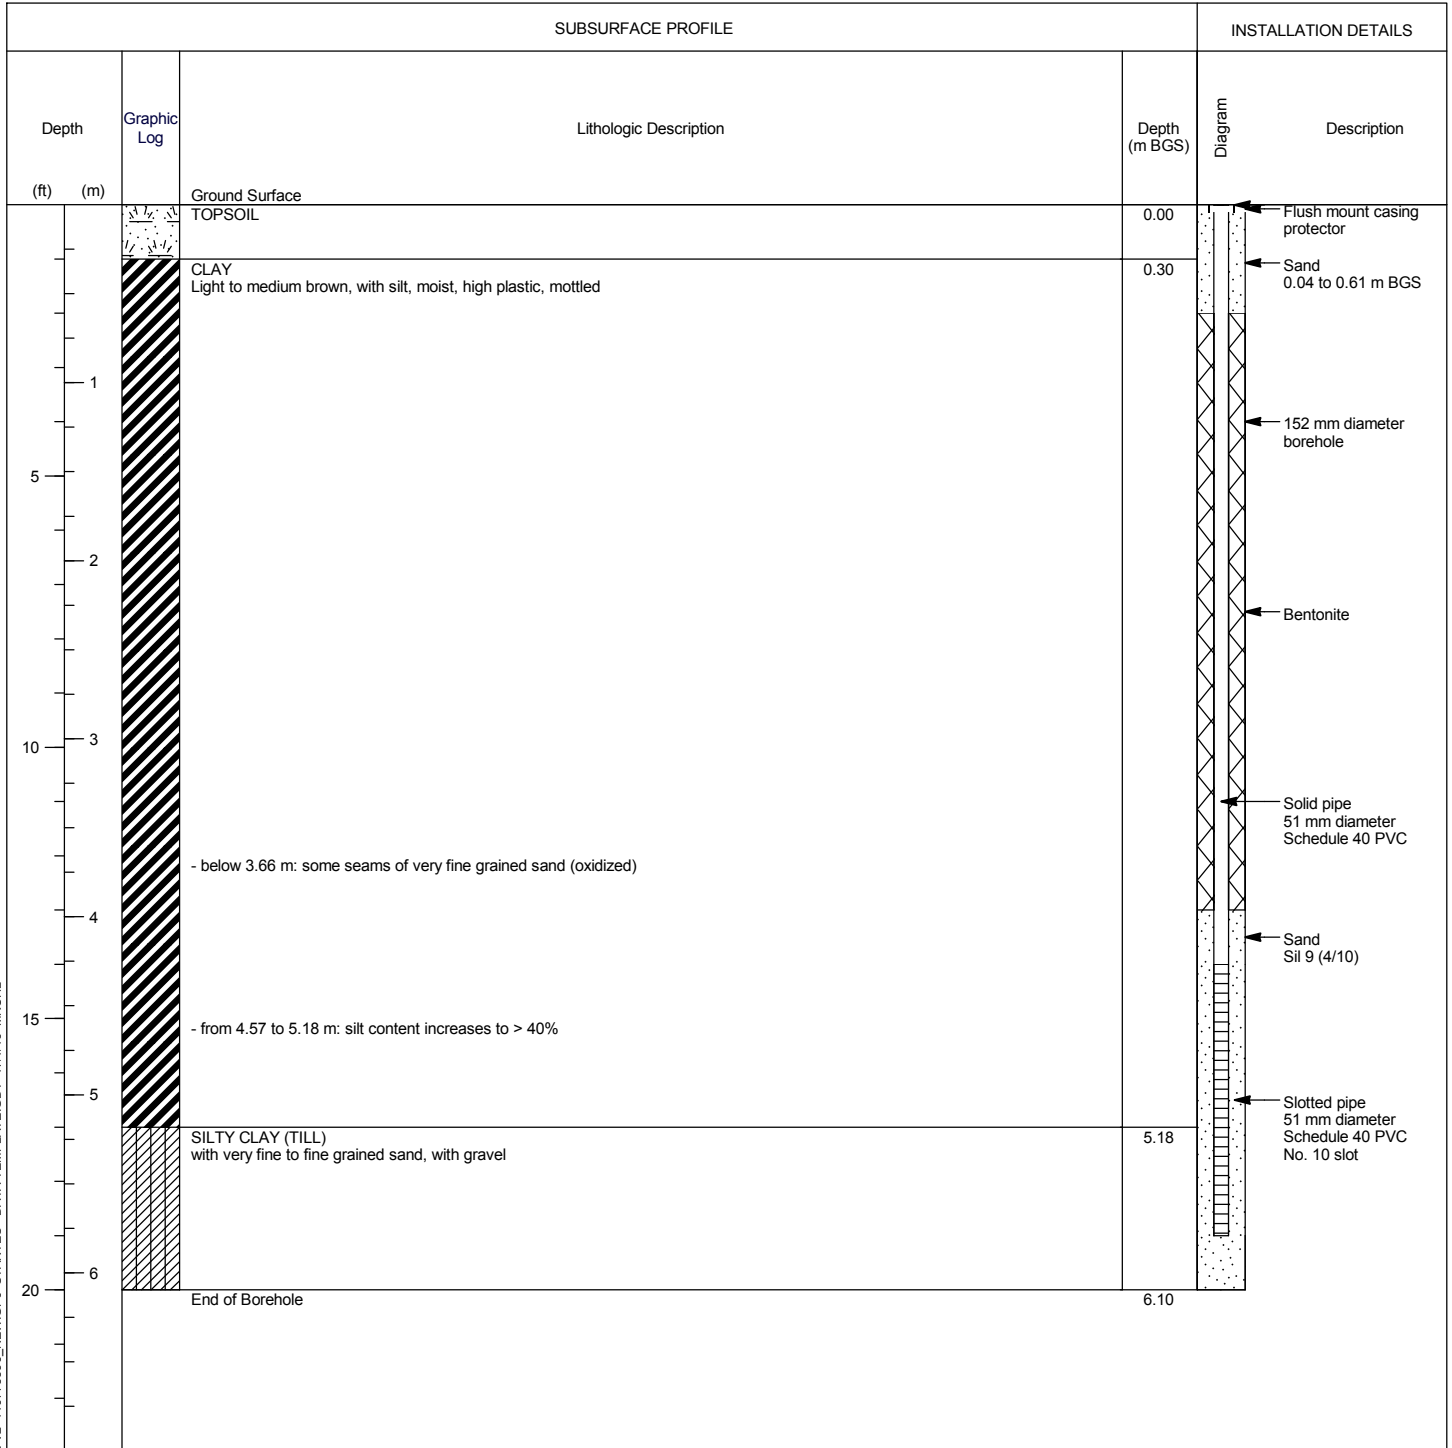
Drilling method: Solid-stem auger (Truck mounted)
Date started/completed: 02-Aug-2016
Ground surface elevation: n/a
Top of casing elevation: n/a
Easting: -30236.405
Northing: 5659076.781

Screen Interval: 4.27 - 5.79 m BGS
 Sand Pack Interval: 3.96 - 6.10 m BGS
 Well Seal Interval: 0.61 - 3.96 m BGS

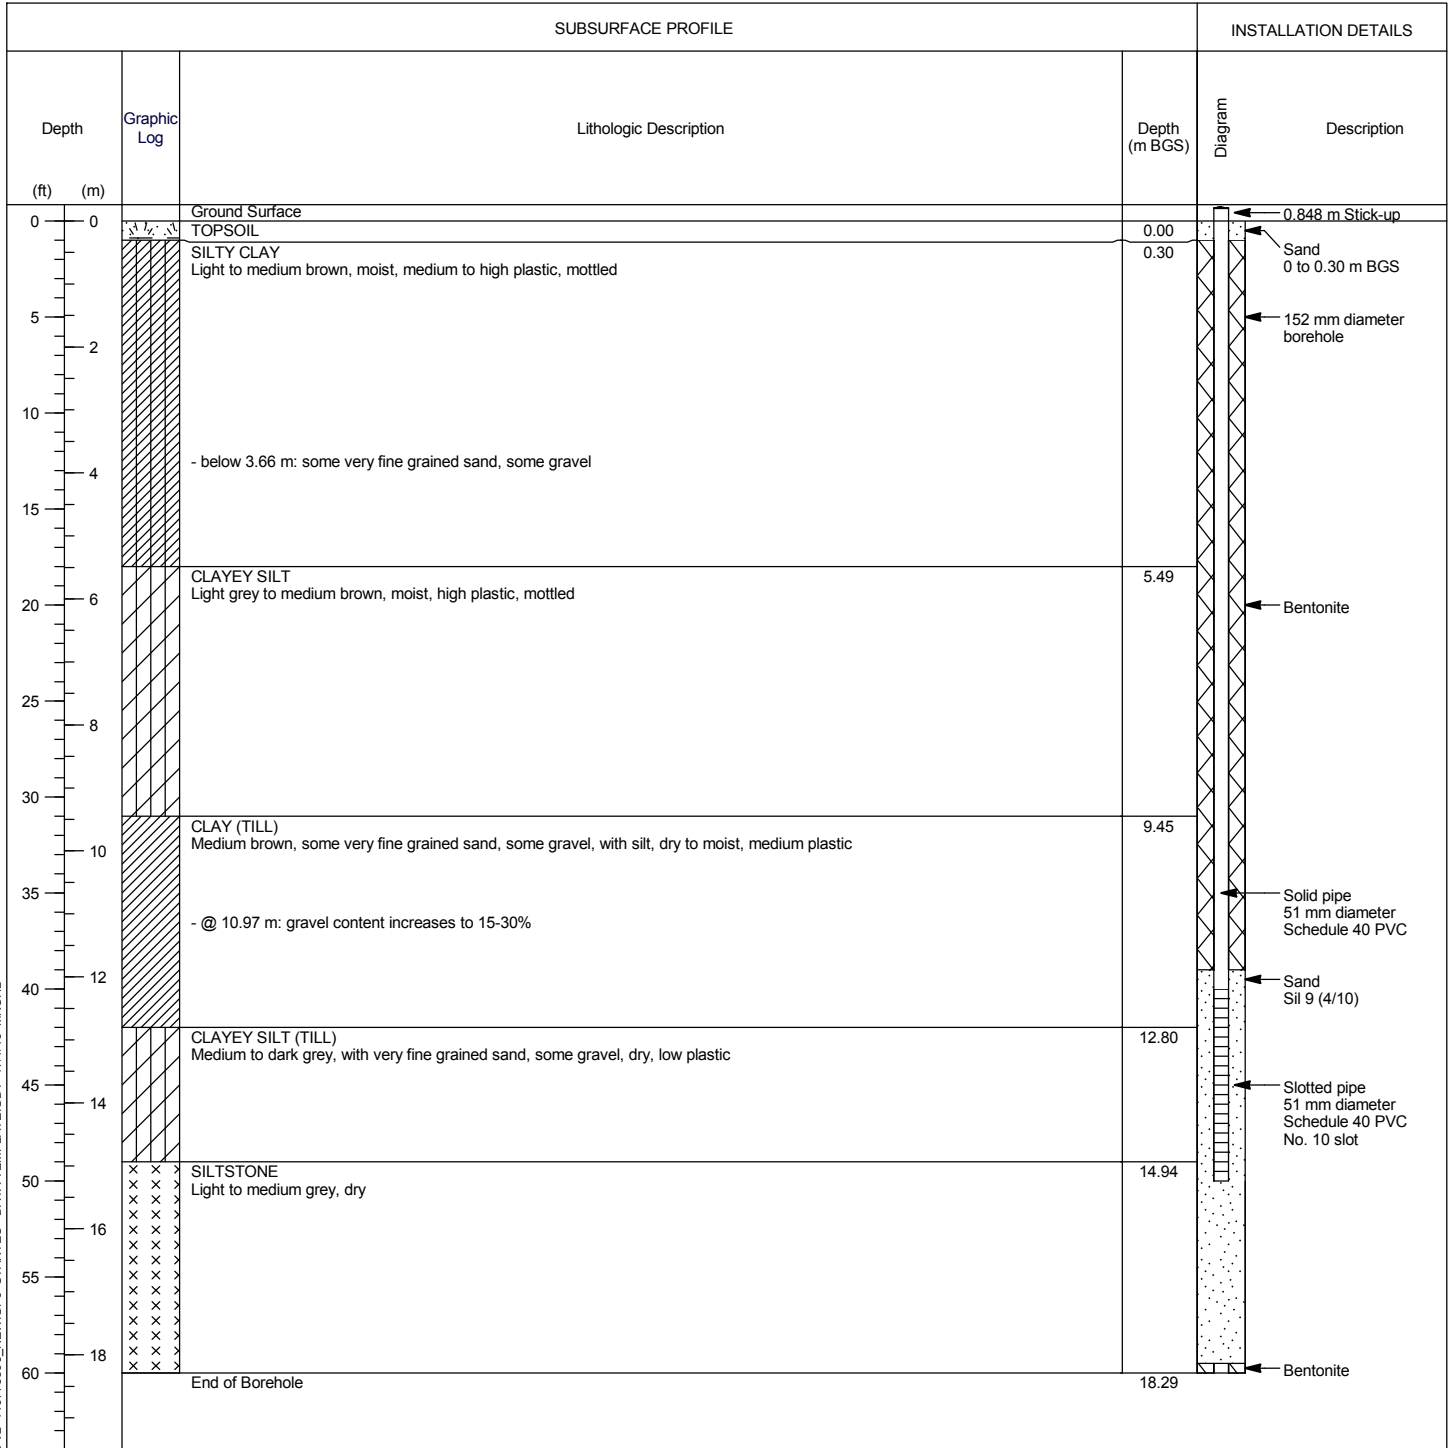
Drilling method: Solid-stem auger (Track mounted)
Date started/completed: 10-Aug-2016
Ground surface elevation: n/a
Top of casing elevation: n/a
Easting: -30461.405
Northing: 5658478.167

Screen Interval: 12.19 - 15.24 m BGS
 Sand Pack Interval: 11.89 - 18.14 m BGS
 Well Seal Interval: 18.14 - 18.29 m BGS

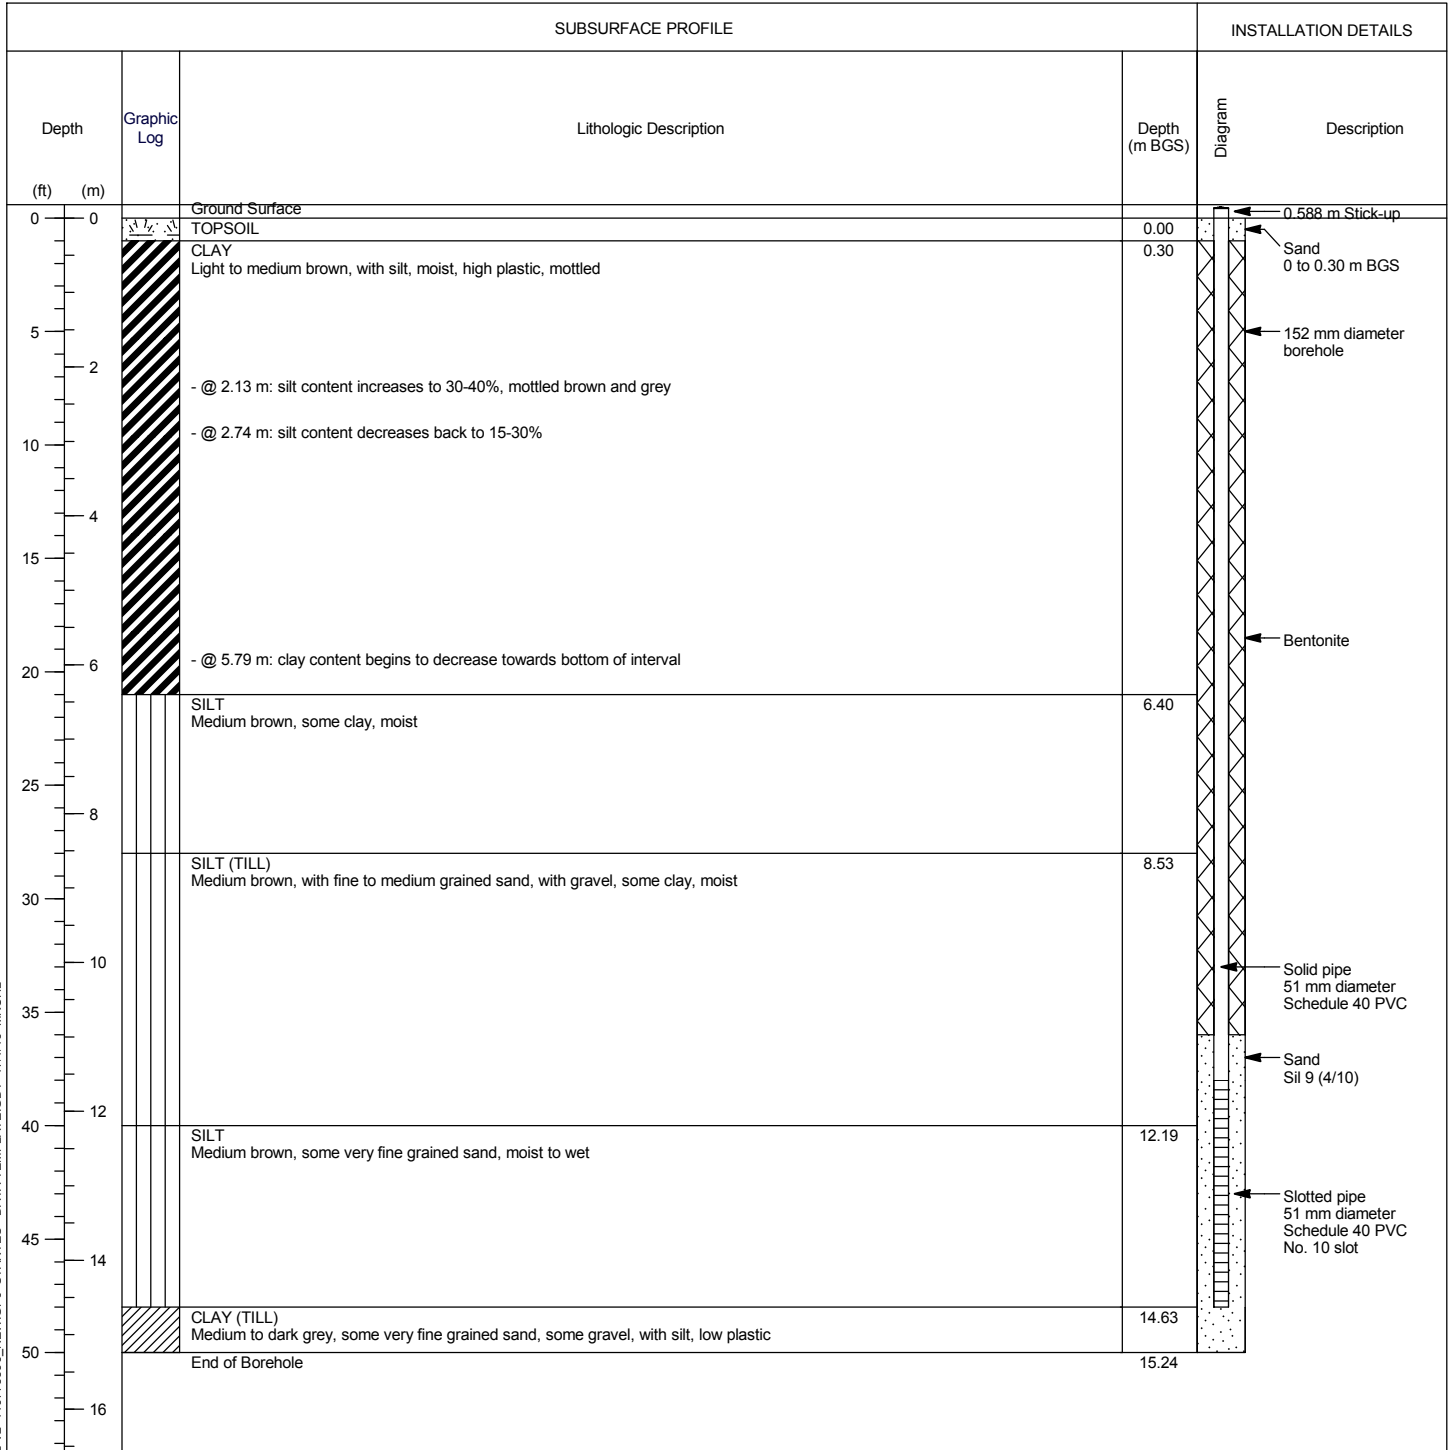
Drilling method: Solid-stem auger (Track mounted)
Date started/completed: 30-Jun-2016
Ground surface elevation: n/a
Top of casing elevation: n/a
Easting: -30269.84
Northing: 5657742.889

Screen Interval: 11.58 - 14.63 m BGS
 Sand Pack Interval: 10.97 - 15.24 m BGS
 Well Seal Interval: 0.30 - 10.97 m BGS
