Springbank Off-stream Reservoir Project

Impact Assessment Agency
of Canada
Annual Report - 2021/2022
Reporting Year

Prepared for:
Alberta Transportation

Prepared by:
Stantec Consulting Ltd.

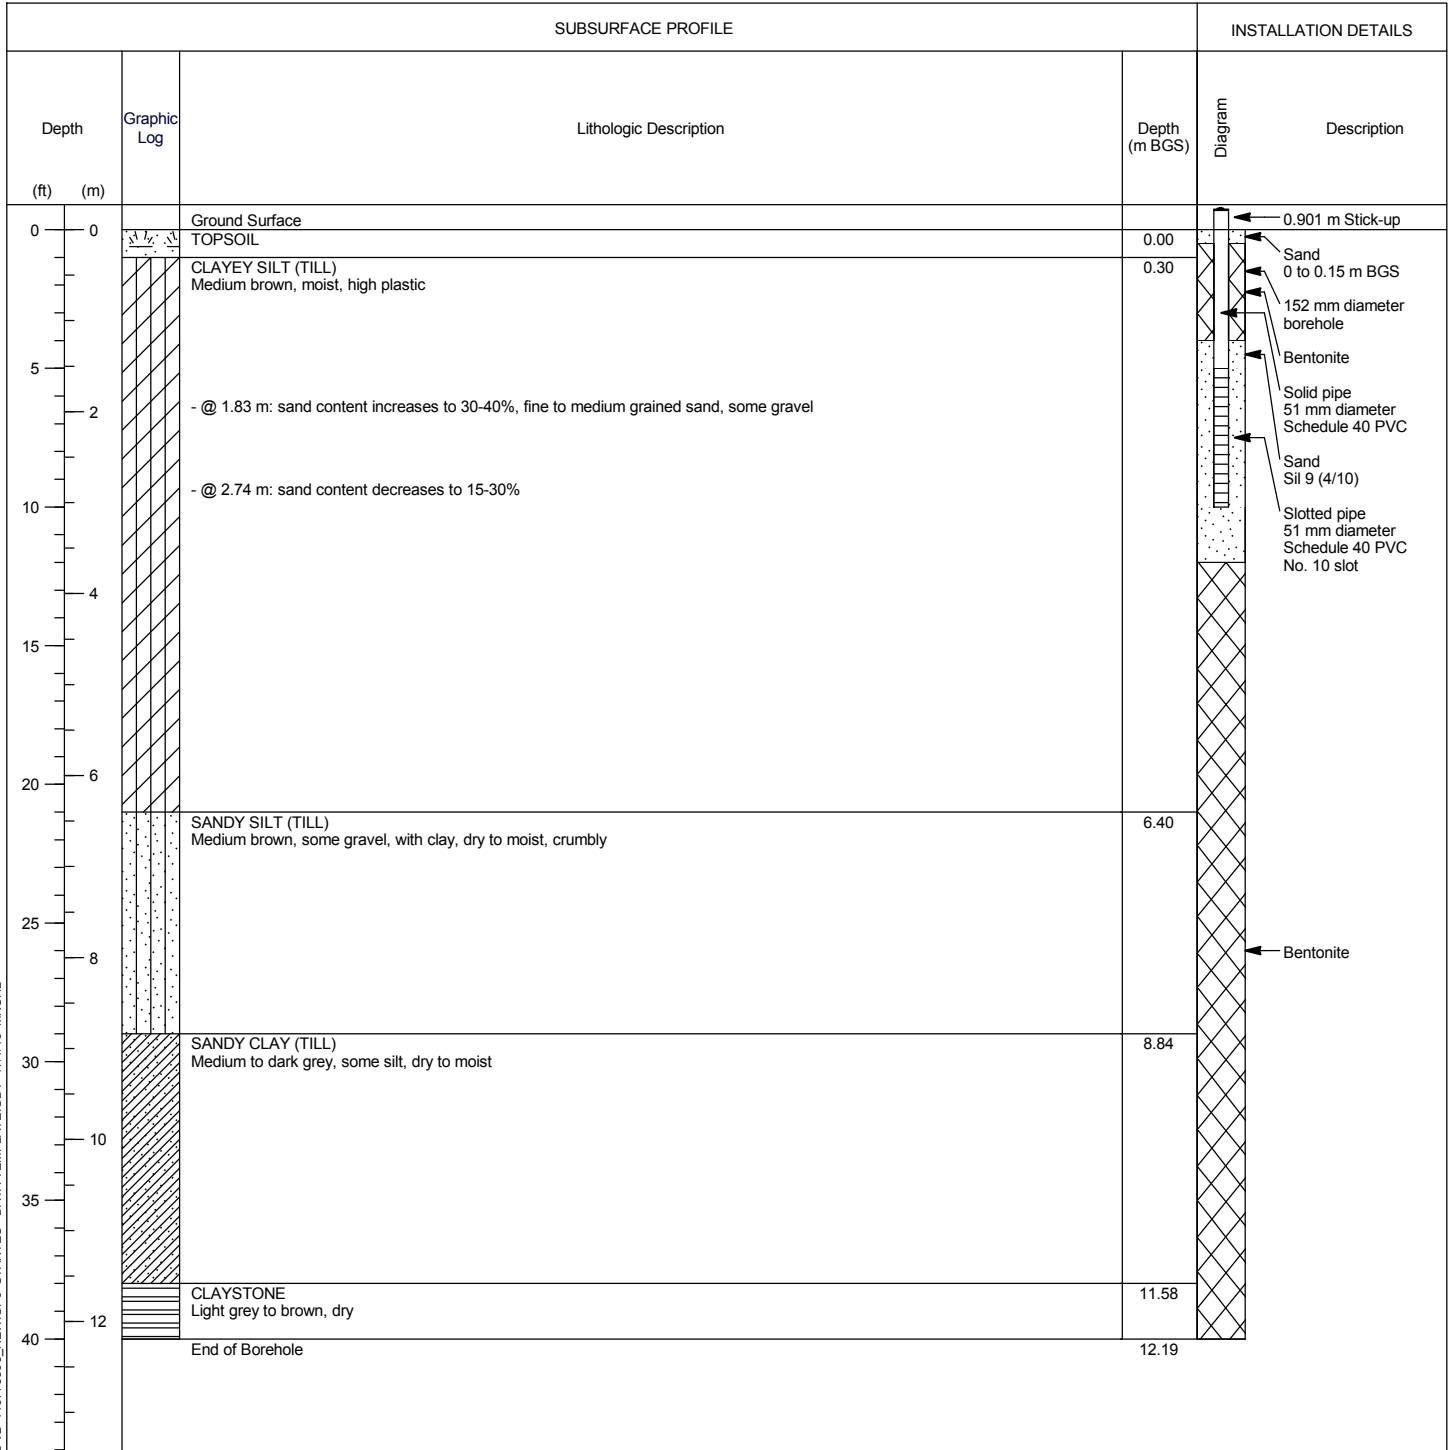
Drilling method: Solid-stem auger (Track mounted)
Date started/completed: 19-Aug-2016
Ground surface elevation: n/a
Top of casing elevation: n/a
Easting: -29160.284
Northing: 5657858.348

Screen Interval: 1.52 - 3.05 m BGS
 Sand Pack Interval: 1.22 - 3.66 m BGS
 Well Seal Interval: 0.15 - 1.22 m BGS

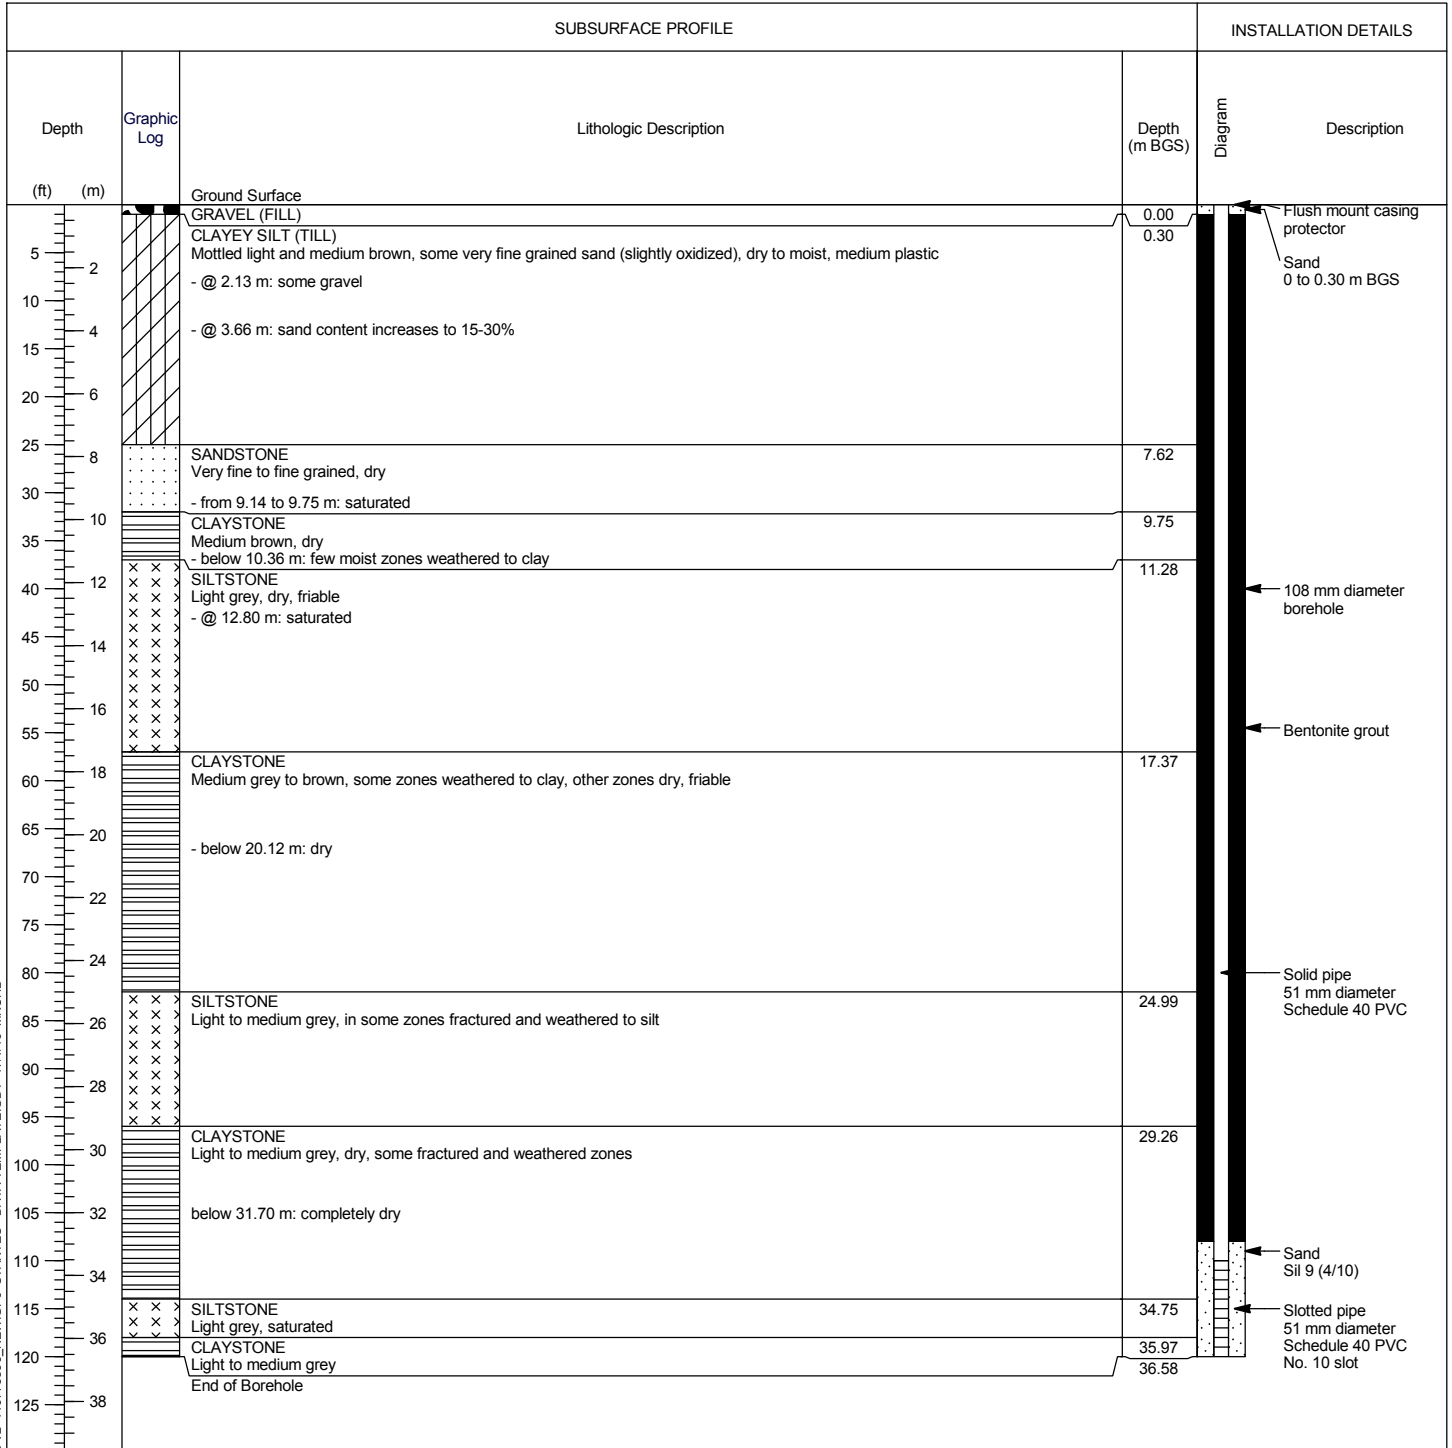
Drilling method: Air rotary auger (Truck mounted)
Date started/completed: 08-Aug-2016 / 09-Aug-2016
Ground surface elevation: n/a
Top of casing elevation: n/a
Easting: n/a
Northing: n/a

Screen Interval: 33.53 - 36.58 m BGS
 Sand Pack Interval: 32.92 - 36.58 m BGS
 Well Seal Interval: 0.30 - 32.92 m BGS

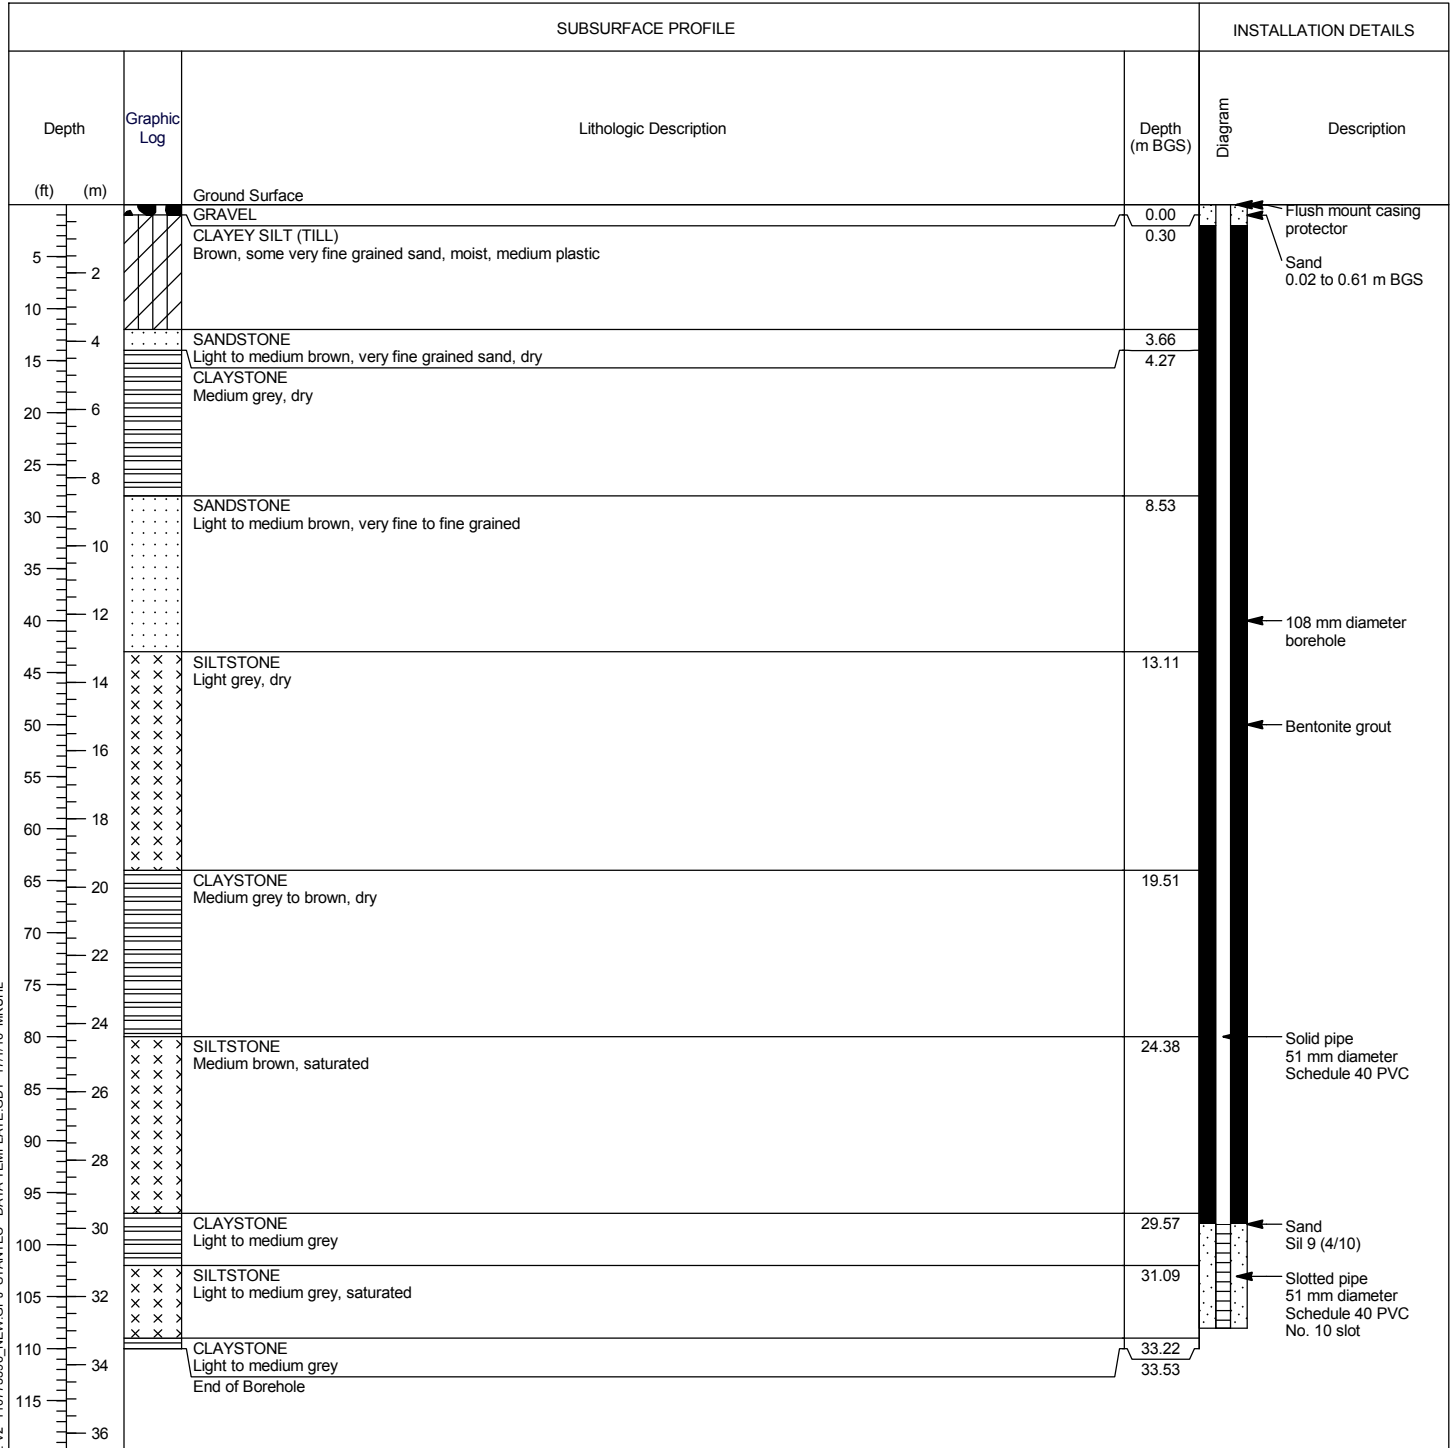
Drilling method: Air rotary auger (Truck mounted)
Date started/completed: 09-Aug-2016
Ground surface elevation: n/a
Top of casing elevation: n/a
Easting: -28592.189
Northing: 5659018.428

Screen Interval: 29.88 - 32.93 m BGS
 Sand Pack Interval: 29.87 - 32.93 m BGS
 Well Seal Interval: 0.61 - 29.87 m BGS

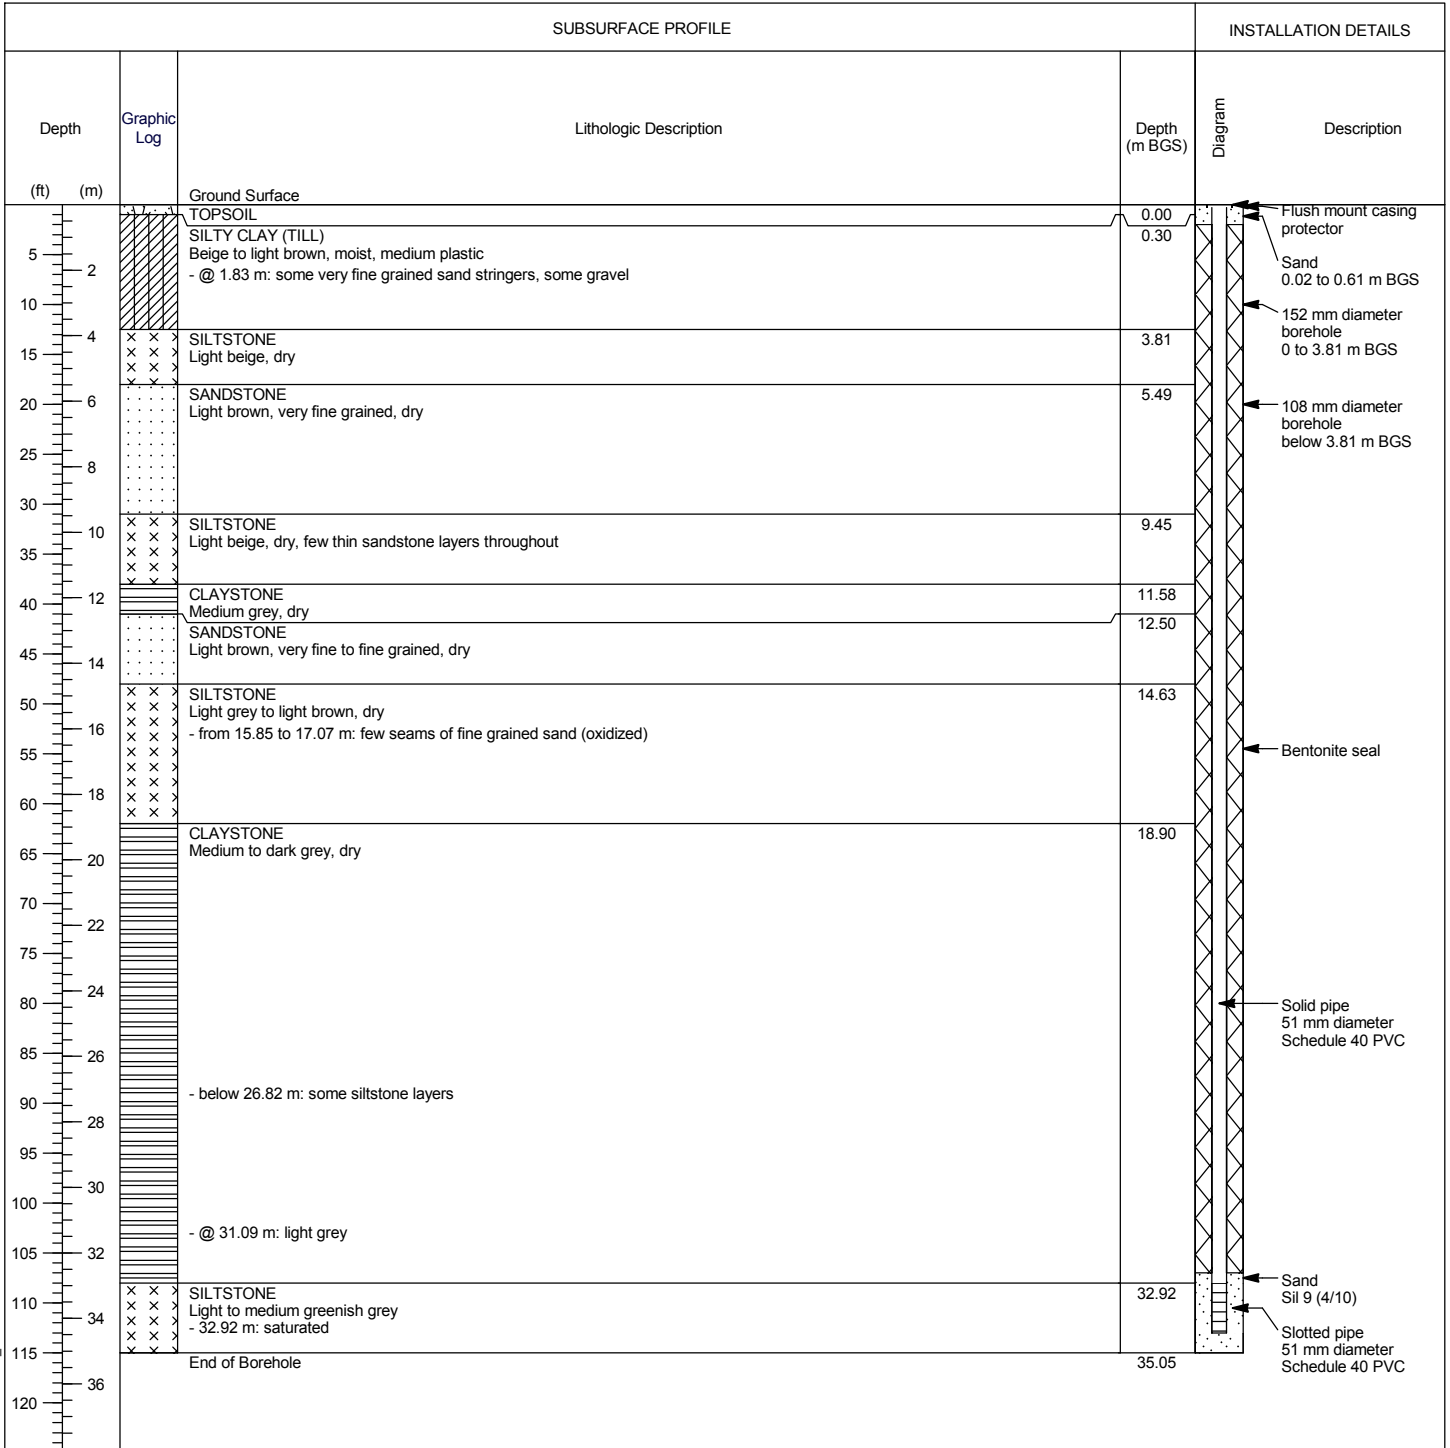
Monitoring Well: MW16-15-34 (GW15)

Project: Springbank Off-Stream Reservoir Project (SR1) Client: Alberta Transportation Location: Rocky View County, Alberta Number: 110773396 Field investigator: D. Nisbet Contractor: All Service Drilling Inc.	Drilling method: Solid-stem/ air rotary auger (Truck mounted) Date started/completed: 27-Jul-2016 Ground surface elevation: n/a Top of casing elevation: n/a Easting: -27818.819 Northing: 5658214.931
---	---

Screen Interval: 32.92 - 34.44 m BGS
 Sand Pack Interval: 32.61 - 35.05 m BGS
 Well Seal Interval: 0.61 - 32.61 m BGS

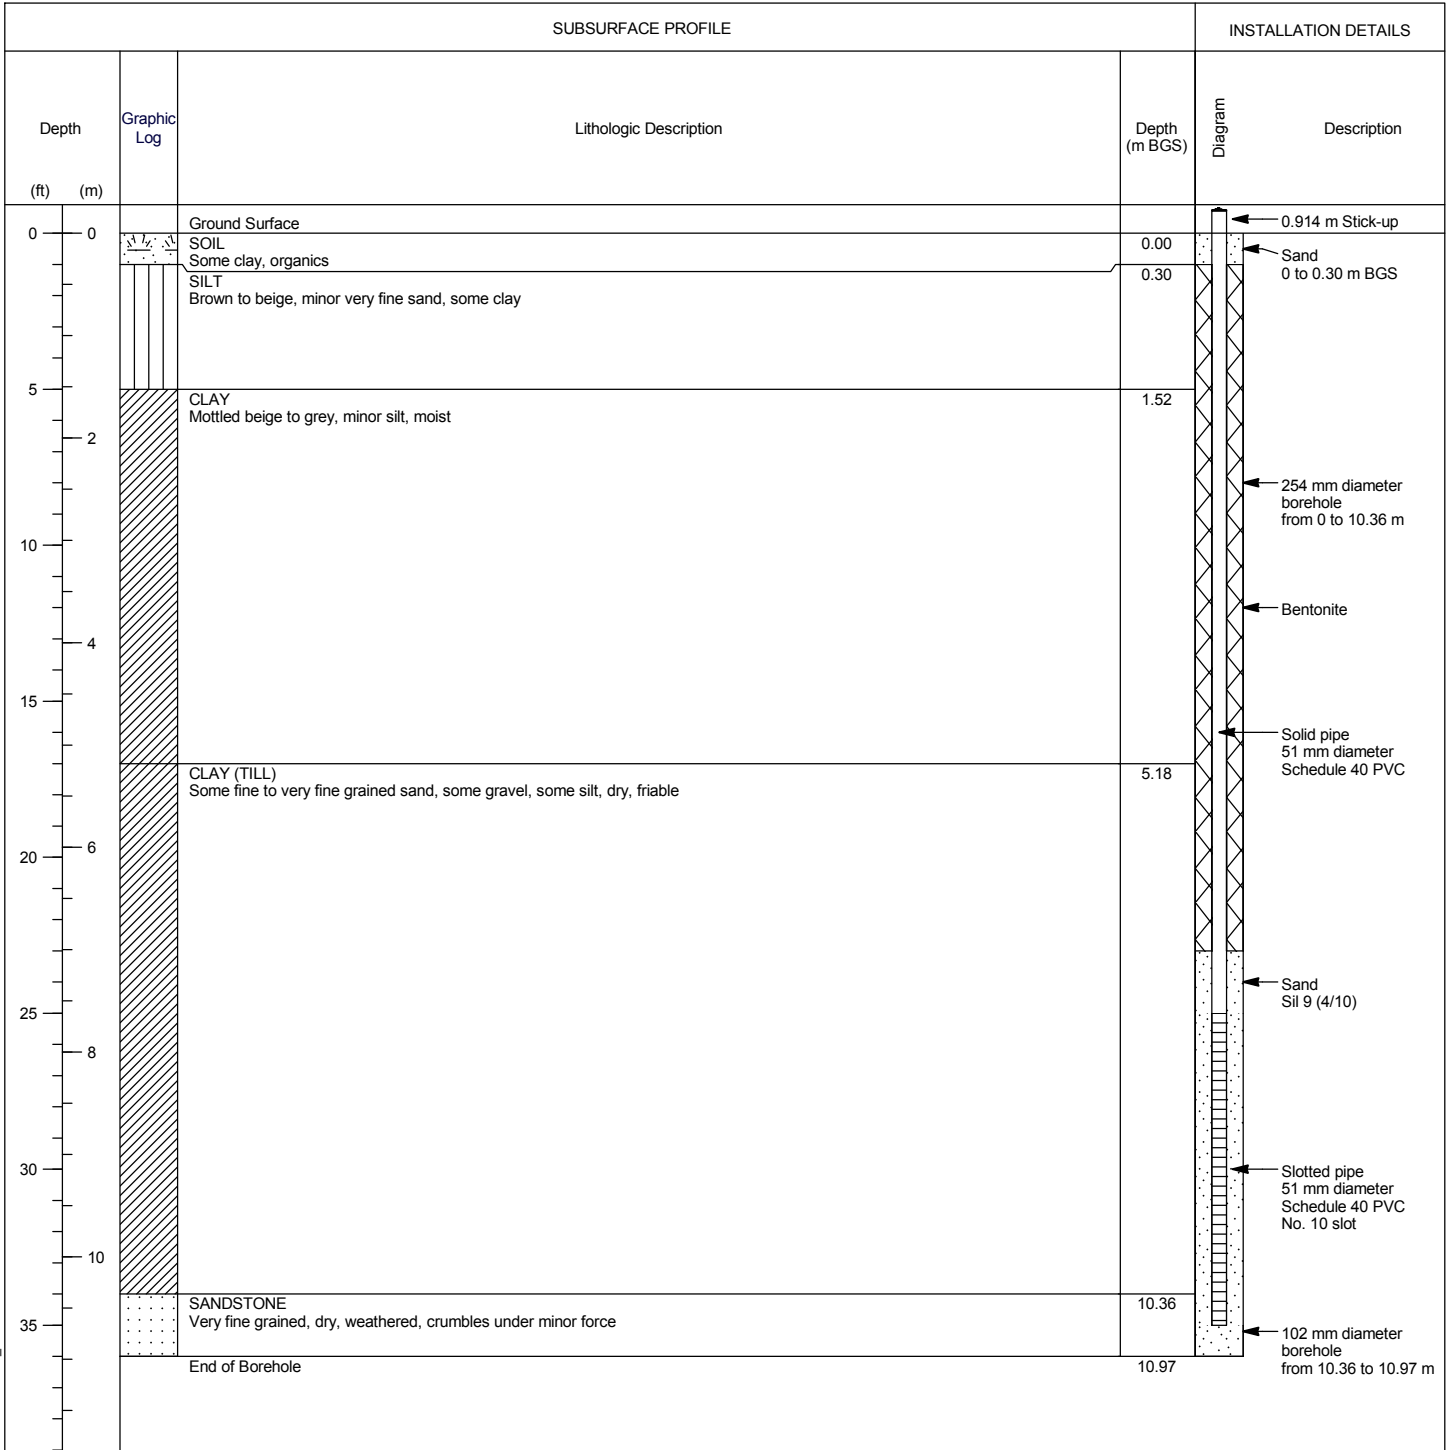
Monitoring Well: MW16-16-11 (DC-9)

Project: Springbank Off-Stream Reservoir Project (SR1) Client: Alberta Transportation Location: Rocky View County, Alberta Number: 110773396 Field investigator: D. Nisbet Contractor: All Service Drilling Inc.	Drilling method: Hollow-stem auger (Track mounted)/ Coring Date started/completed: 15-Apr-2016 Ground surface elevation: n/a Top of casing elevation: n/a Easting: -33453.625 Northing: 5655154.279
---	--

Screen Interval: 7.62 - 10.67 m BGS
 Sand Pack Interval: 7.01 - 10.97 m BGS
 Well Seal Interval: 0.30 - 7.01 m BGS

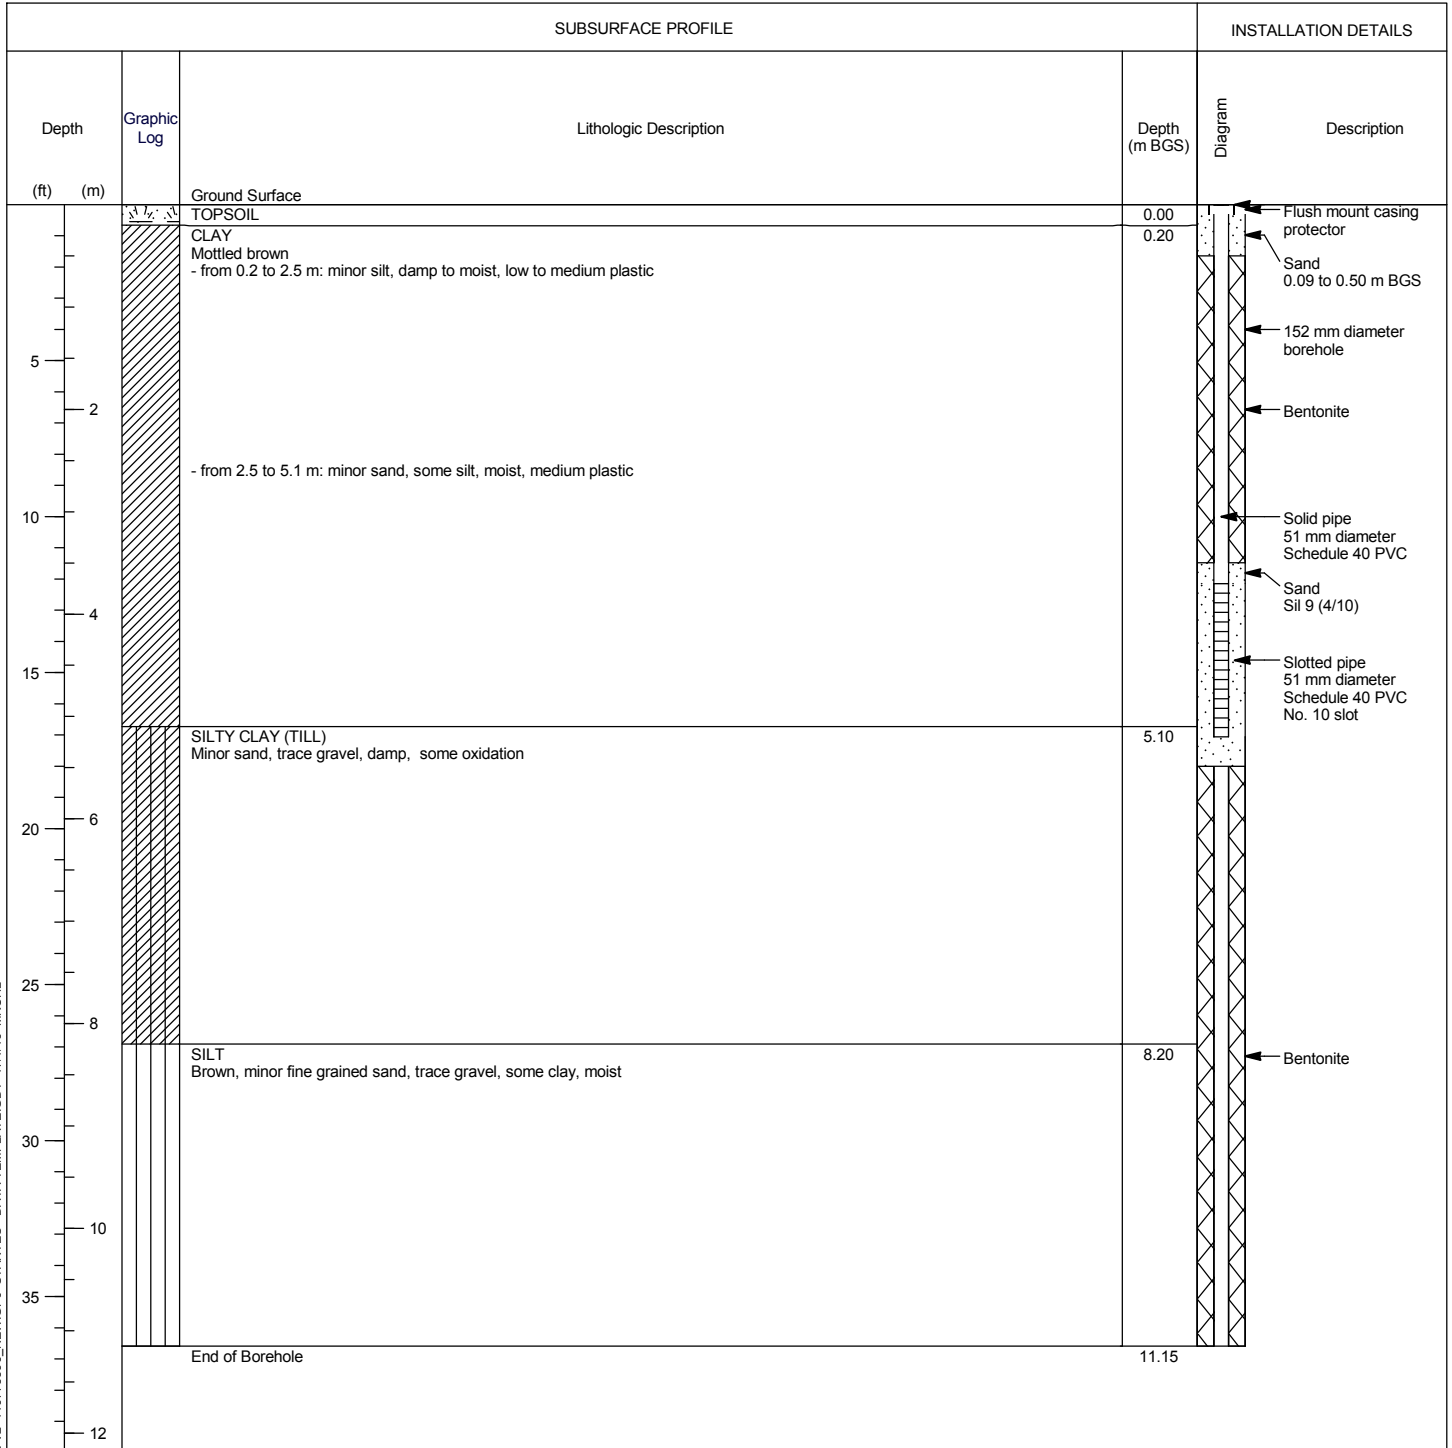
Project: Springbank Off-Stream Reservoir Project (SR1)
Client: Alberta Transportation
Location: Rocky View County, Alberta
Number: 110773396
Field investigator: D. Nisbet
Contractor: All Service Drilling Inc.

Drilling method: Solid-stem auger (Track mounted)
Date started/completed: 11-May-2016
Ground surface elevation: n/a
Top of casing elevation: n/a
Easting: -33226.452
Northing: 5656140.553

Screen Interval: 3.70 - 5.20 m BGS
 Sand Pack Interval: 3.50 - 5.49 m BGS
 Well Seal Interval: 5.49 - 11.15 m BGS

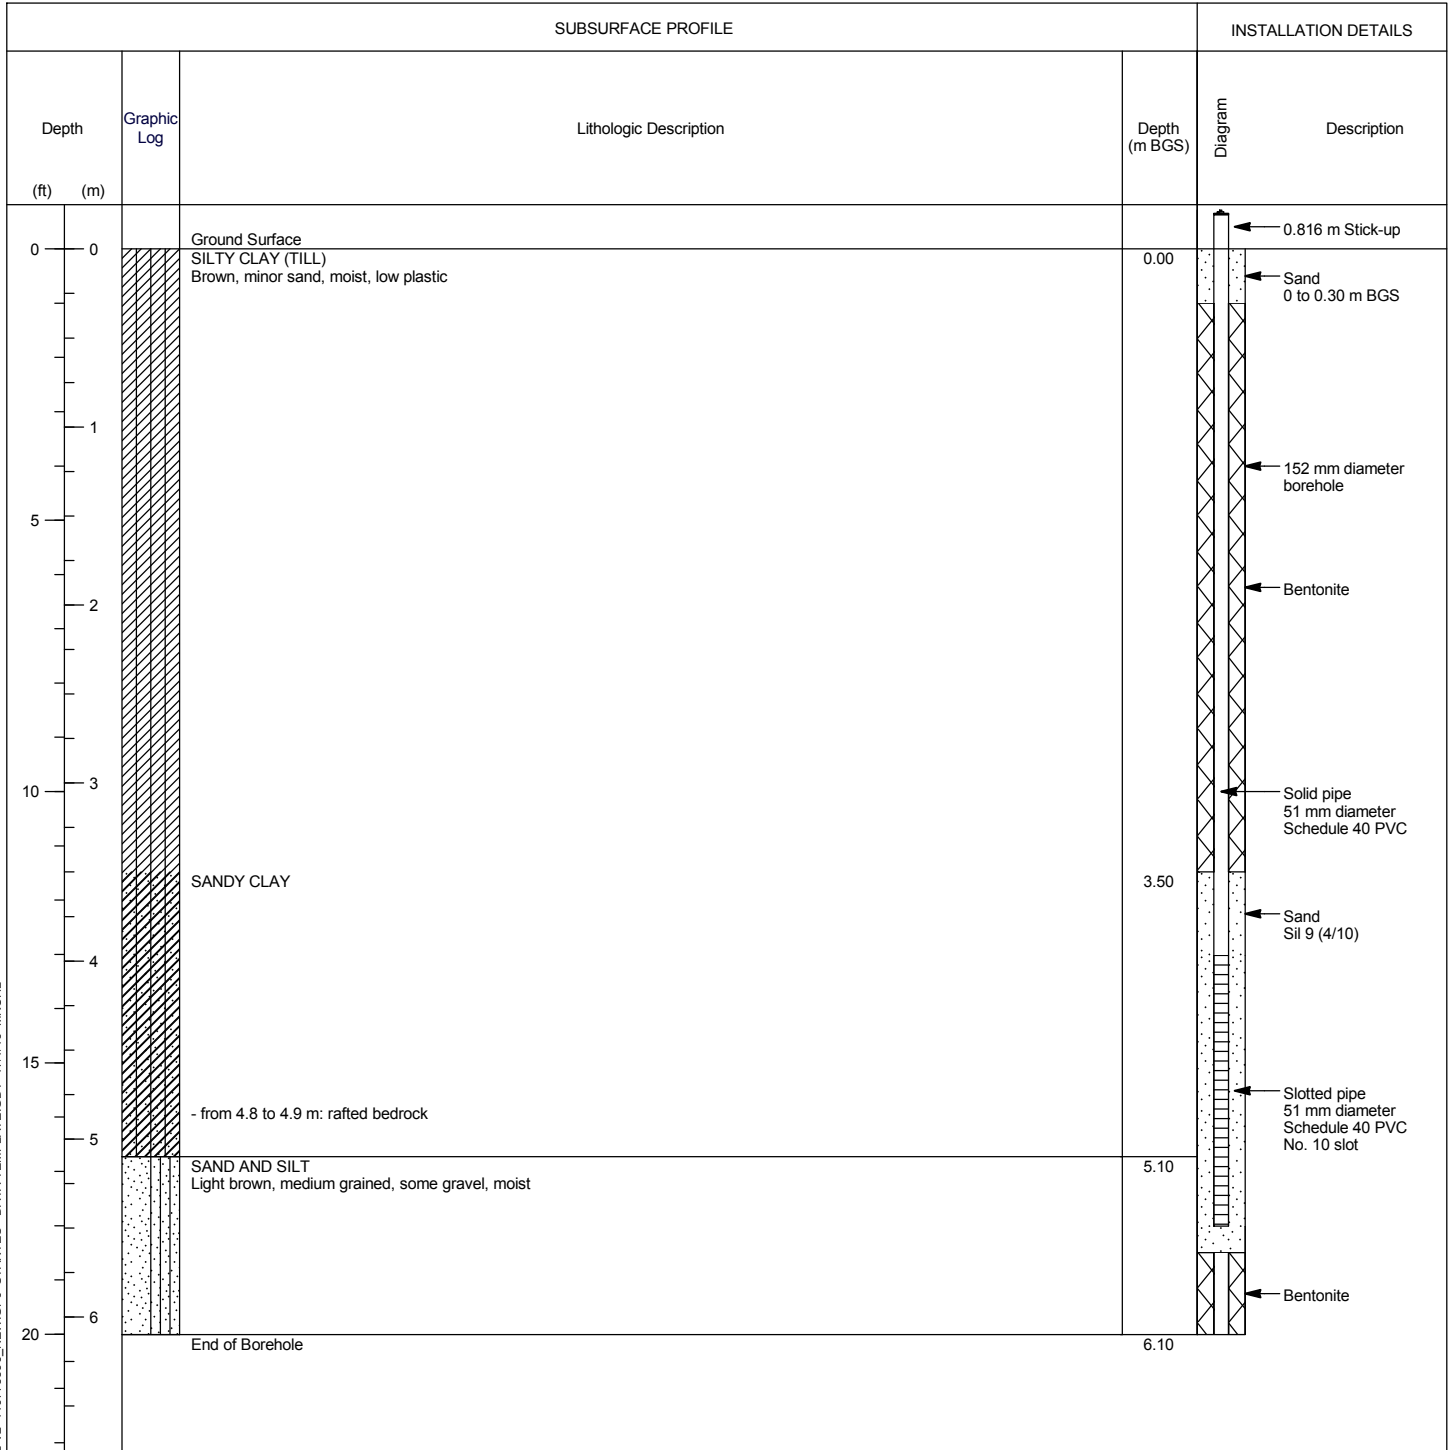
Drilling method: Hollow-stem auger (Track mounted)
Date started/completed: 11-May-2016
Ground surface elevation: n/a
Top of casing elevation: n/a
Easting: -32406.586
Northing: 5656749.506

Screen Interval: 3.97 - 5.49 m BGS
 Sand Pack Interval: 3.50 - 5.64 m BGS
 Well Seal Interval: 5.64 - 6.10 m BGS

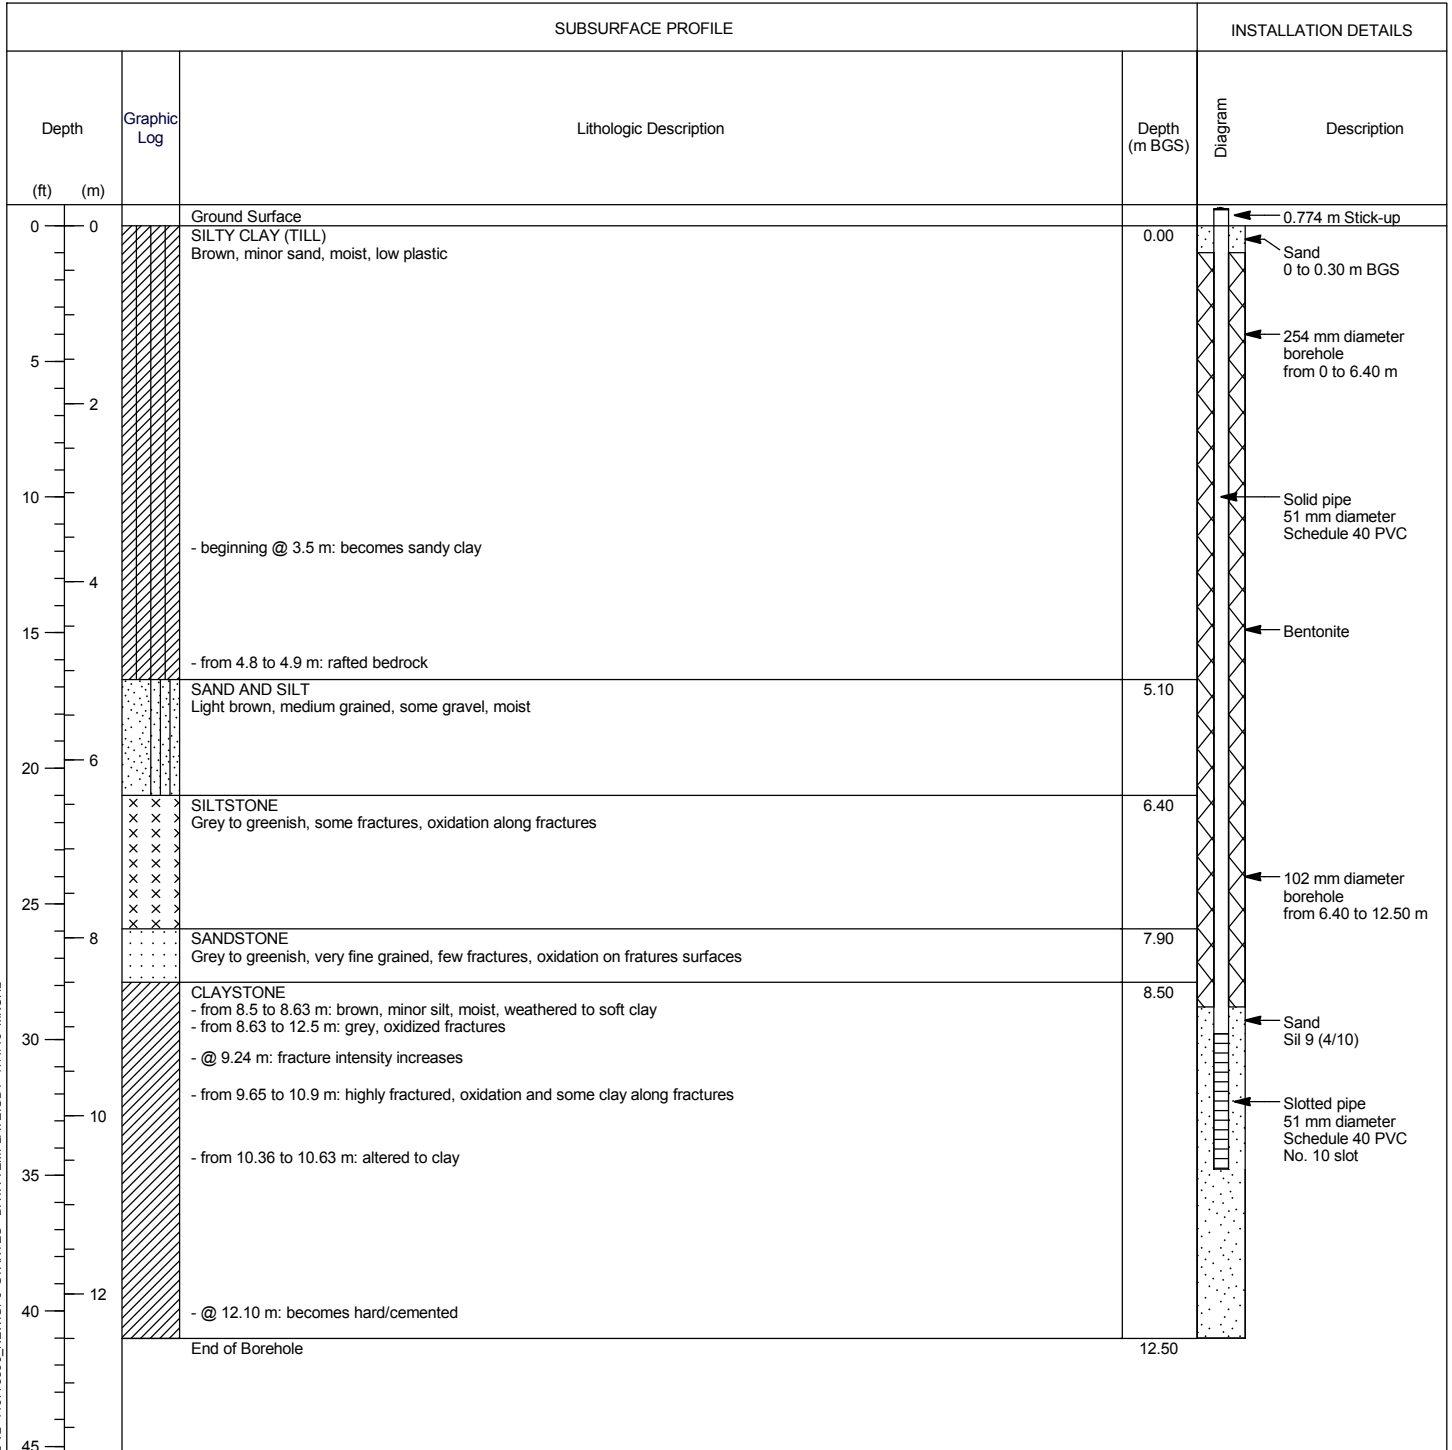
Project: Springbank Off-Stream Reservoir Project (SR1) Client: Alberta Transportation Location: Rocky View County, Alberta Number: 110773396 Field investigator: D. Nisbet Contractor: All Service Drilling Inc.	Drilling method: Hollow-stem auger (Track mounted)/ Coring Date started/completed: 11-May-2016 Ground surface elevation: n/a Top of casing elevation: n/a Easting: -32406.714 Northing: 5656750.577
---	--

Screen Interval: 9.08 - 10.60 m BGS
 Sand Pack Interval: 8.78 - 12.50 m BGS
 Well Seal Interval: 0.30 - 8.78 m BGS

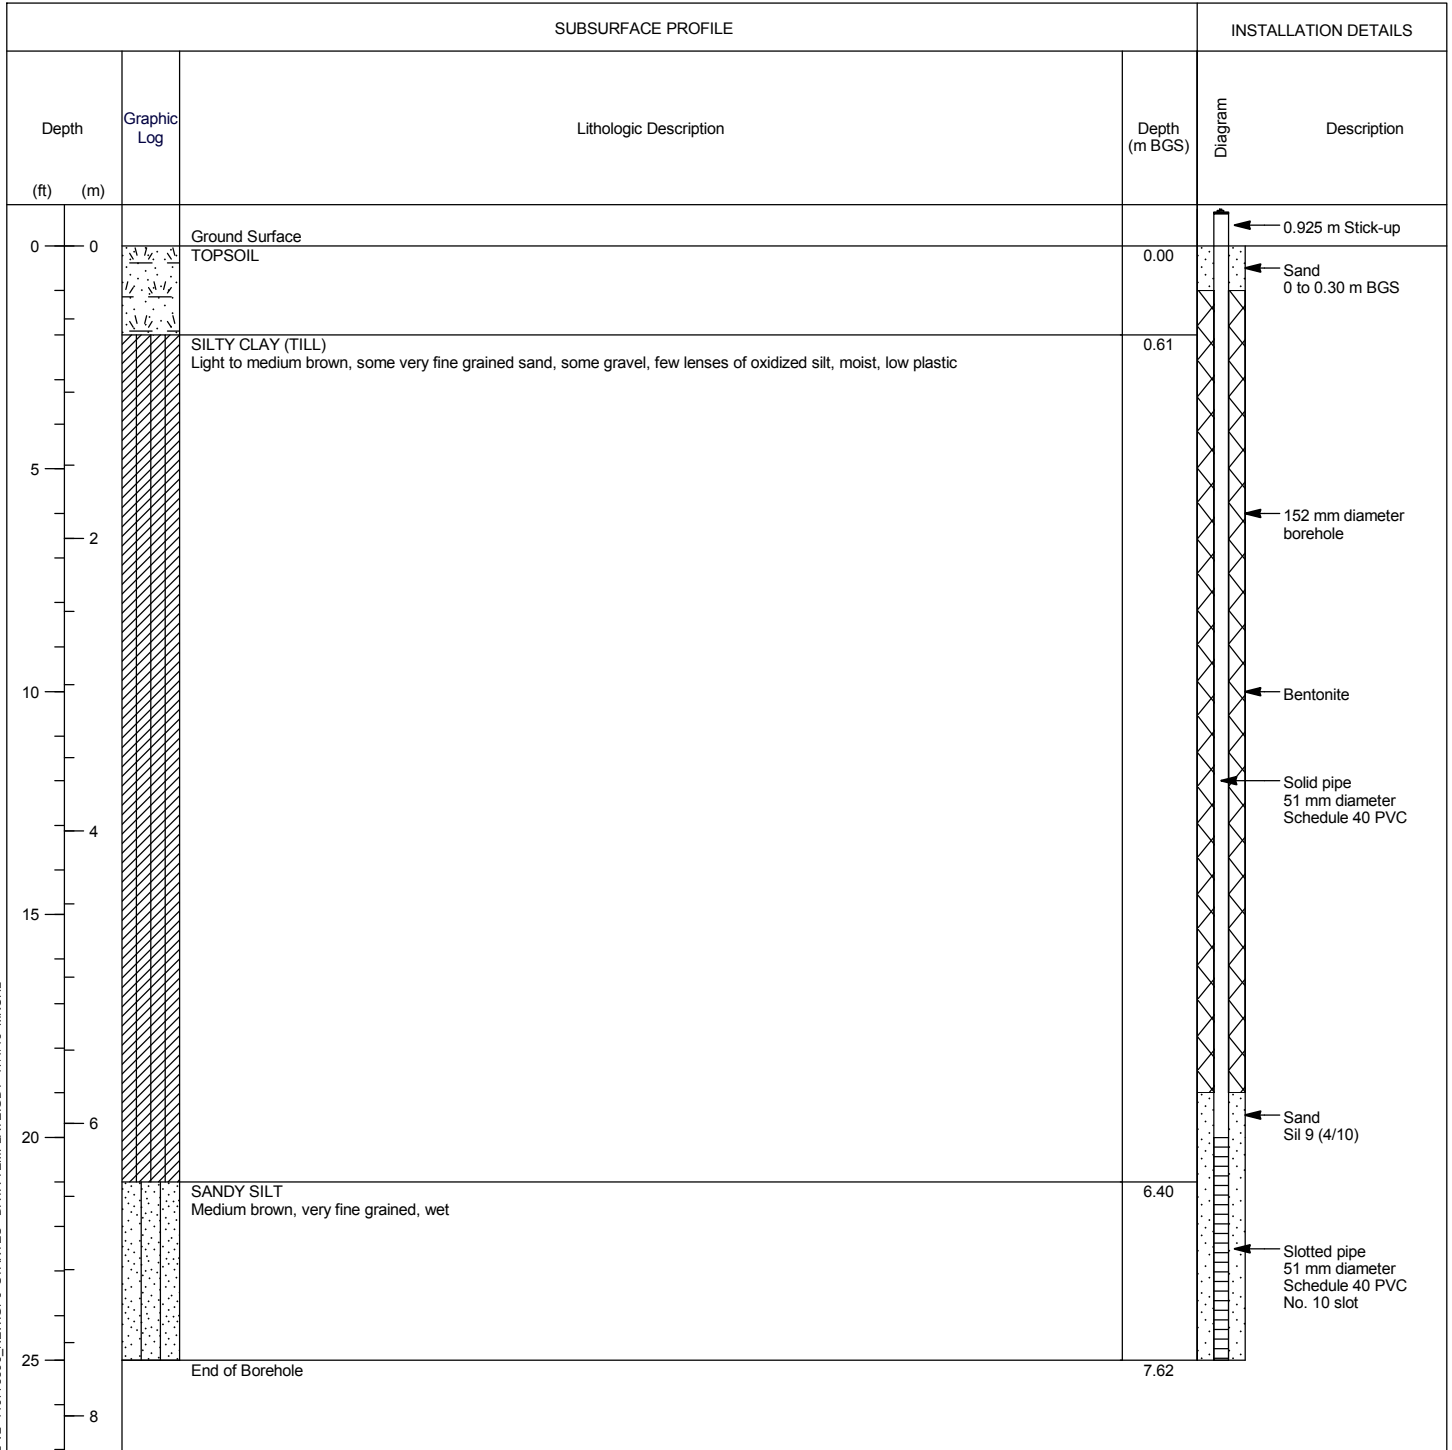
Drilling method: Solid-stem auger
Date started/completed: 09-Jun-2016
Ground surface elevation: n/a
Top of casing elevation: n/a
Easting: -31684.576
Northing: 5657262.245

Screen Interval: 6.10 - 7.62 m BGS
 Sand Pack Interval: 5.79 - 7.62 m BGS
 Well Seal Interval: 0.30 - 5.79 m BGS

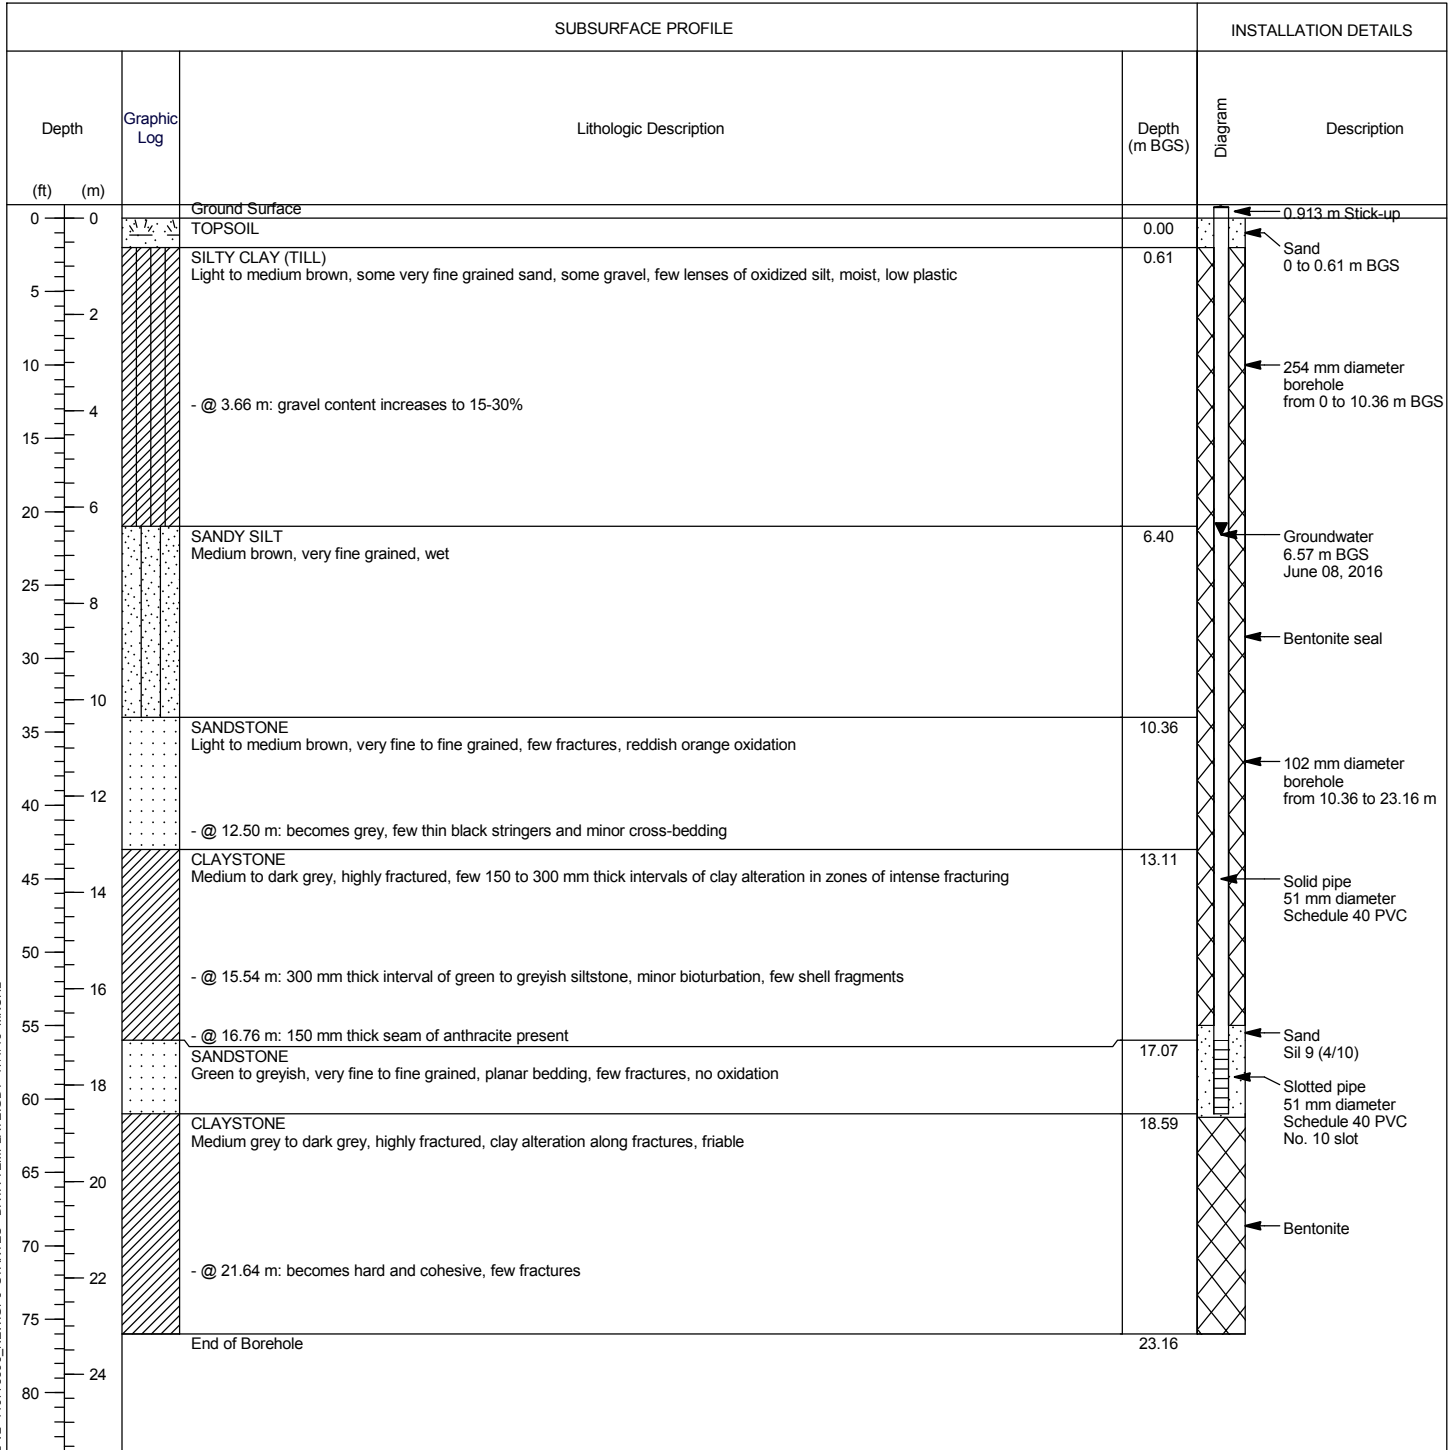
Project: Springbank Off-Stream Reservoir Project (SR1) Client: Alberta Transportation Location: Rocky View County, Alberta Number: 110773396 Field investigator: D. Nisbet Contractor: All Service Drilling Inc.	Drilling method: Hollow-stem auger (Track mounted)/ Coring Date started/completed: 08-Jun-2016 Ground surface elevation: n/a Top of casing elevation: n/a Easting: -31684.489 Northing: 5657263.177
---	--

Screen Interval: 17.07 - 18.59 m BGS
 Sand Pack Interval: 16.76 - 18.67 m BGS
 Well Seal Interval: 0.61 - 16.76 m BGS
