Springbank Off-stream Reservoir Project

Impact Assessment Agency
of Canada
Annual Report - 2021/2022
Reporting Year

Prepared for:
Alberta Transportation

Prepared by:
Stantec Consulting Ltd.

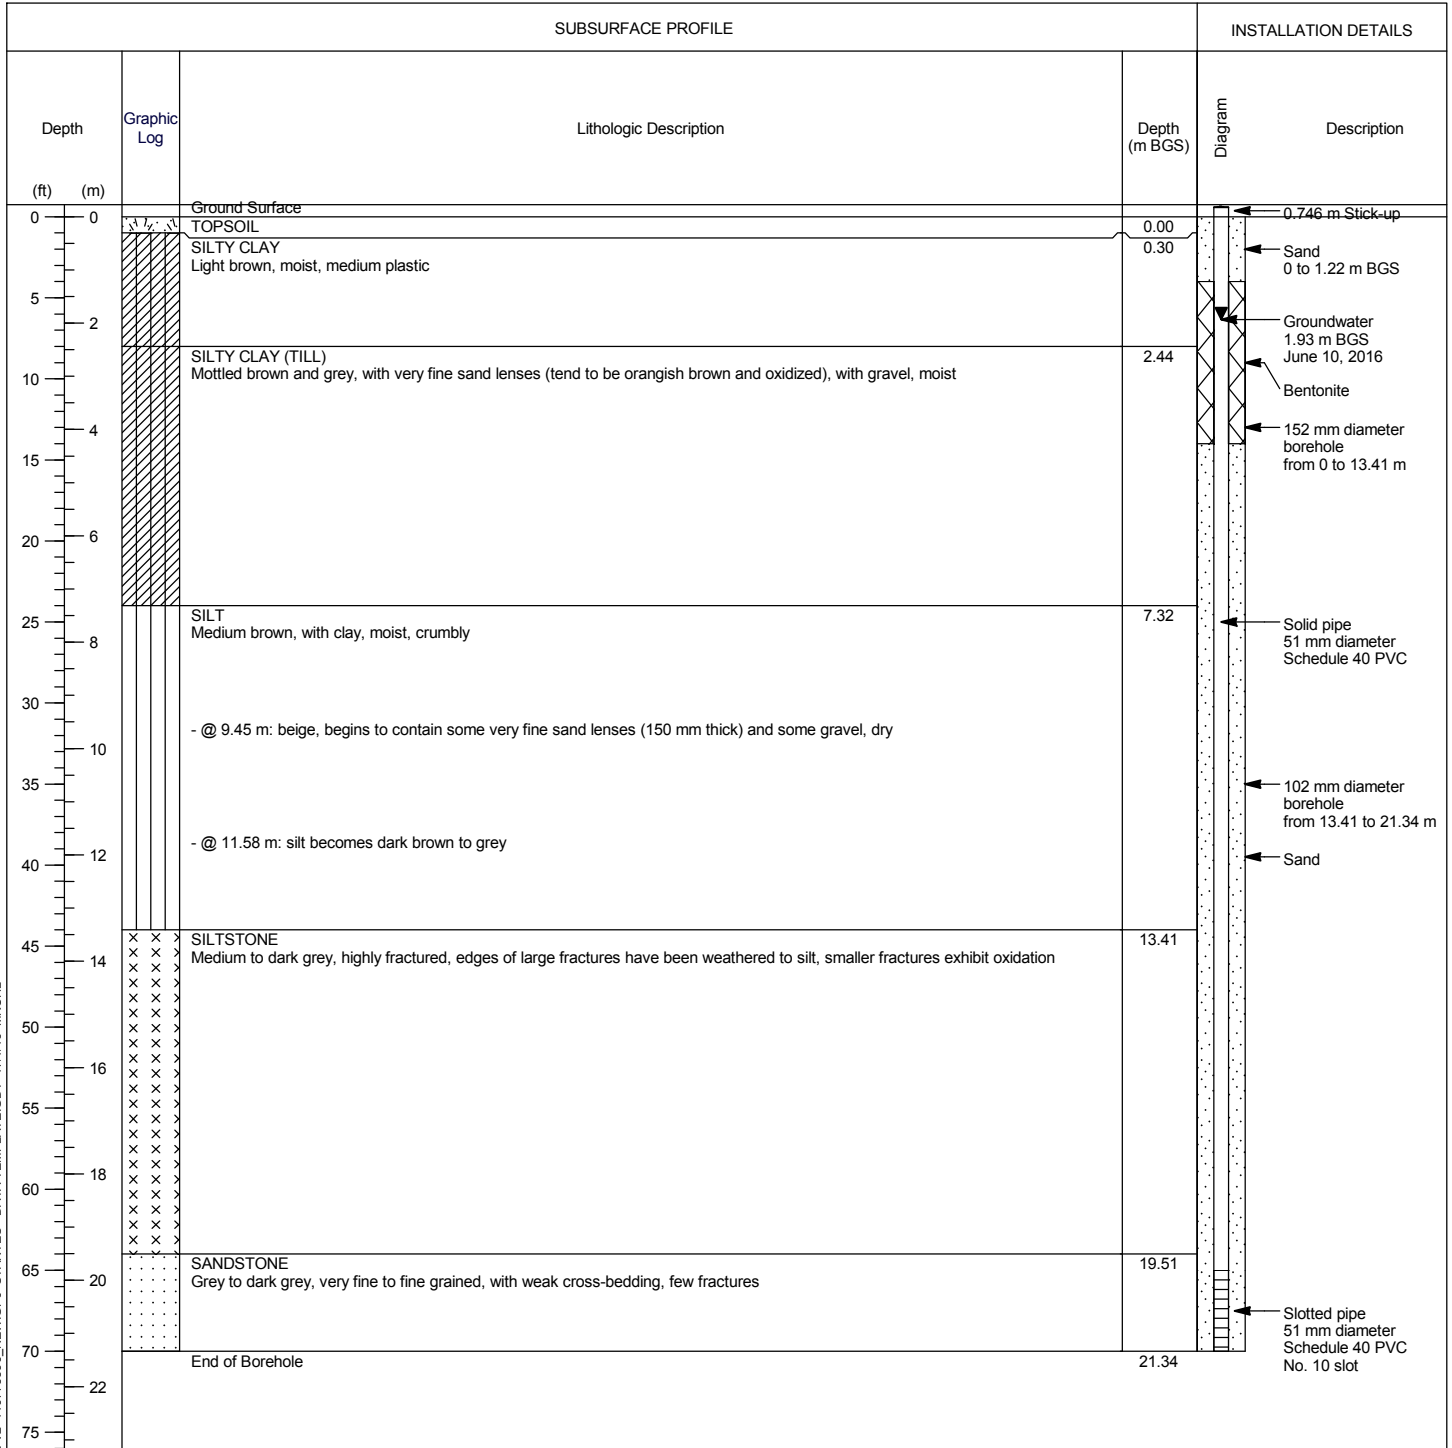
Project: Springbank Off-Stream Reservoir Project (SR1)
Client: Alberta Transportation
Location: Rocky View County, Alberta
Number: 110773396
Field investigator: D. Nisbet
Contractor: All Service Drilling Inc.

Drilling method: Solid-stem auger
Date started/completed: 10-Jun-2016
Ground surface elevation: n/a
Top of casing elevation: n/a
Easting: -31218.384
Northing: 5657498.57

Screen Interval: 19.81 - 21.34 m BGS
 Sand Pack Interval: 4.27 - 21.34 m BGS
 Well Seal Interval: 1.22 - 4.27 m BGS

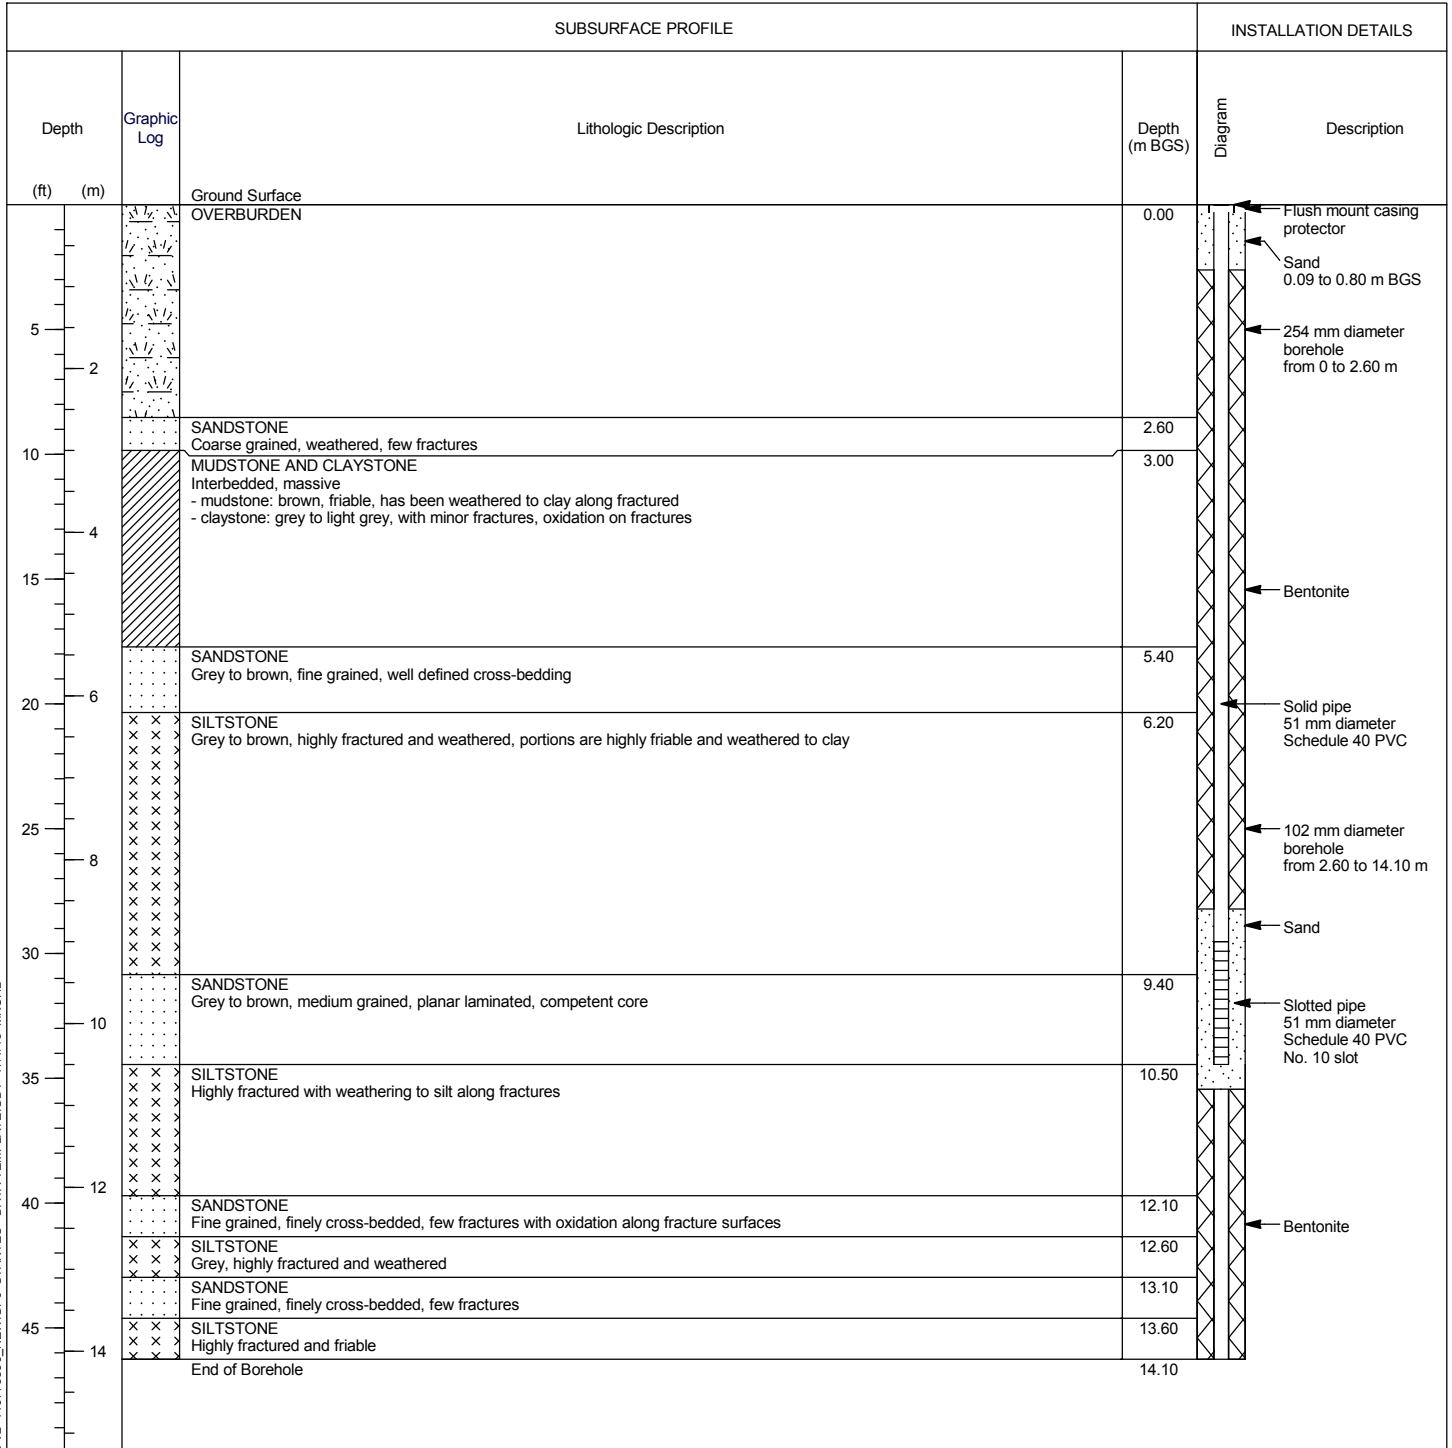
Monitoring Well: MW16-21-11 (D9)

Project: Springbank Off-Stream Reservoir Project (SR1) Client: Alberta Transportation Location: Rocky View County, Alberta Number: 110773396 Field investigator: D. Nisbet Contractor: All Service Drilling Inc.	Drilling method: Hollow-stem auger (Track mounted)/ Coring Date started/completed: 01-May-2016 Ground surface elevation: n/a Top of casing elevation: n/a Easting: -30383.805 Northing: 5656987.083
---	--

Screen Interval: 9.00 - 10.50 m BGS
 Sand Pack Interval: 8.60 - 10.80 m BGS
 Well Seal Interval: 10.80 - 14.10 m BGS

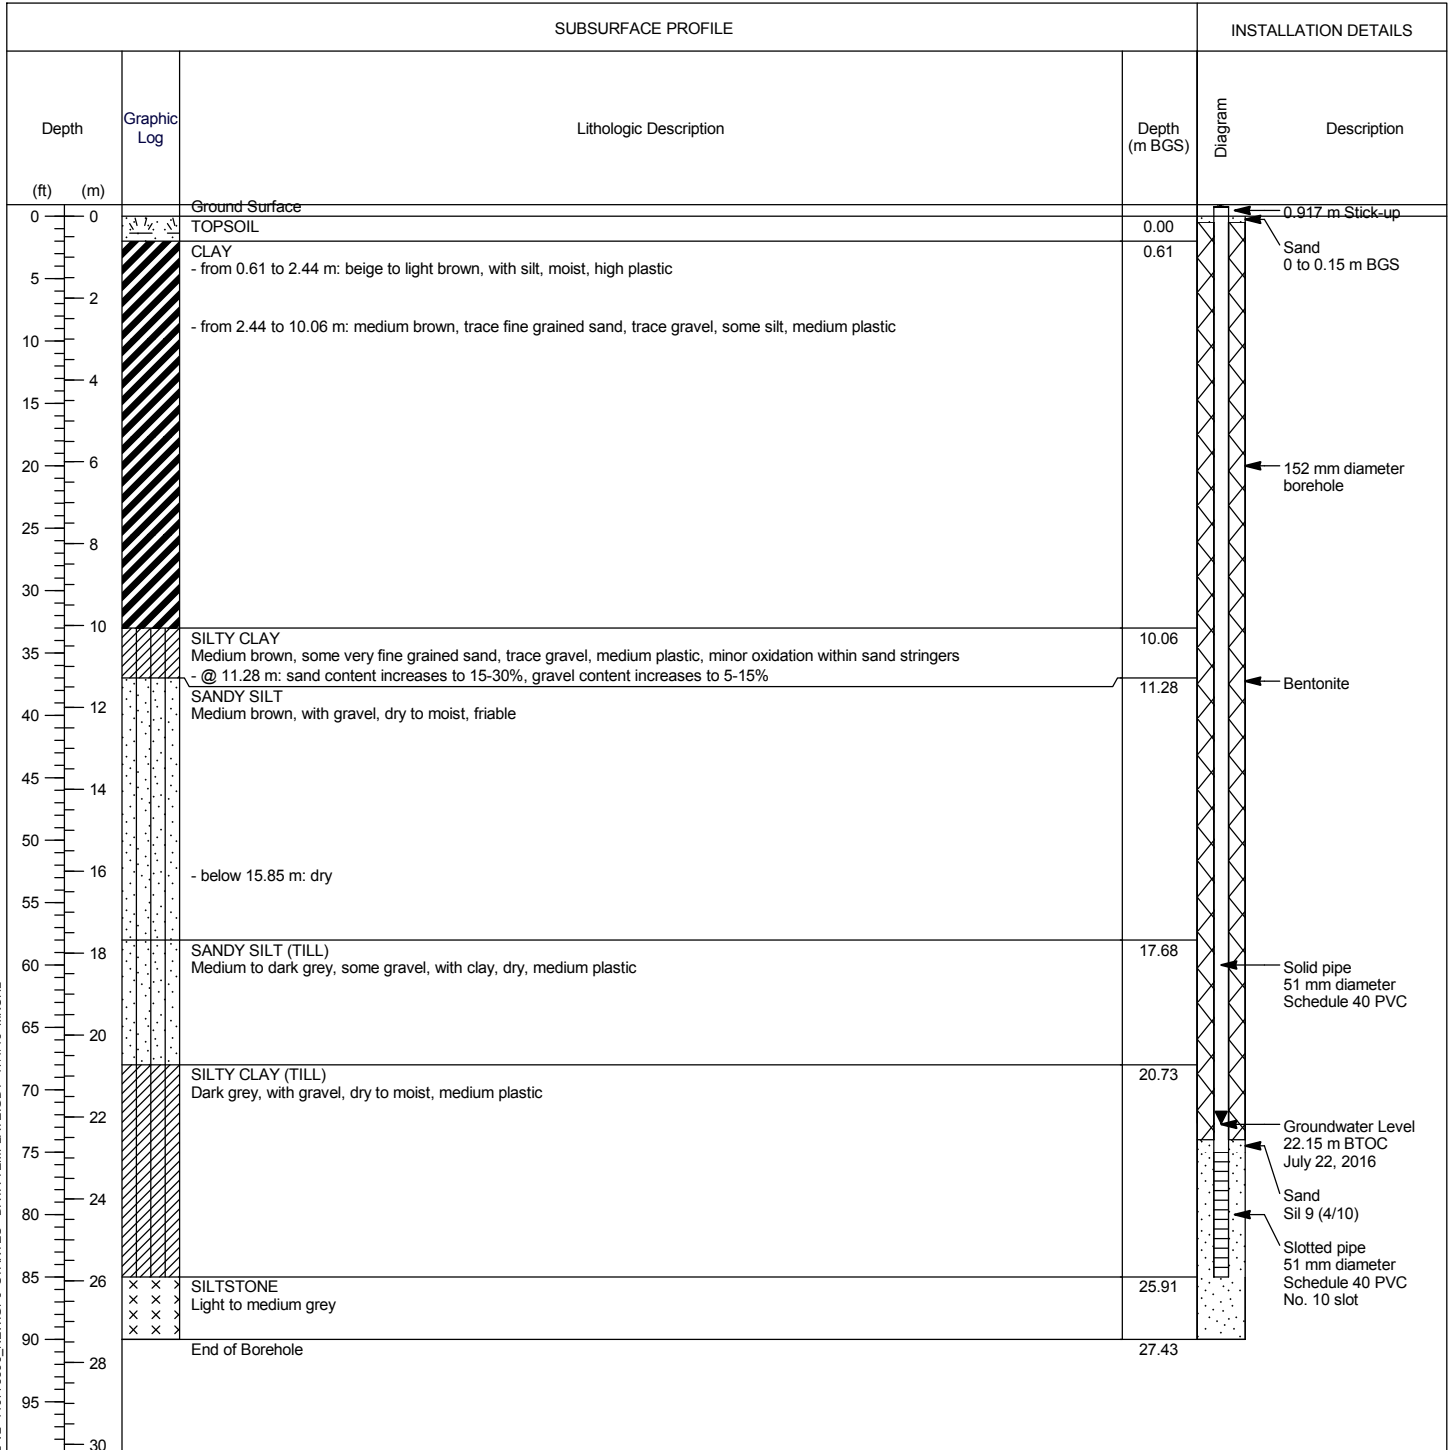
Drilling method: Solid-stem auger (Track mounted)
Date started/completed: 21-Jul-2016 / 22-Jul-2016
Ground surface elevation: n/a
Top of casing elevation: n/a
Easting: -29330.853
Northing: 5656907.343

Screen Interval: 22.86 - 25.91 m BGS
 Sand Pack Interval: 22.56 - 27.43 m BGS
 Well Seal Interval: 0.15 - 22.56 m BGS

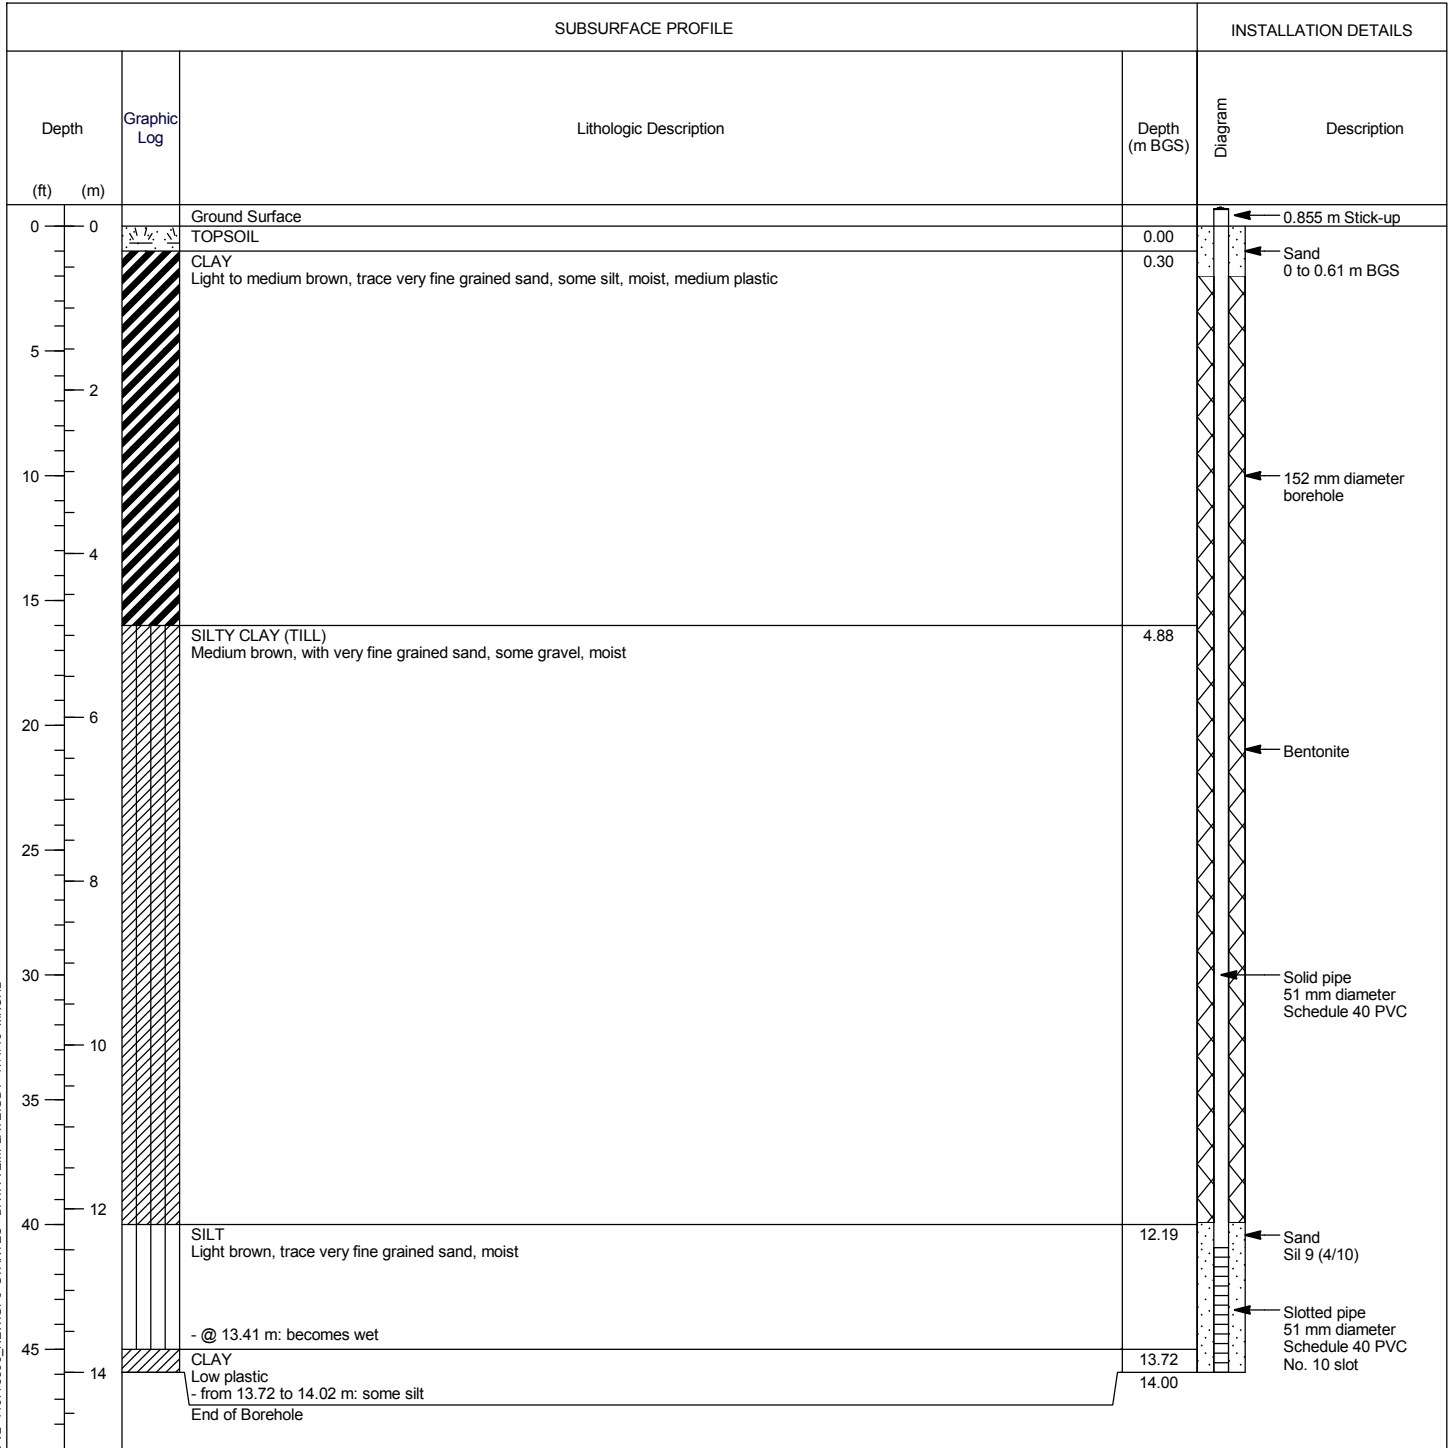
Project: Springbank Off-Stream Reservoir Project (SR1)
Client: Alberta Transportation
Location: Rocky View County, Alberta
Number: 110773396
Field investigator: D. Nisbet
Contractor: All Service Drilling Inc.

Drilling method: Hollow-stem auger (Track mounted)
Date started/completed: 24-Jul-2016 / 25-Jul-2016
Ground surface elevation: n/a
Top of casing elevation: n/a
Easting: -29019.682
Northing: 5657309.567

Screen Interval: 12.48 - 14.00 m BGS
 Sand Pack Interval: 12.17 - 14.00 m BGS
 Well Seal Interval: 0.61 - 12.17 m BGS

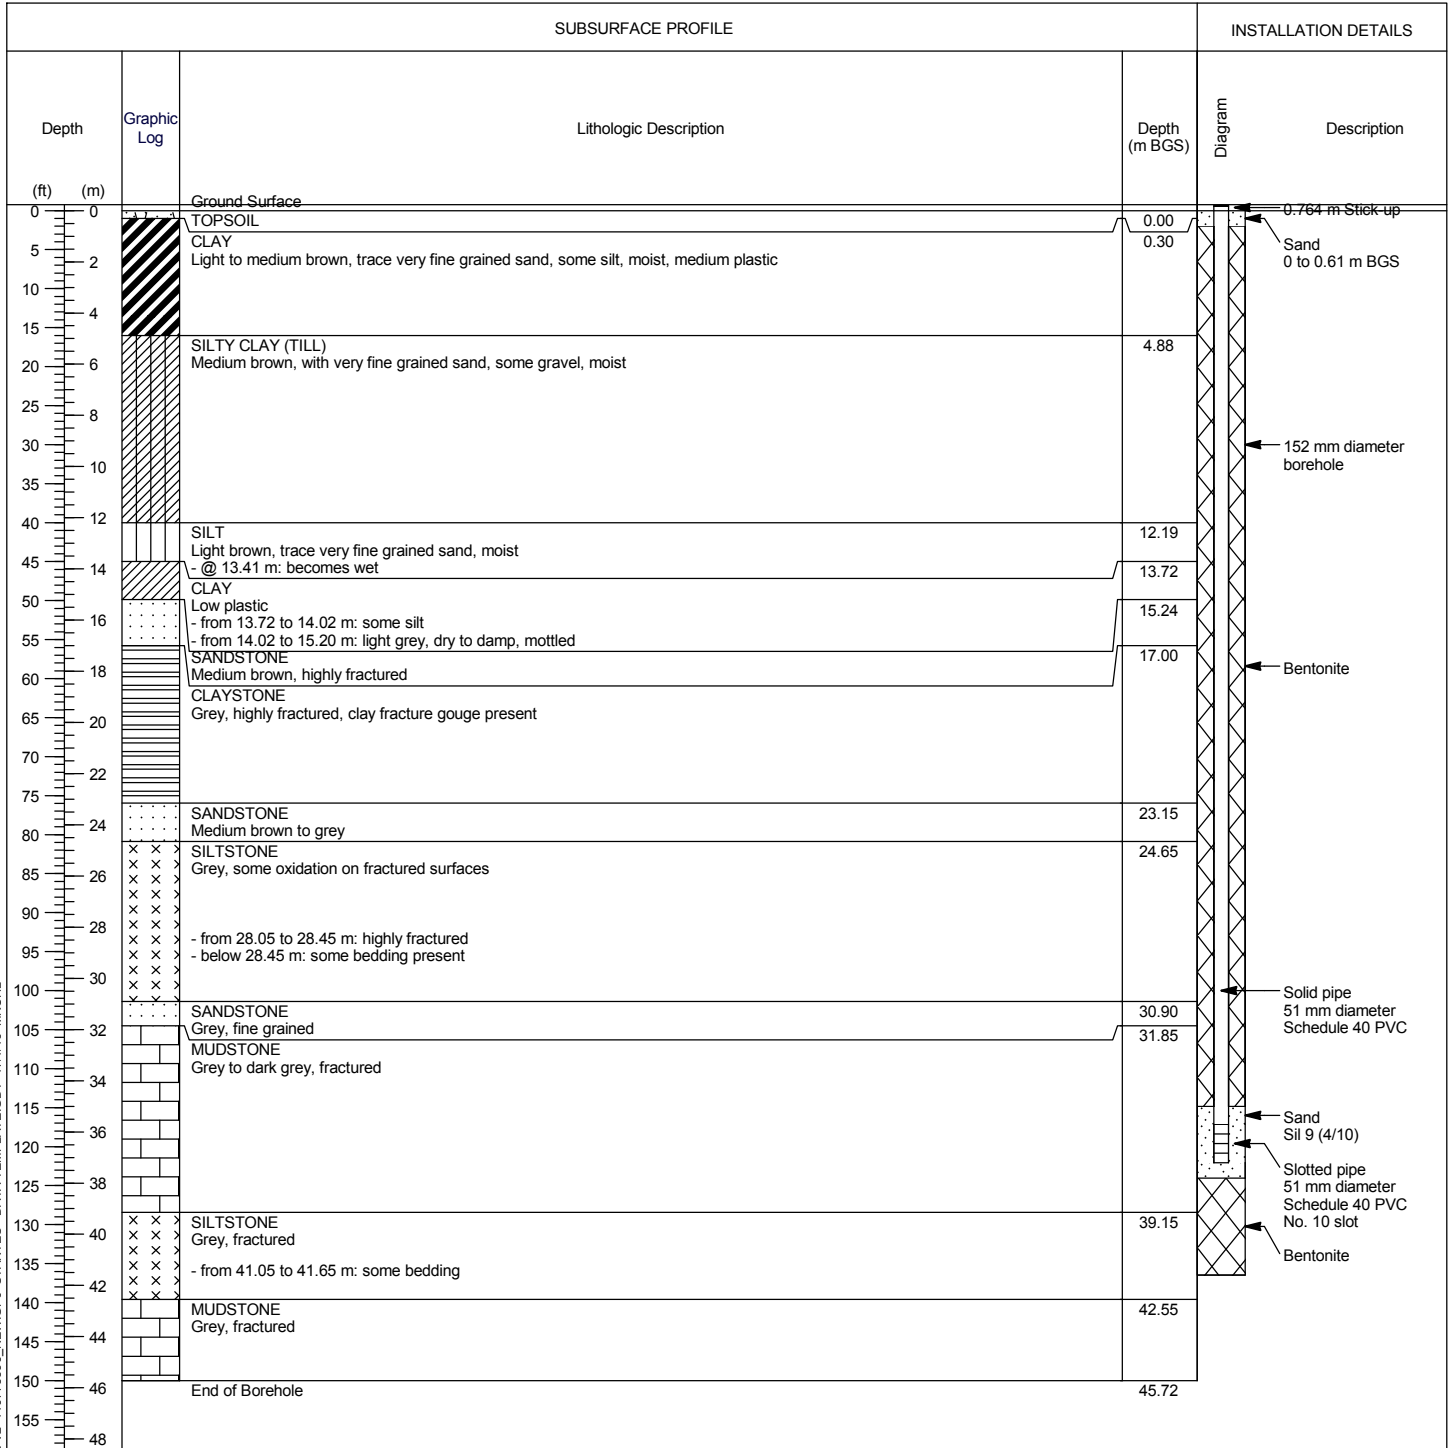
Monitoring Well: MW16-23-36 (D36D)

Project: Springbank Off-Stream Reservoir Project (SR1) Client: Alberta Transportation Location: Rocky View County, Alberta Number: 110773396 Field investigator: D. Nisbet Contractor: All Service Drilling Inc.	Drilling method: Hollow-stem auger (Track mounted)/ Coring Date started/completed: 24-Jul-2016 / 25-Jul-2016 Ground surface elevation: n/a Top of casing elevation: n/a Easting: -29019.349 Northing: 5657308.346
---	--

Screen Interval: 35.70 - 37.20 m BGS
 Sand Pack Interval: 35.00 - 37.80 m BGS
 Well Seal Interval: 0.61 - 35.00 m BGS

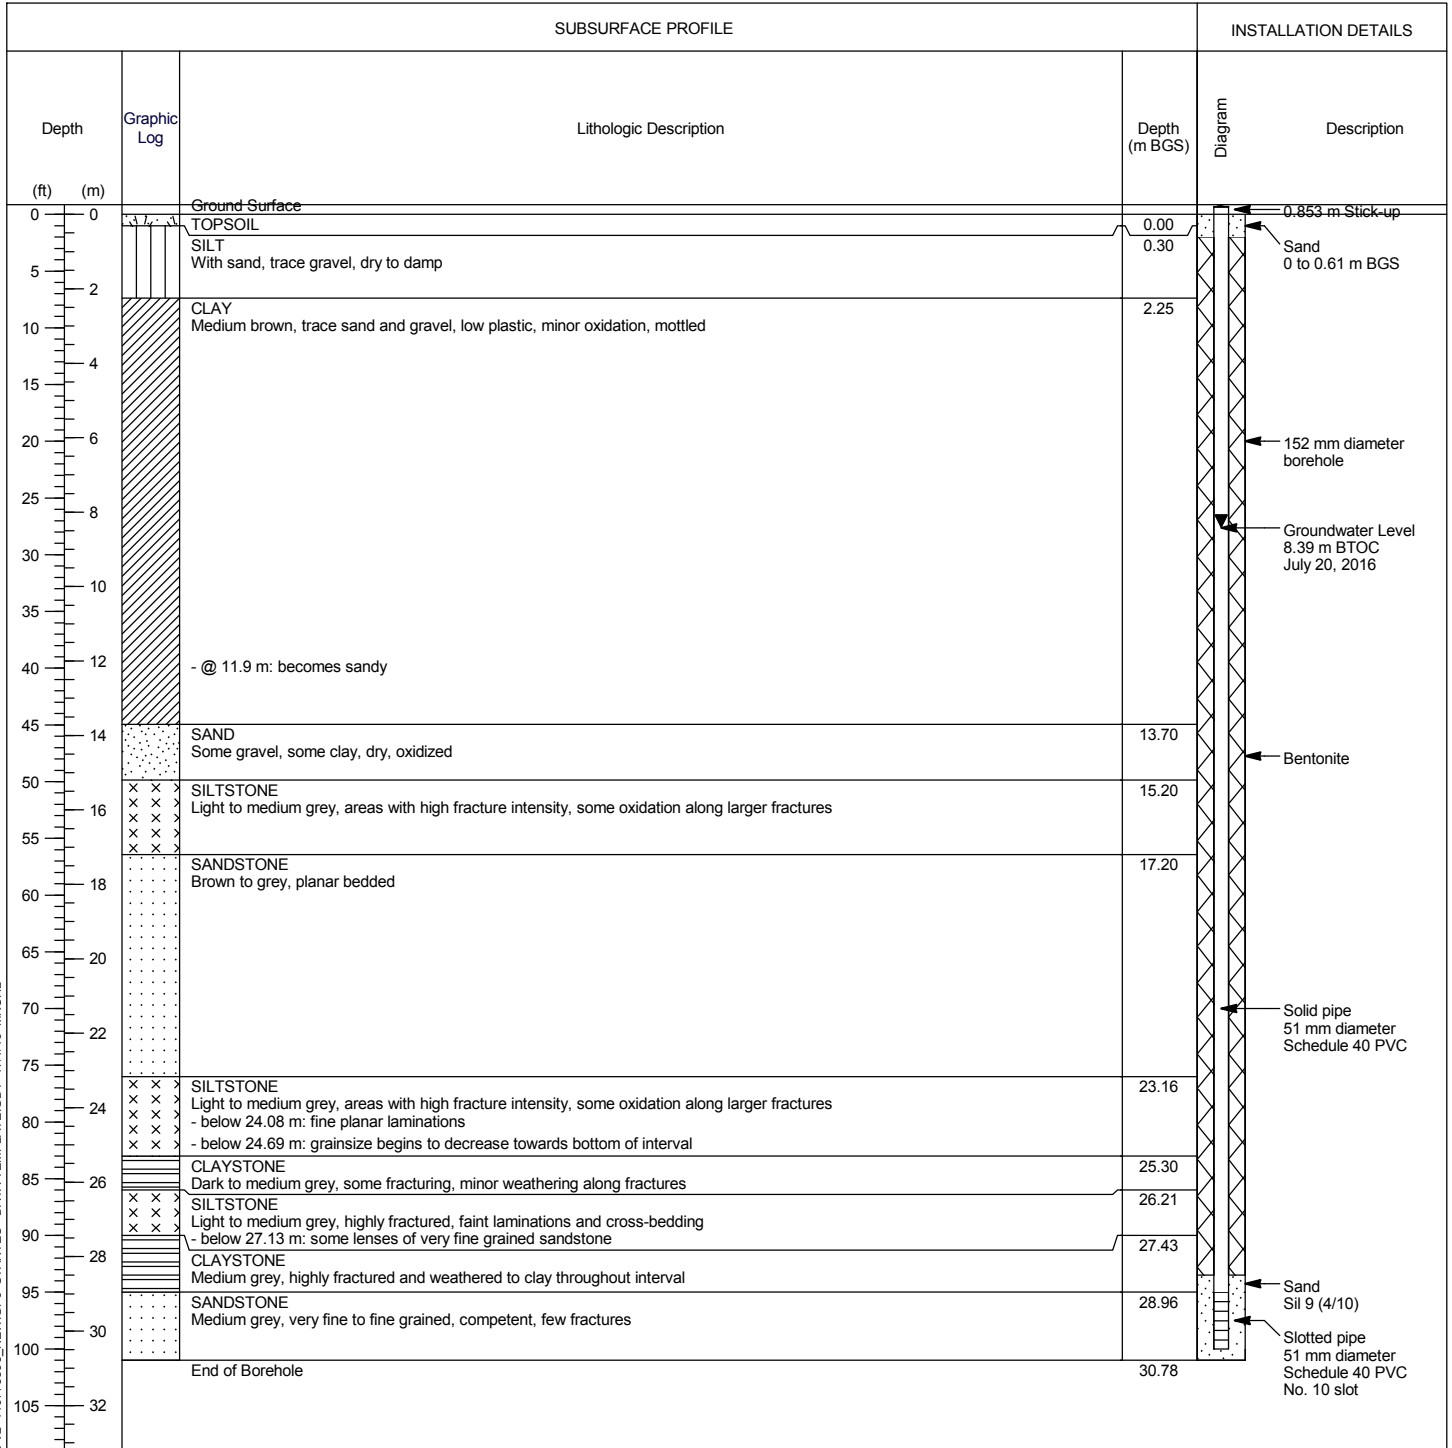
Project: Springbank Off-Stream Reservoir Project (SR1)
Client: Alberta Transportation
Location: Rocky View County, Alberta
Number: 110773396
Field investigator: D. Nisbet
Contractor: All Service Drilling Inc.

Drilling method: Hollow-stem auger / Coring
Date started/completed: 19-Jul-2016 / 20-Jul-2016
Ground surface elevation: n/a
Top of casing elevation: n/a
Easting: -28761.753
Northing: 5657740.483

Screen Interval: 28.96 - 30.48 m BGS
 Sand Pack Interval: 28.50 - 30.78 m BGS
 Well Seal Interval: 0.61 - 28.50 m BGS

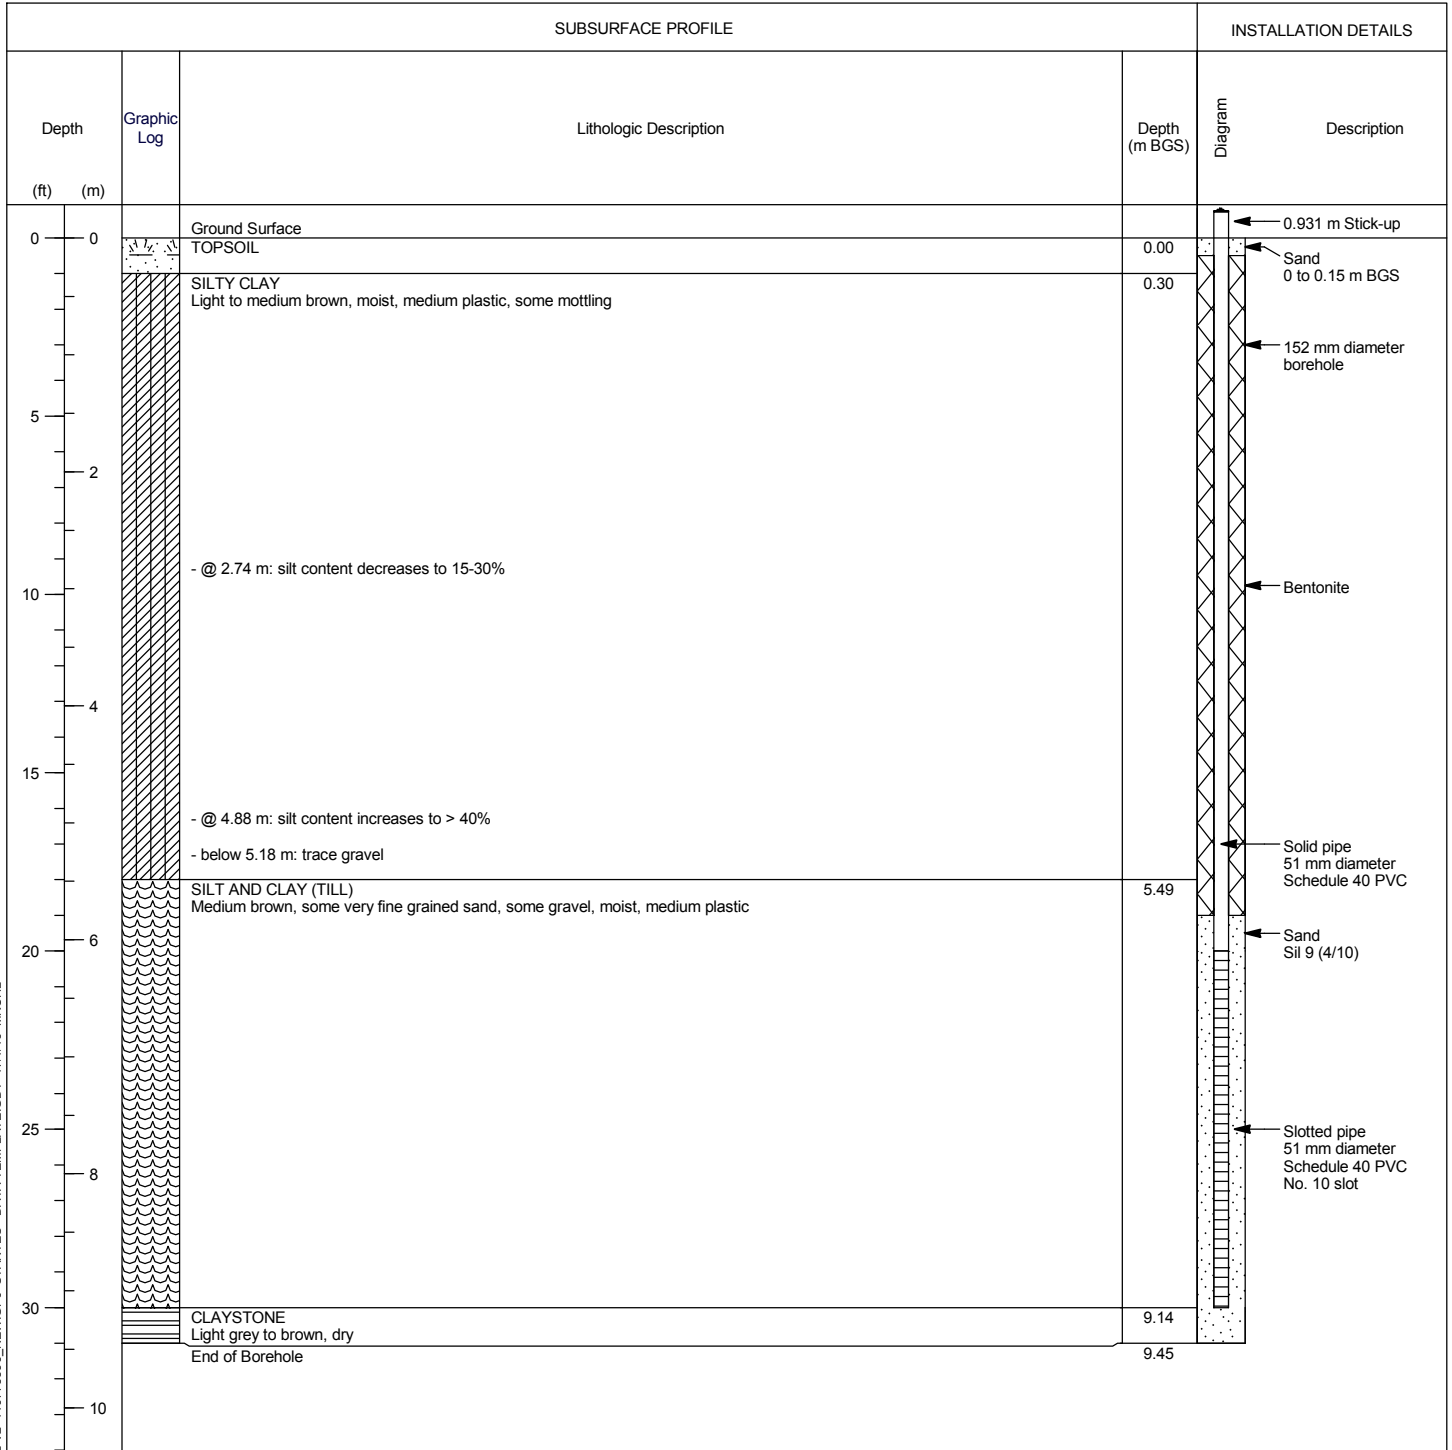
Drilling method: Solid-stem auger (Track mounted)
Date started/completed: 19-Aug-2016
Ground surface elevation: n/a
Top of casing elevation: n/a
Easting: -29274.736
Northing: 5658230.981

Screen Interval: 6.10 - 9.14 m BGS
 Sand Pack Interval: 5.79 - 9.45 m BGS
 Well Seal Interval: 0.15 - 5.79 m BGS

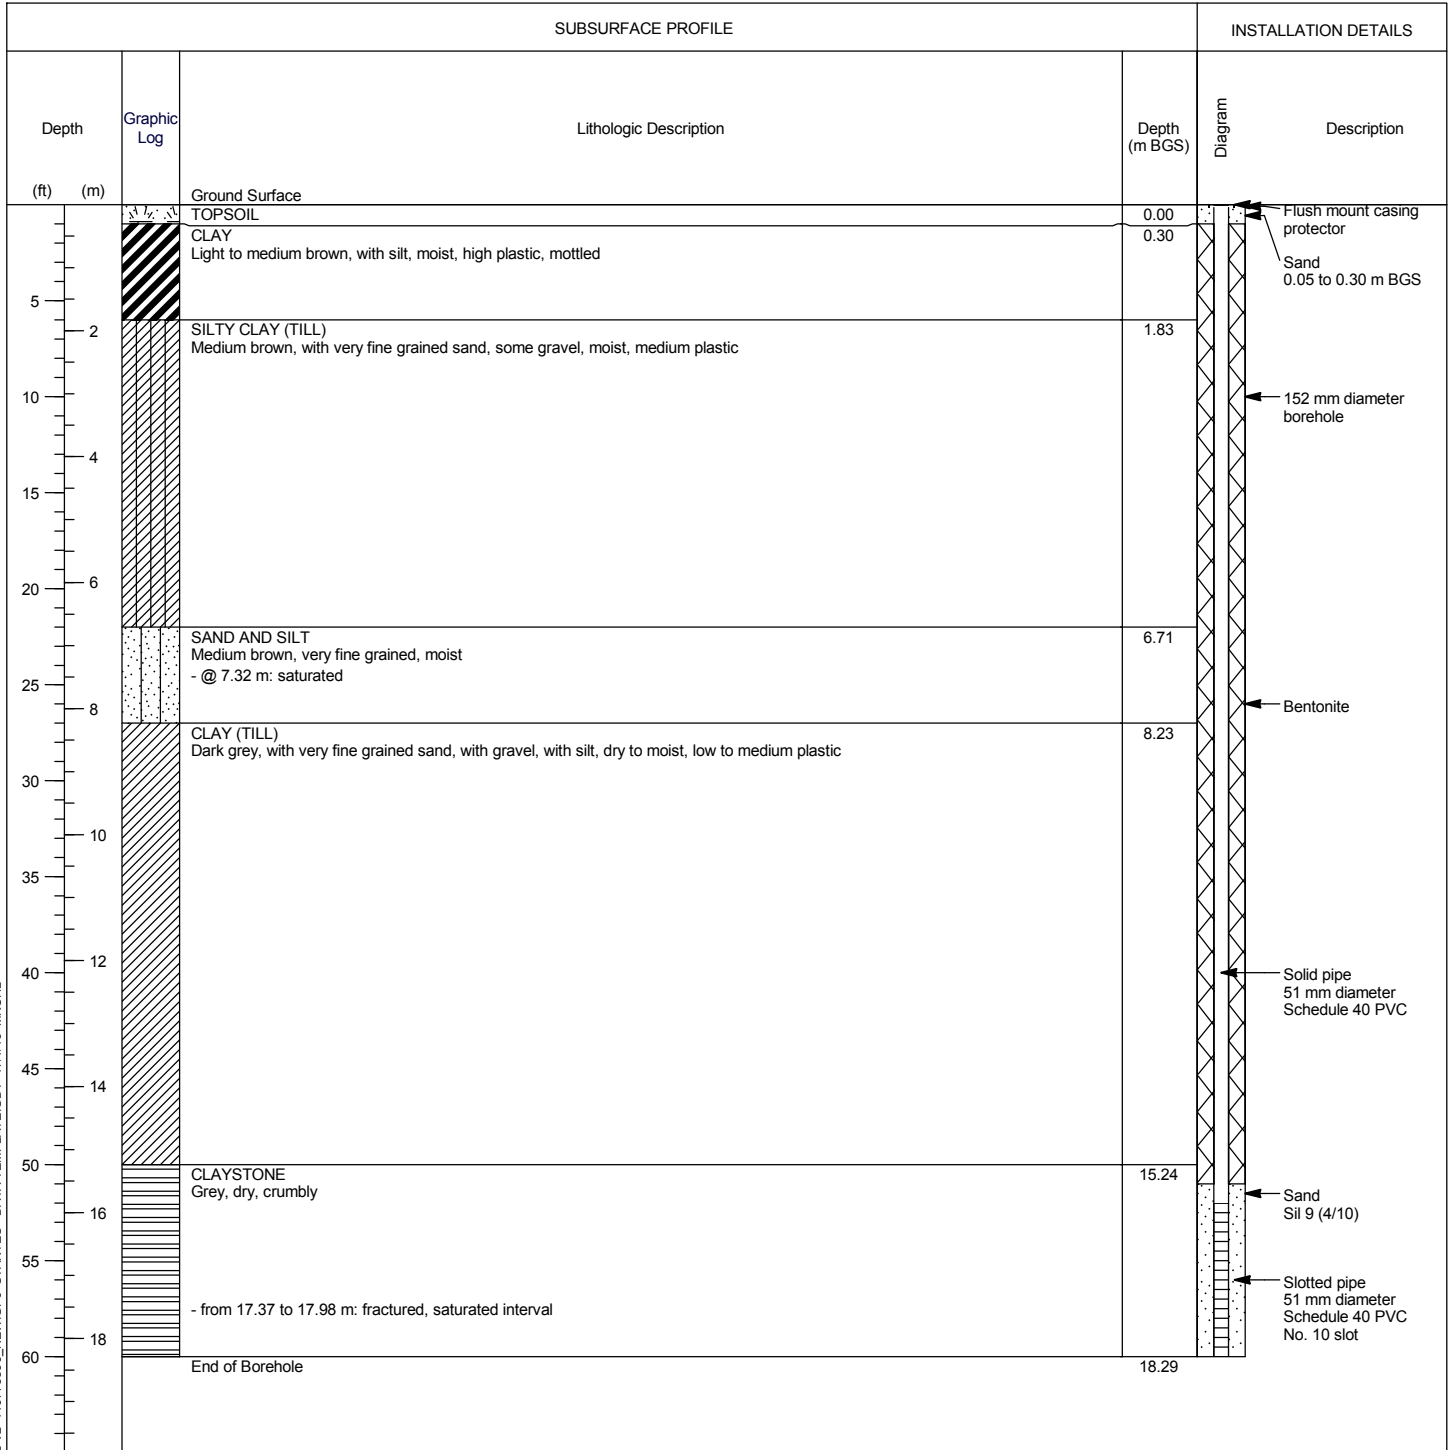
Drilling method: Solid-stem auger (Track mounted)
Date started/completed: 29-Aug-2016
Ground surface elevation: n/a
Top of casing elevation: n/a
Easting: -32702.727
Northing: 5659178.128

Screen Interval: 15.85 - 18.29 m BGS
 Sand Pack Interval: 15.54 - 18.29 m BGS
 Well Seal Interval: 0.30 - 15.54 m BGS

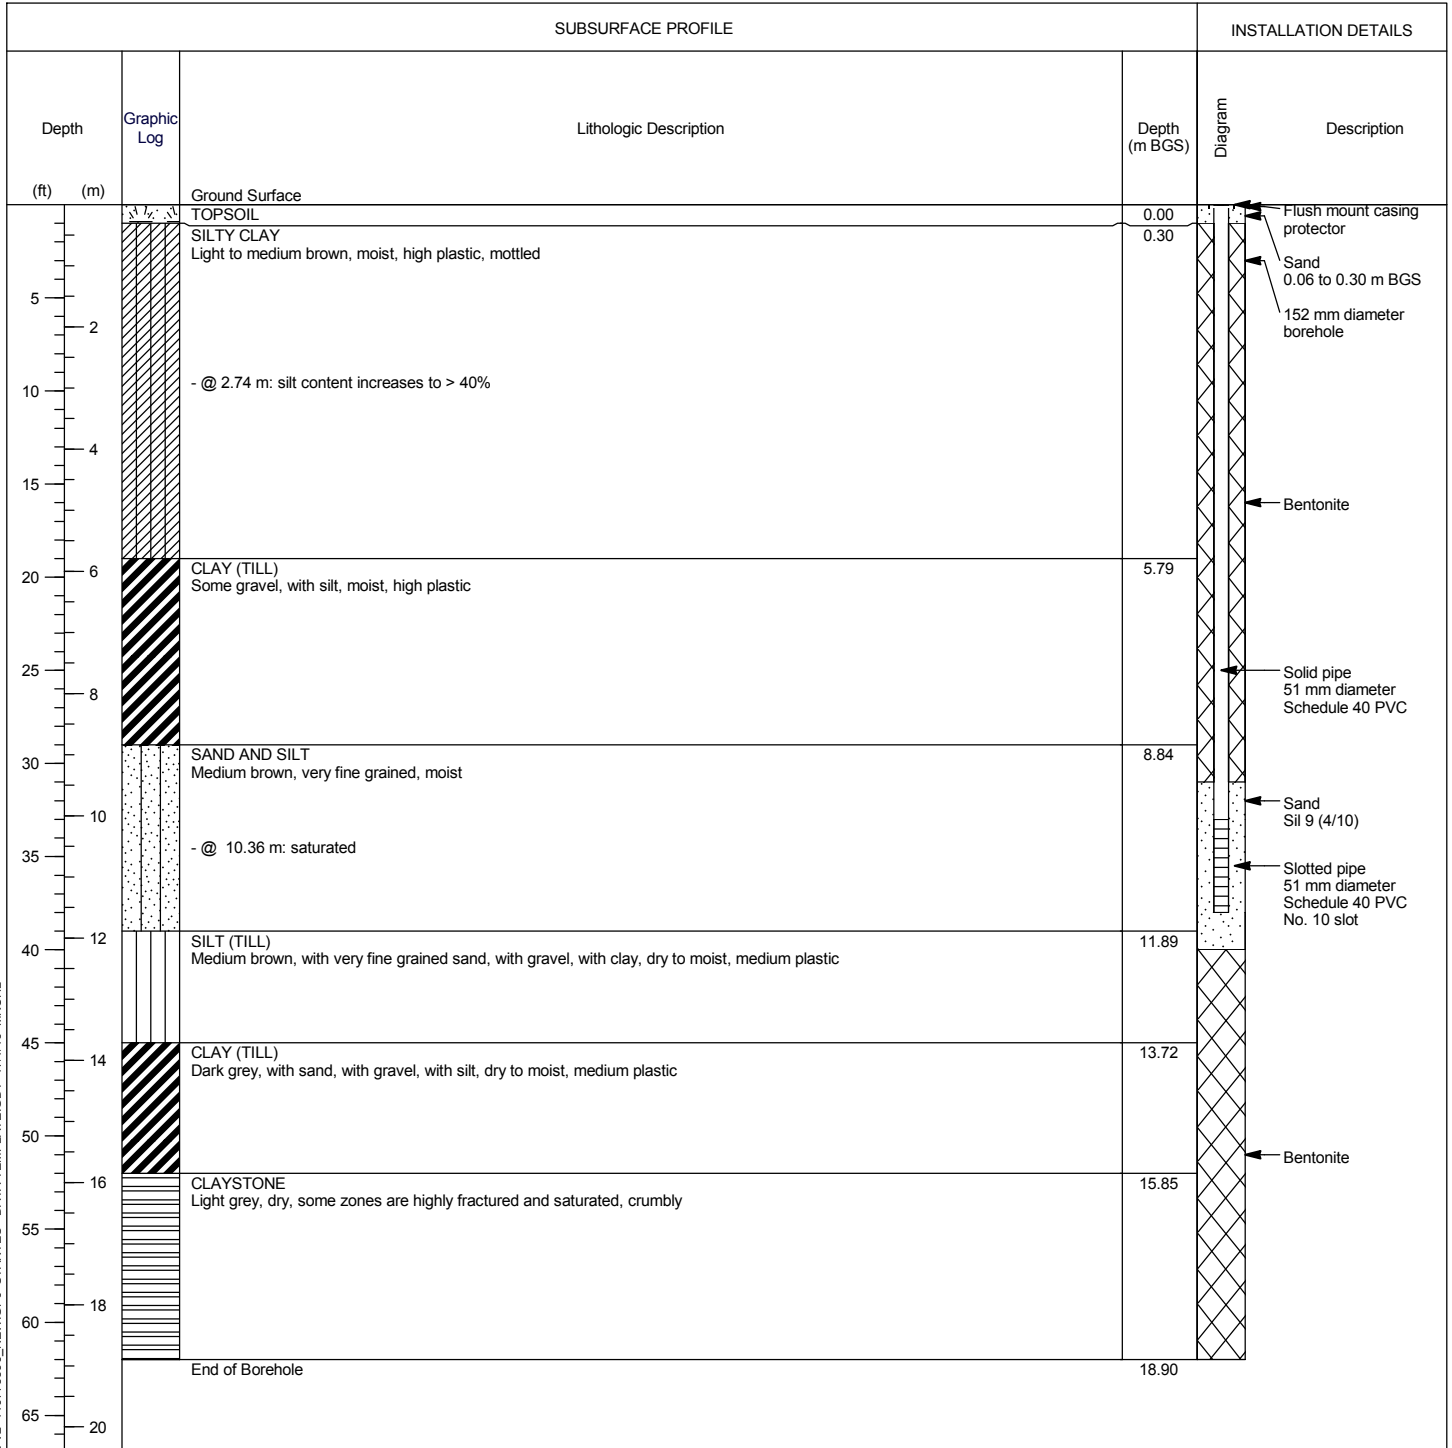
Project: Springbank Off-Stream Reservoir Project (SR1)
Client: Alberta Transportation
Location: Rocky View County, Alberta
Number: 110773396
Field investigator: D. Nisbet
Contractor: All Service Drilling Inc.

Drilling method: Solid-stem auger (Track mounted)
Date started/completed: 29-Aug-2016
Ground surface elevation: n/a
Top of casing elevation: n/a
Easting: -32702.328
Northing: 5659766.161

Screen Interval: 10.06 - 11.58 m BGS
 Sand Pack Interval: 9.45 - 12.19 m BGS
 Well Seal Interval: 0.30 - 9.45 m BGS

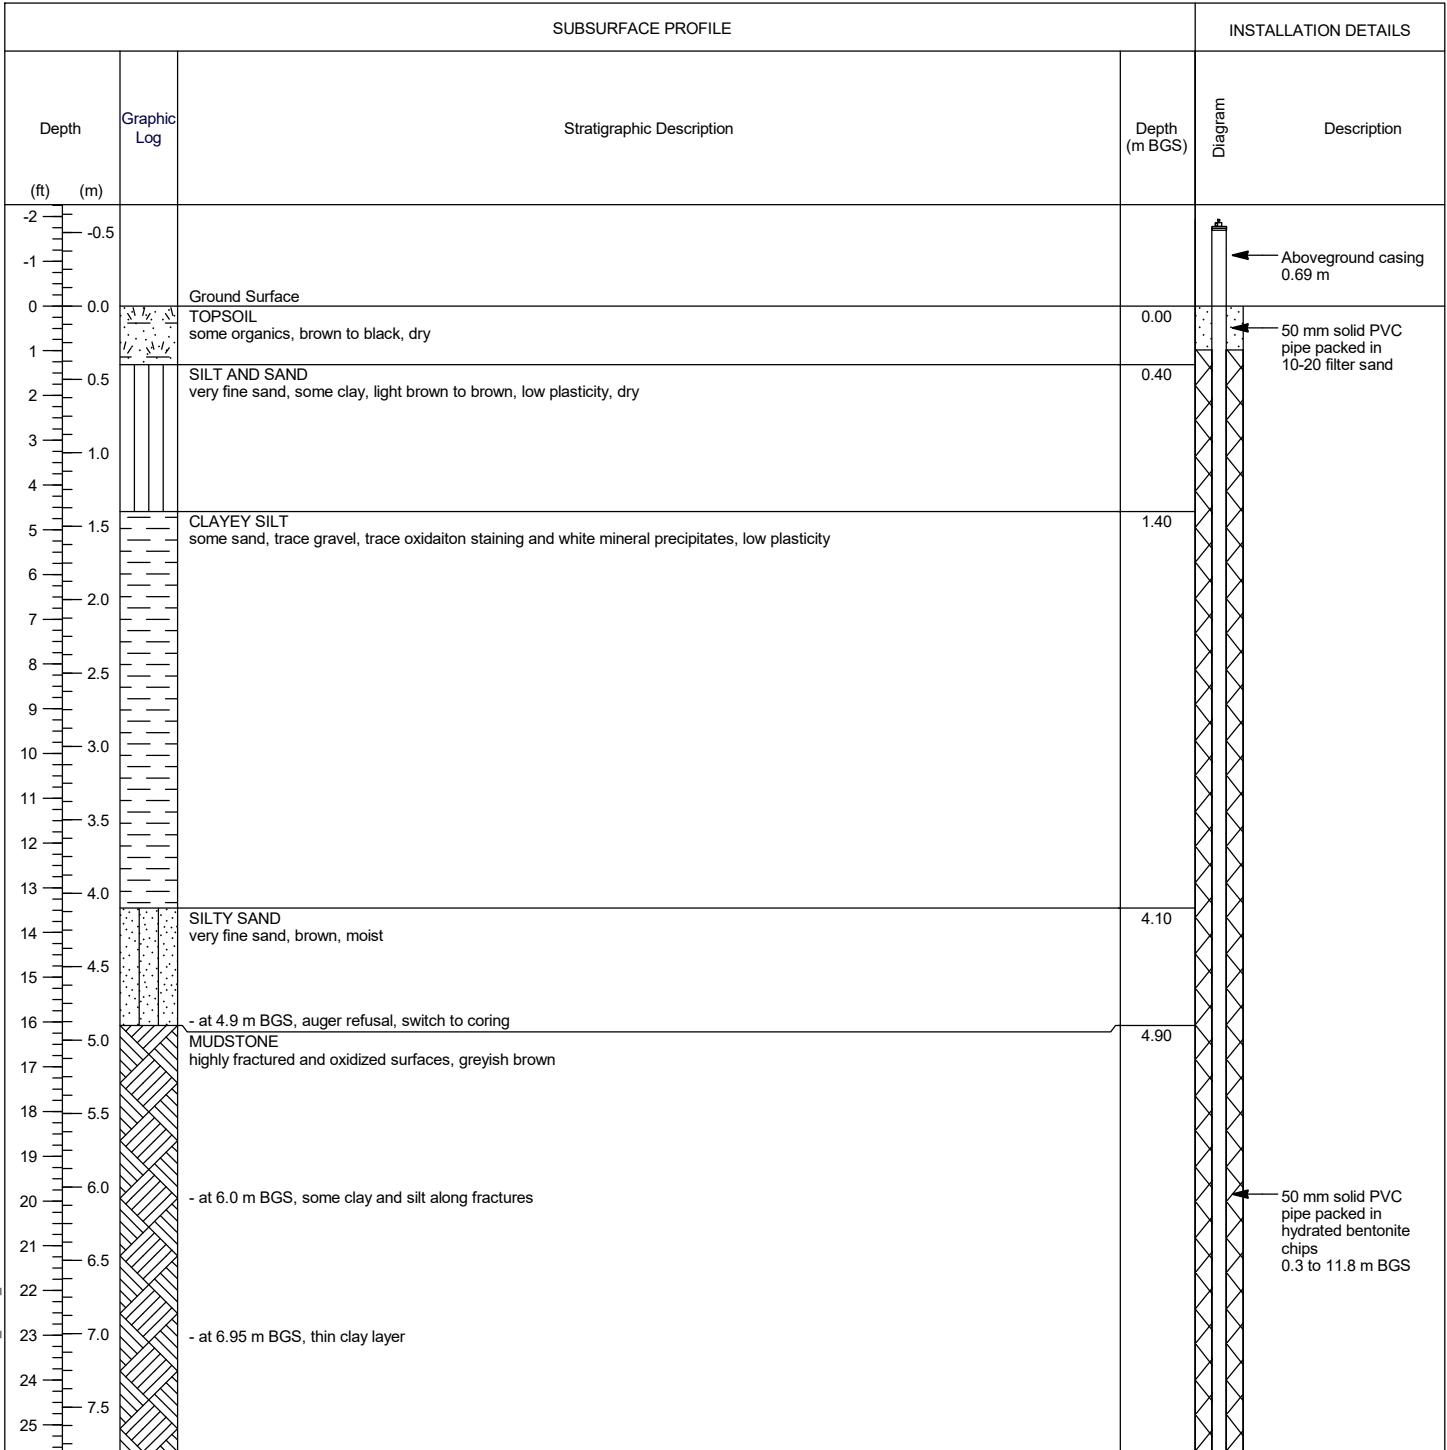
Monitoring Well: MW21-3-15

Project: SR1/Springank	Method: Solid Stem Auger
Client: Alberta Transportaiton	Date started/completed: 26-Aug-2022
Location: Rockyview County	Ground surface elevation: n/a
Number: 10773396.5210.215	Top of casing elevation: n/a
Field investigator: WT	Easting: 677300
Contractor: All Service Drilling	Northing: 5660000

Screen Interval: 12.40 - 15.40 m BGS
 Sand Pack Interval: 11.80 - 15.40 m BGS
 Well Seal Interval: 0.30 - 11.80 m BGS
