Springbank Off-stream Reservoir Project

Impact Assessment Agency
of Canada
Annual Report - 2021/2022
Reporting Year

Prepared for:
Alberta Transportation

Prepared by:
Stantec Consulting Ltd.

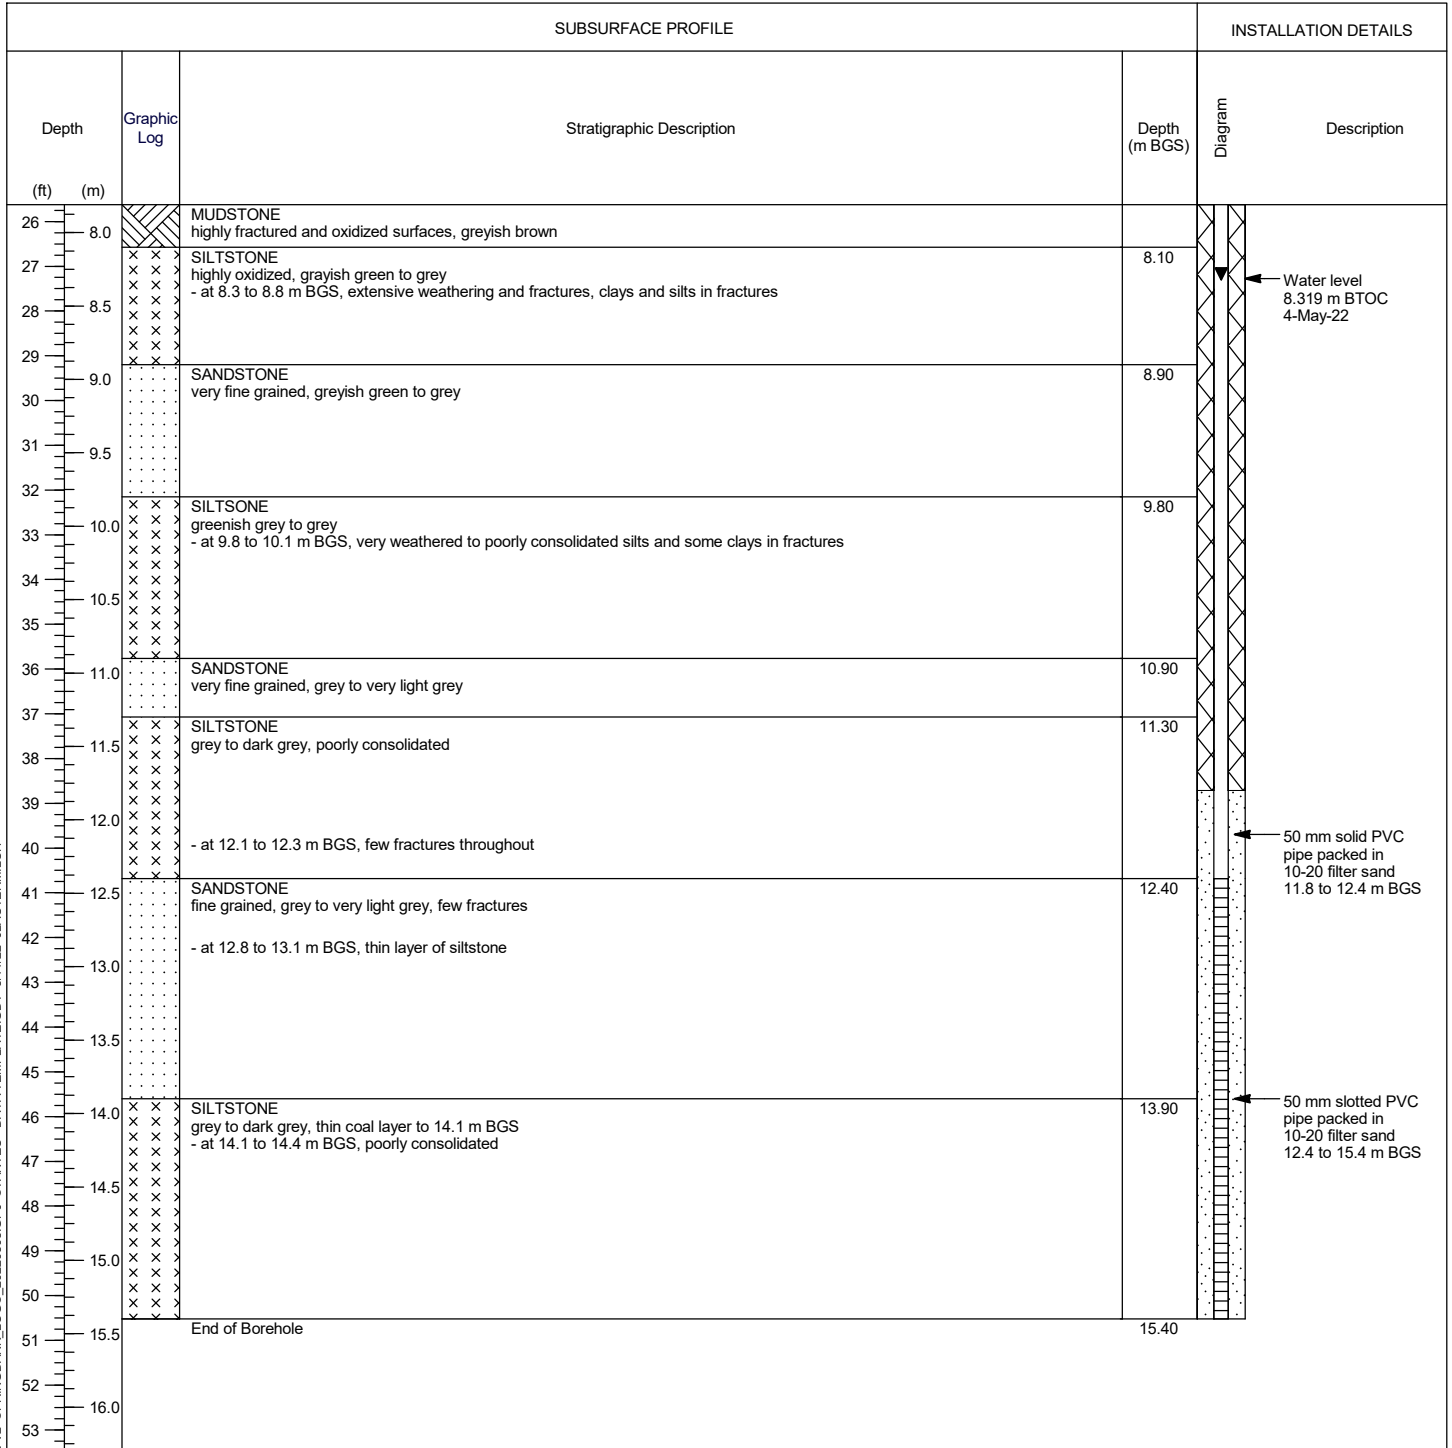
Project: SR1/Springank
Client: Alberta Transportaiton
Location: Rockyview County
Number: 10773396.5210.215
Field investigator: WT
Contractor: All Service Drilling

Method: Solid Stem Auger
Date started/completed: 26-Aug-2022
Ground surface elevation: n/a
Top of casing elevation: n/a
Easting: 677300
Northing: 5660000

Screen Interval: 12.40 - 15.40 m BGS
 Sand Pack Interval: 11.80 - 15.40 m BGS
 Well Seal Interval: 0.30 - 11.80 m BGS

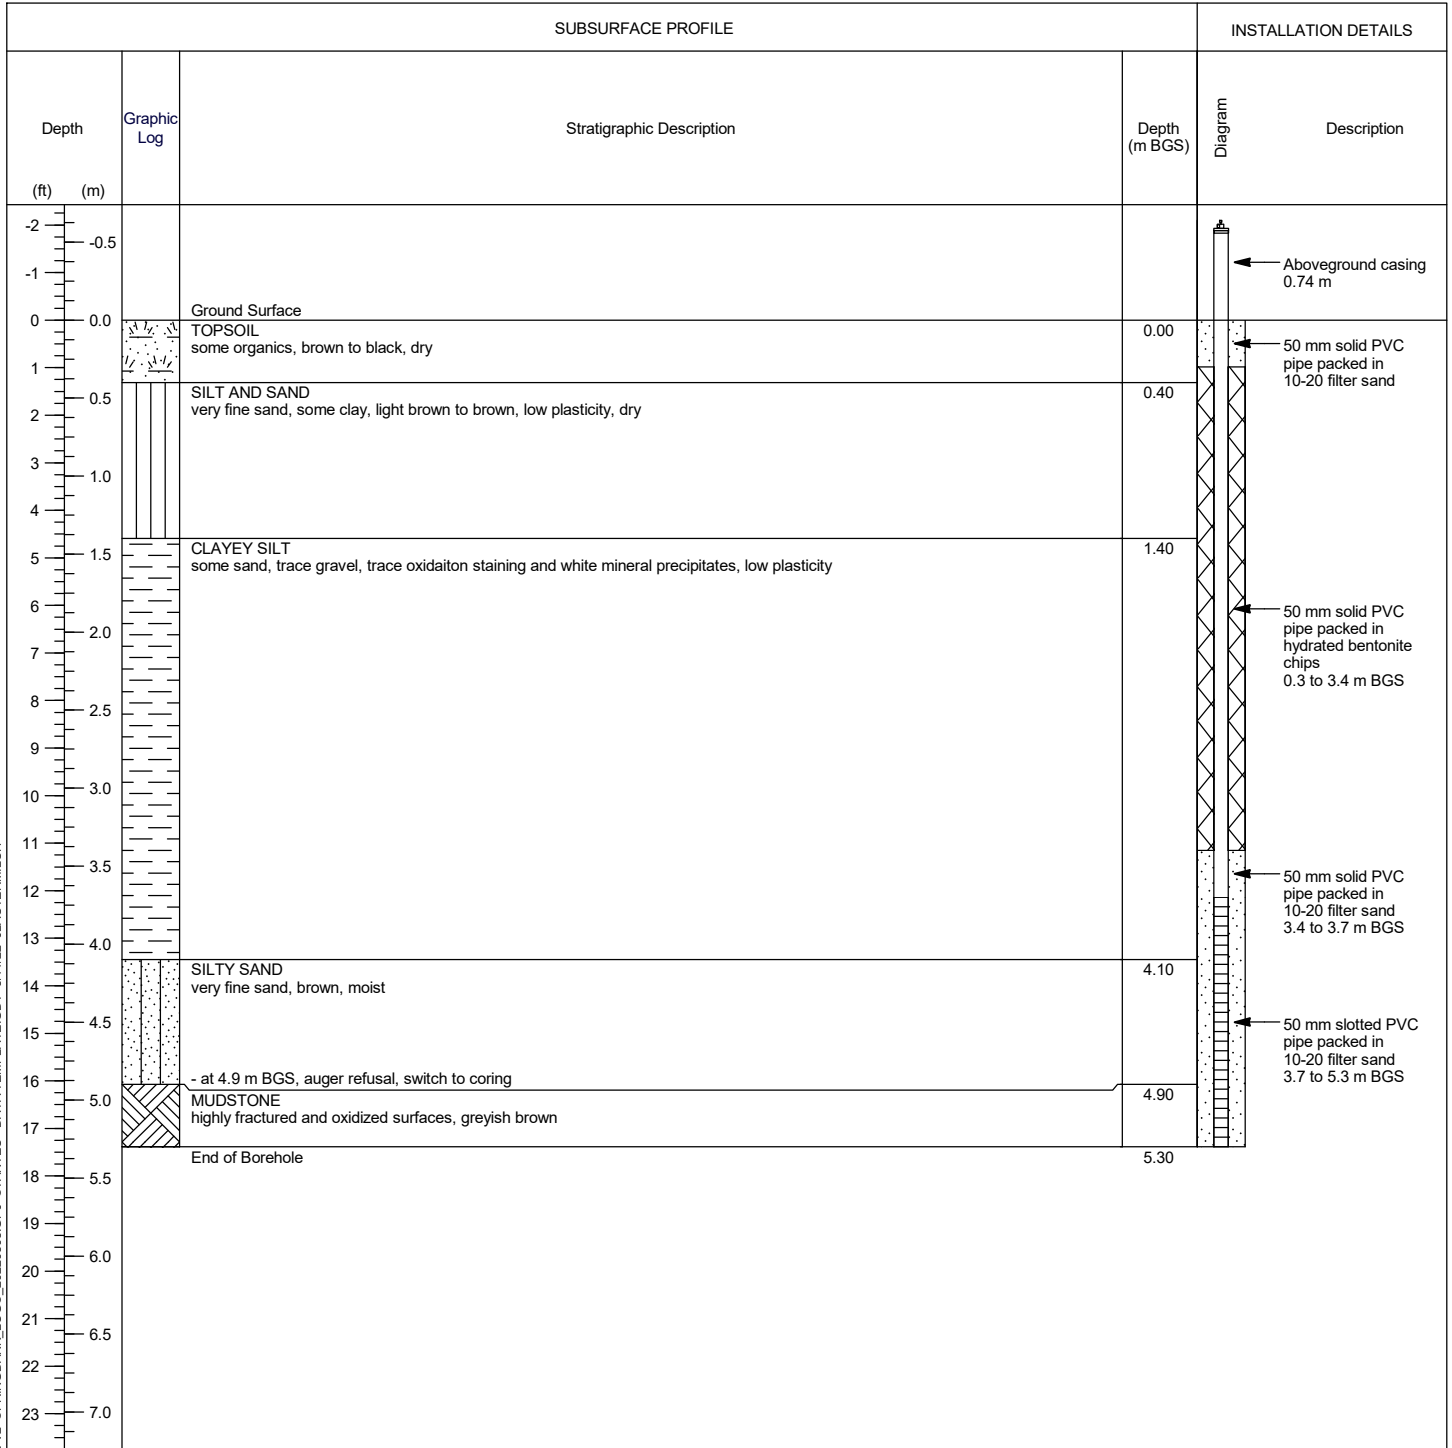
Project: SR1/Springank
Client: Alberta Transportaiton
Location: Rockyview County
Number: 10773396.5210.215
Field investigator: WT
Contractor: All Service Drilling

Method: Solid Stem Auger
Date started/completed: 27-Aug-2022
Ground surface elevation: n/a
Top of casing elevation: n/a
Easting: 677301
Northing: 5660000

Screen Interval: 3.70 - 5.30 m BGS
 Sand Pack Interval: 3.40 - 5.30 m BGS
 Well Seal Interval: 0.30 - 3.40 m BGS

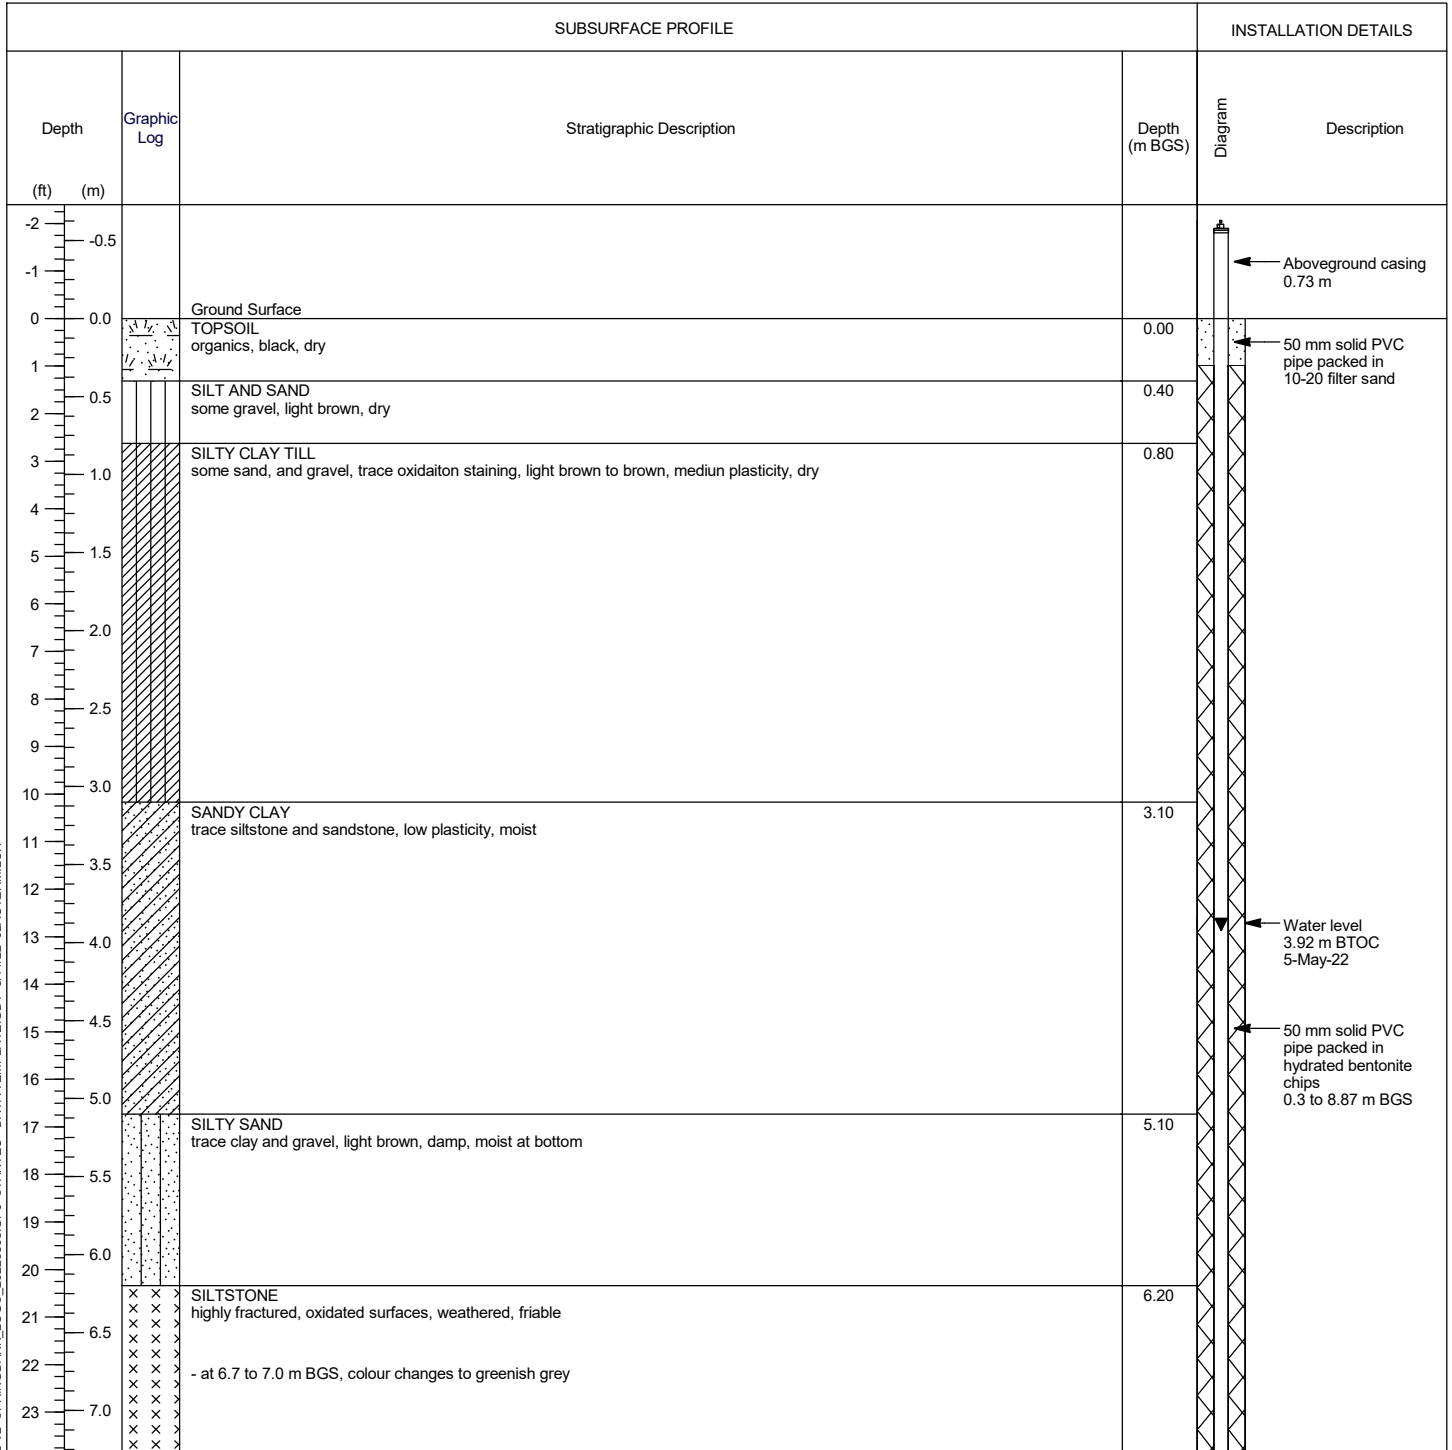
Project: SR1/Springank	Method: Solid Stem Auger
Client: Alberta Transportaiton	Date started/completed: 27-Aug-2021
Location: Rockyview County	Ground surface elevation: n/a
Number: 10773396.5210.215	Top of casing elevation: n/a
Field investigator: WT	Easting: 677606
Contractor: All Service Drilling	Northing: 5658026

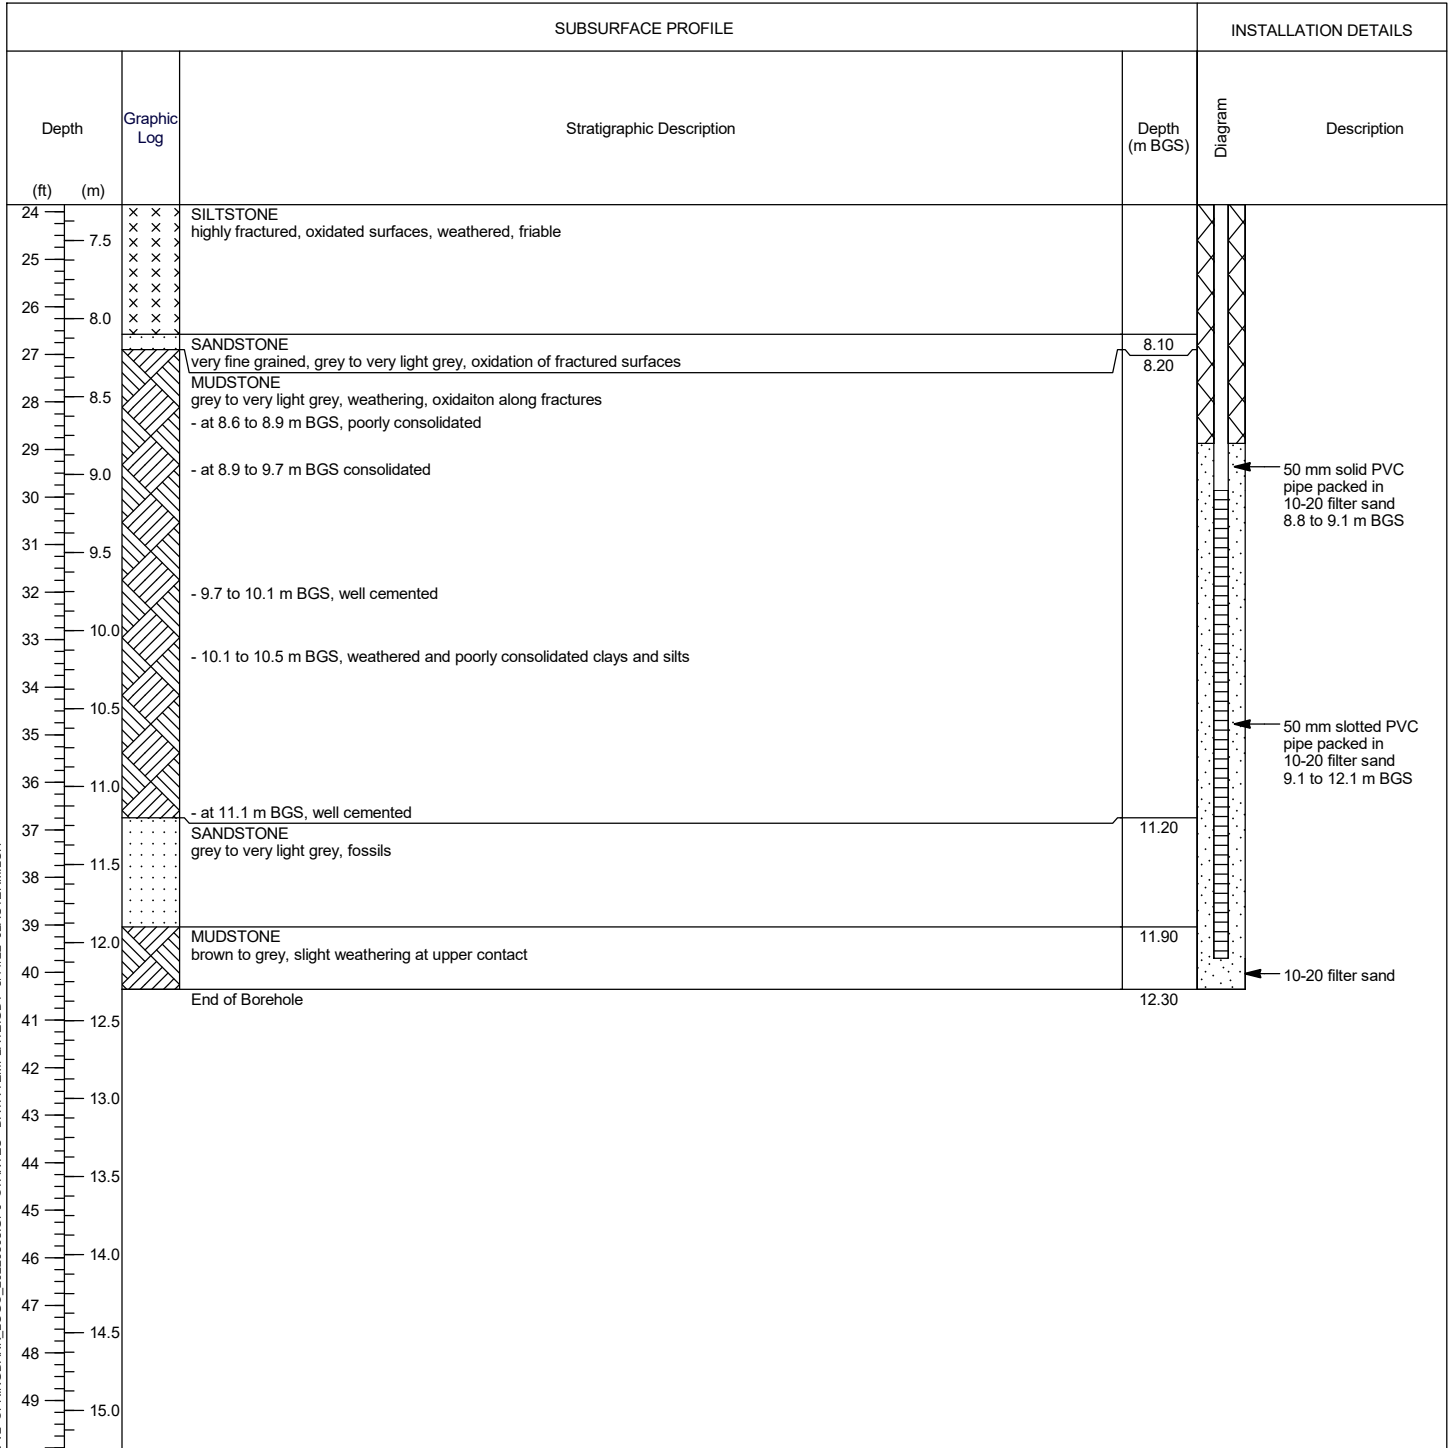
Project: SR1/Springank
Client: Alberta Transportaiton
Location: Rockyview County
Number: 10773396.5210.215
Field investigator: WT
Contractor: All Service Drilling

Method: Solid Stem Auger
Date started/completed: 27-Aug-2021
Ground surface elevation: n/a
Top of casing elevation: n/a
Easting: 677606
Northing: 5658026

Screen Interval: 9.10 - 12.10 m BGS
 Sand Pack Interval: 8.80 - 12.30 m BGS
 Well Seal Interval: 0.30 - 8.80 m BGS

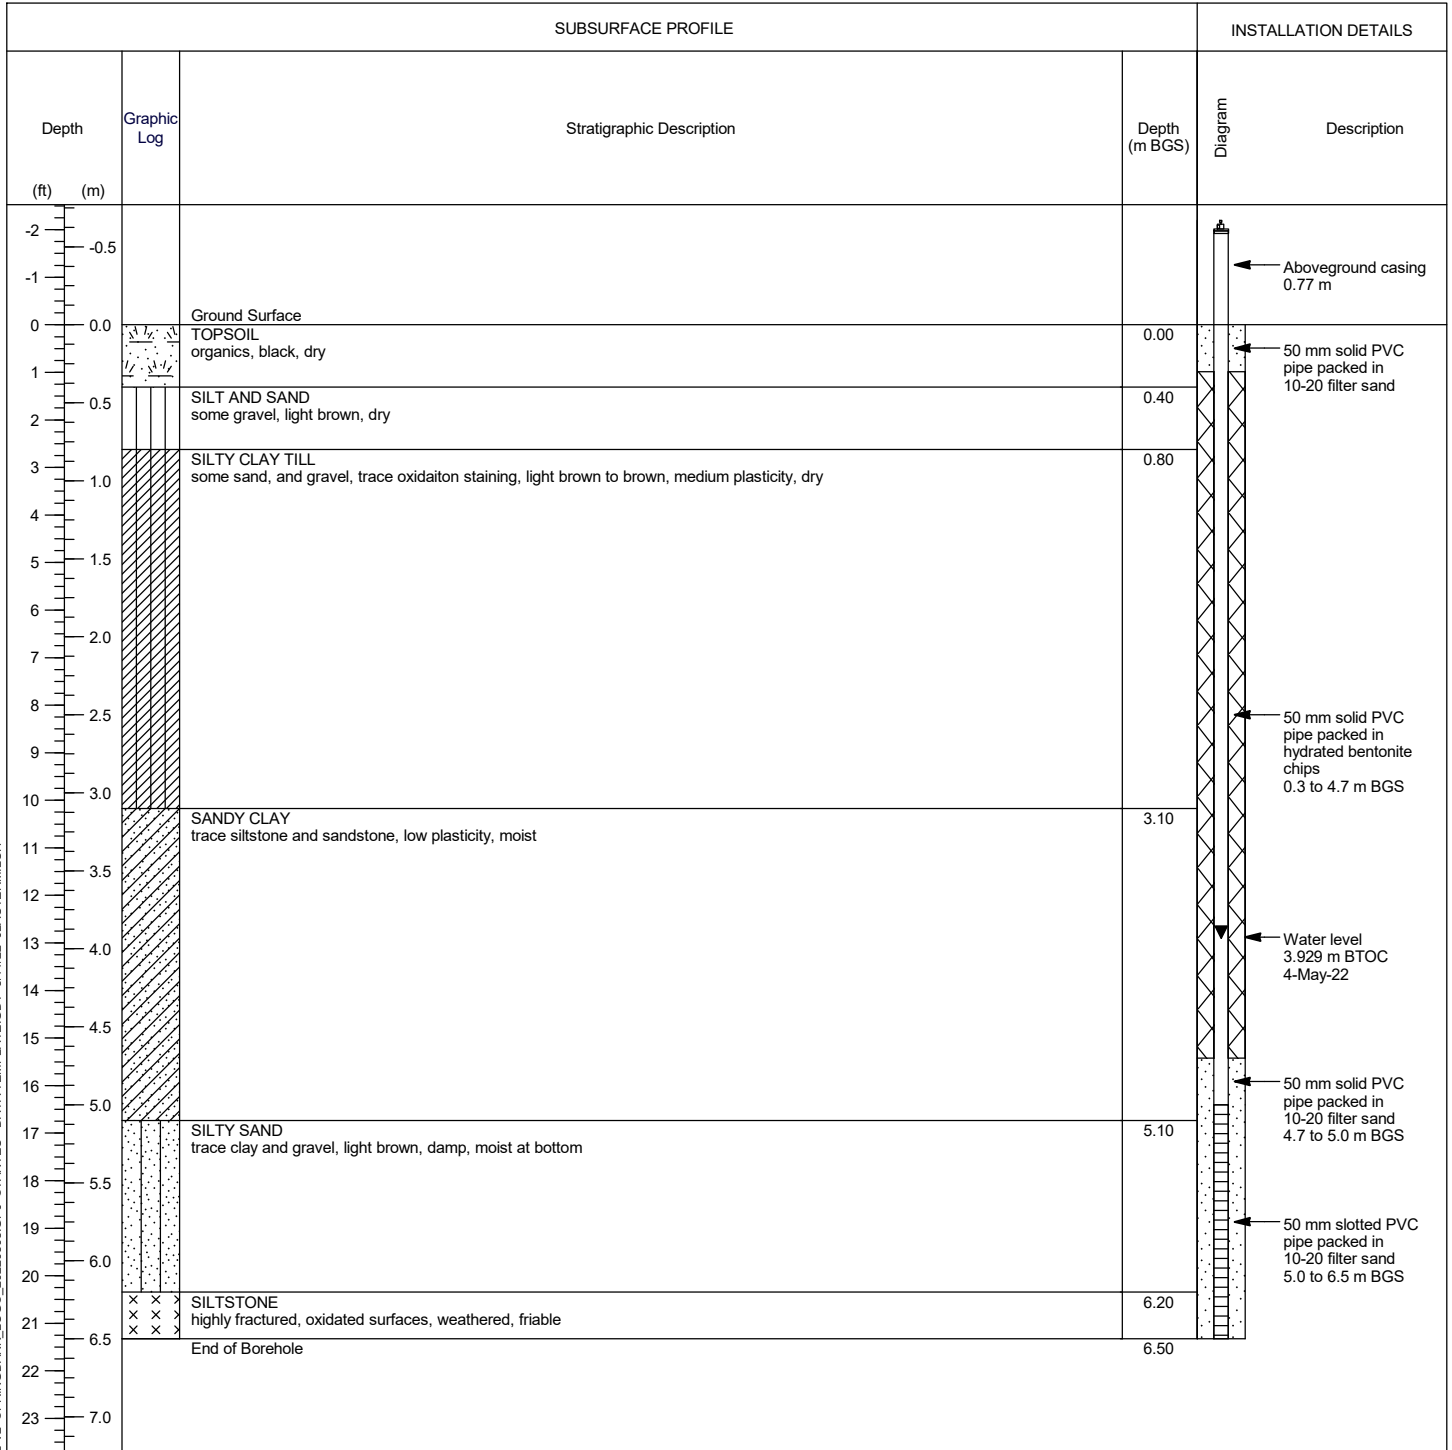
Method: Solid Stem Auger
Date started/completed: 27-Aug-2021
Ground surface elevation: n/a
Top of casing elevation: n/a
Easting: 677606
Northing: 5658026

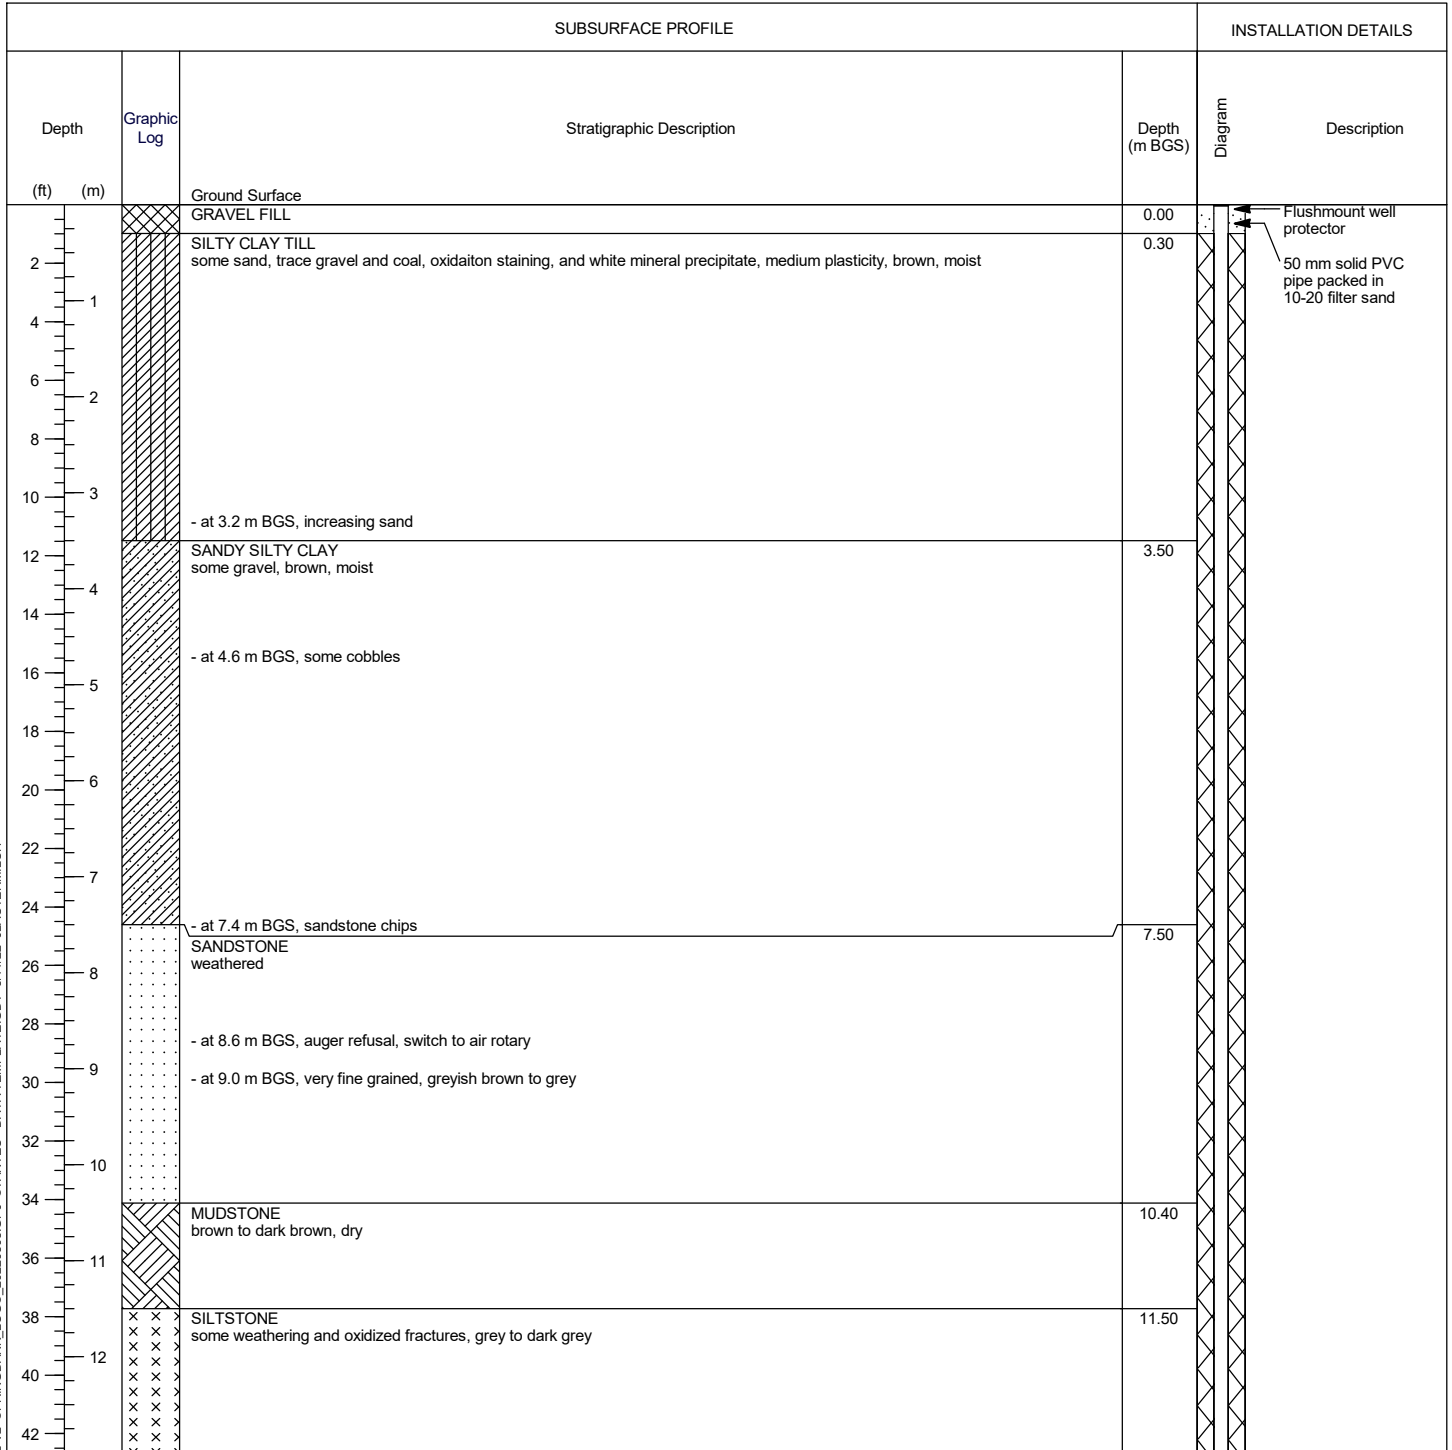
Method: Solid Stem Auger
Date started/completed: 24-Aug-2021
Ground surface elevation: n/a
Top of casing elevation: n/a
Easting: 680595
Northing: 5660430

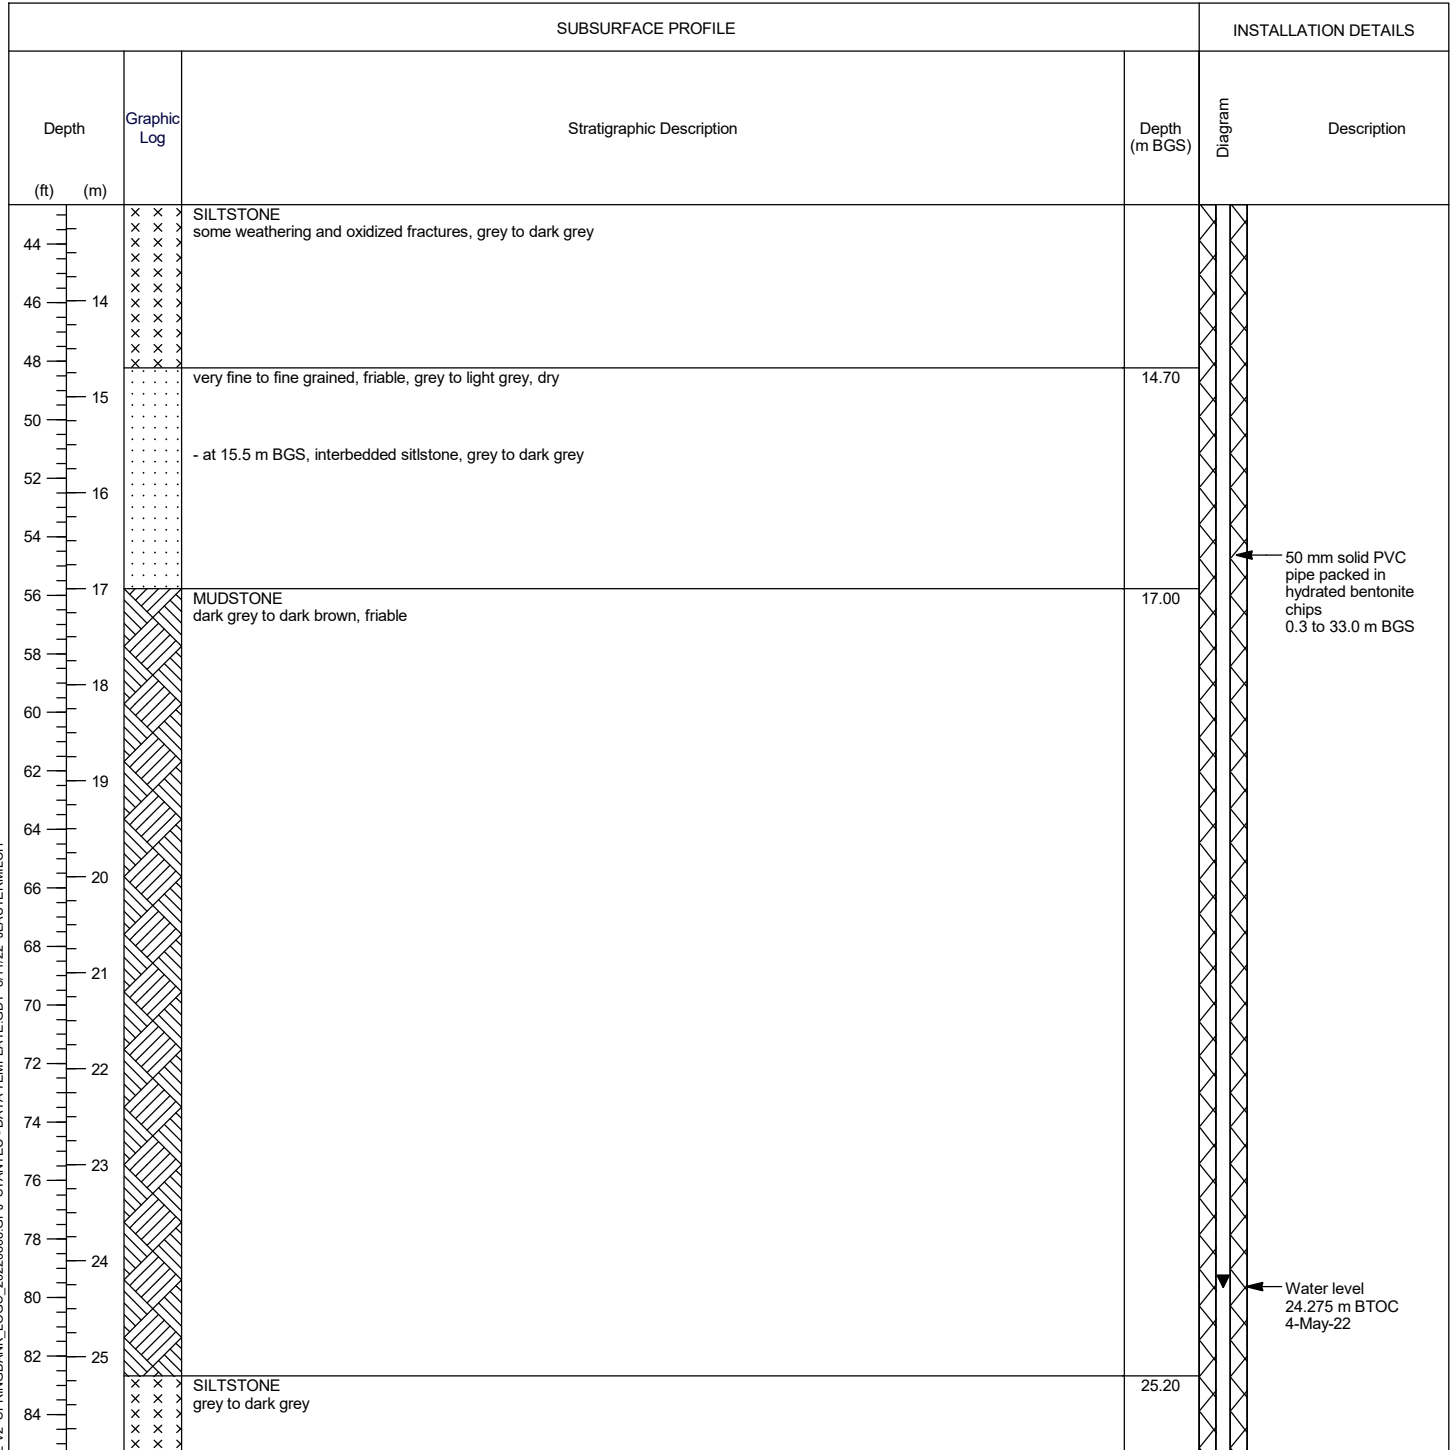
Method: Solid Stem Auger
Date started/completed: 24-Aug-2021
Ground surface elevation: n/a
Top of casing elevation: n/a
Easting: 680595
Northing: 5660430

Screen Interval: 33.50 - 36.50 m BGS
 Sand Pack Interval: 33.00 - 36.50 m BGS
 Well Seal Interval: 0.30 - 33.00 m BGS

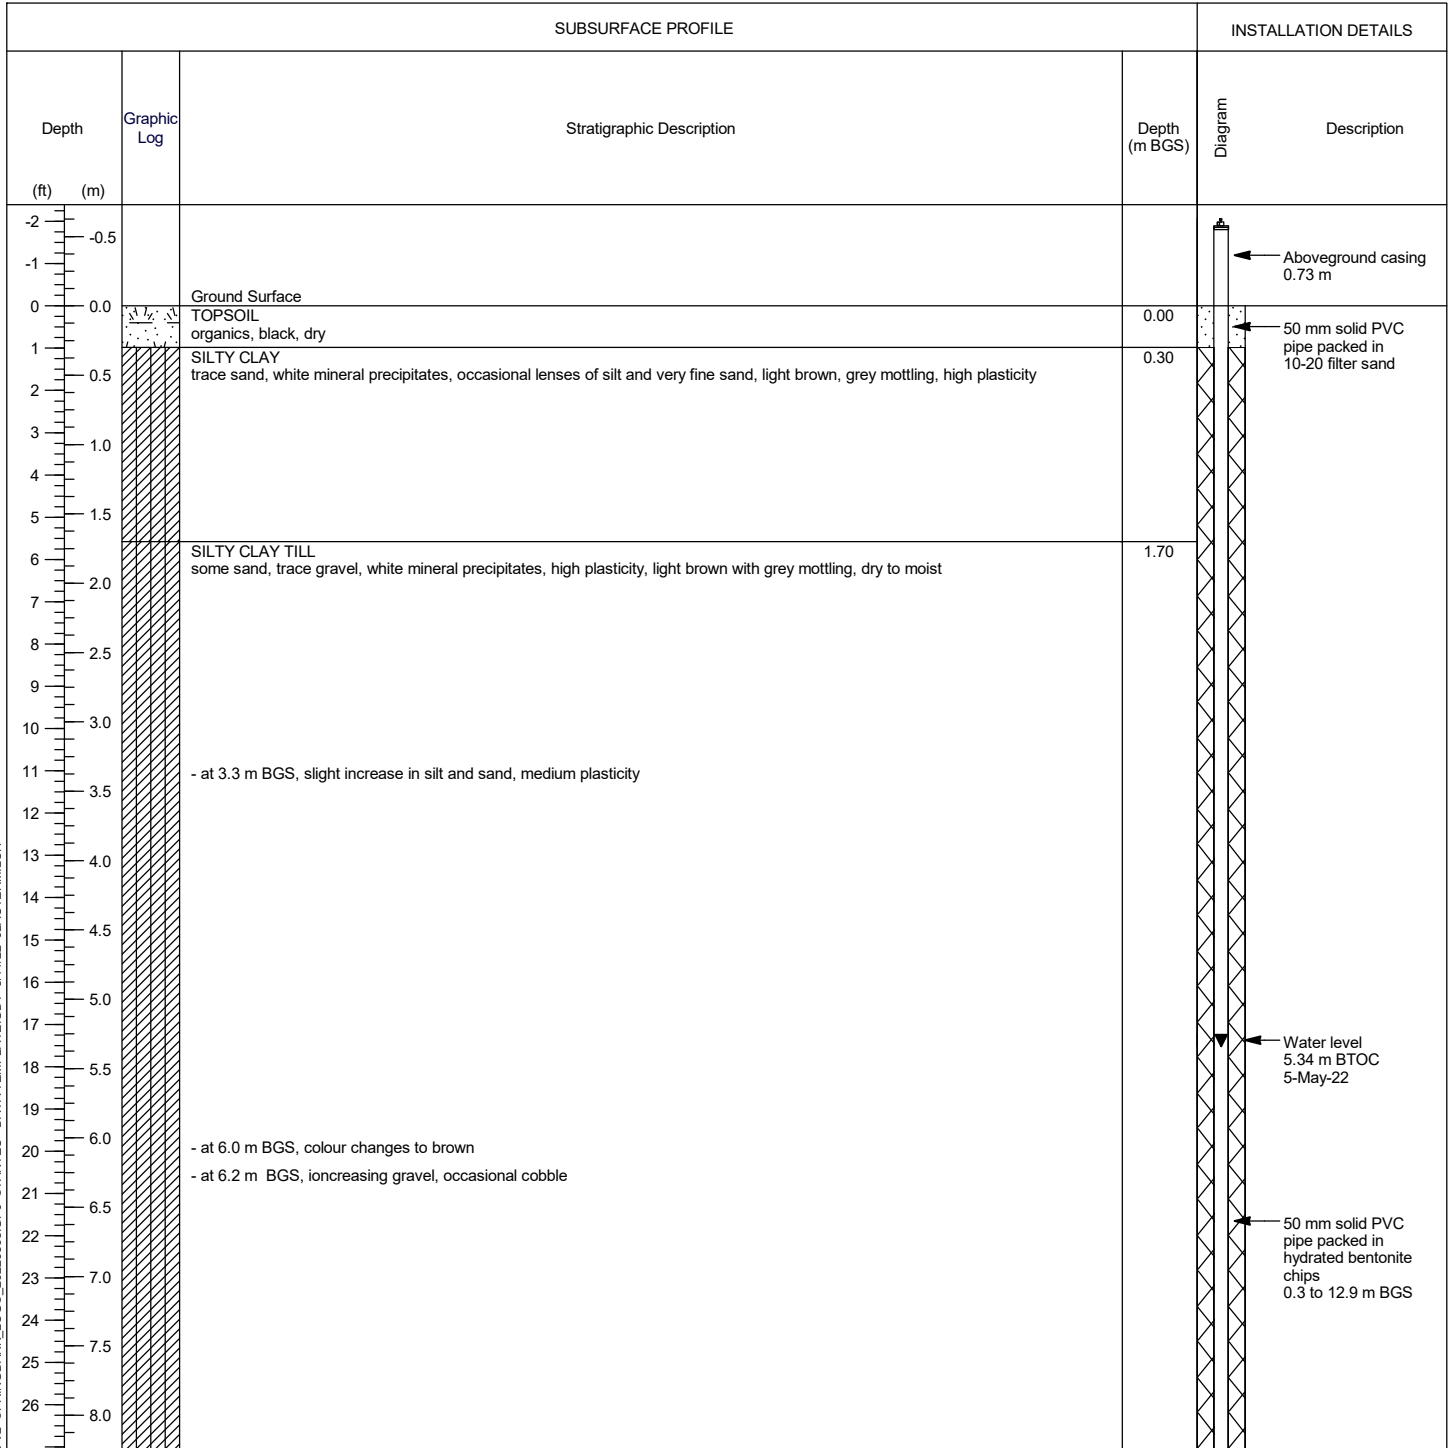
Project: SR1/Springank
Client: Alberta Transportaiton
Location: Rockyview County
Number: 10773396.5210.215
Field investigator: WT
Contractor: All Service Drilling

Method: Solid Stem Auger
Date started/completed: 25-Aug-2021
Ground surface elevation: n/a
Top of casing elevation: n/a
Easting: 677090
Northing: 565364

Screen Interval: 13.50 - 16.50 m BGS
 Sand Pack Interval: 12.90 - 16.50 m BGS
 Well Seal Interval: 0.30 - 12.90 m BGS

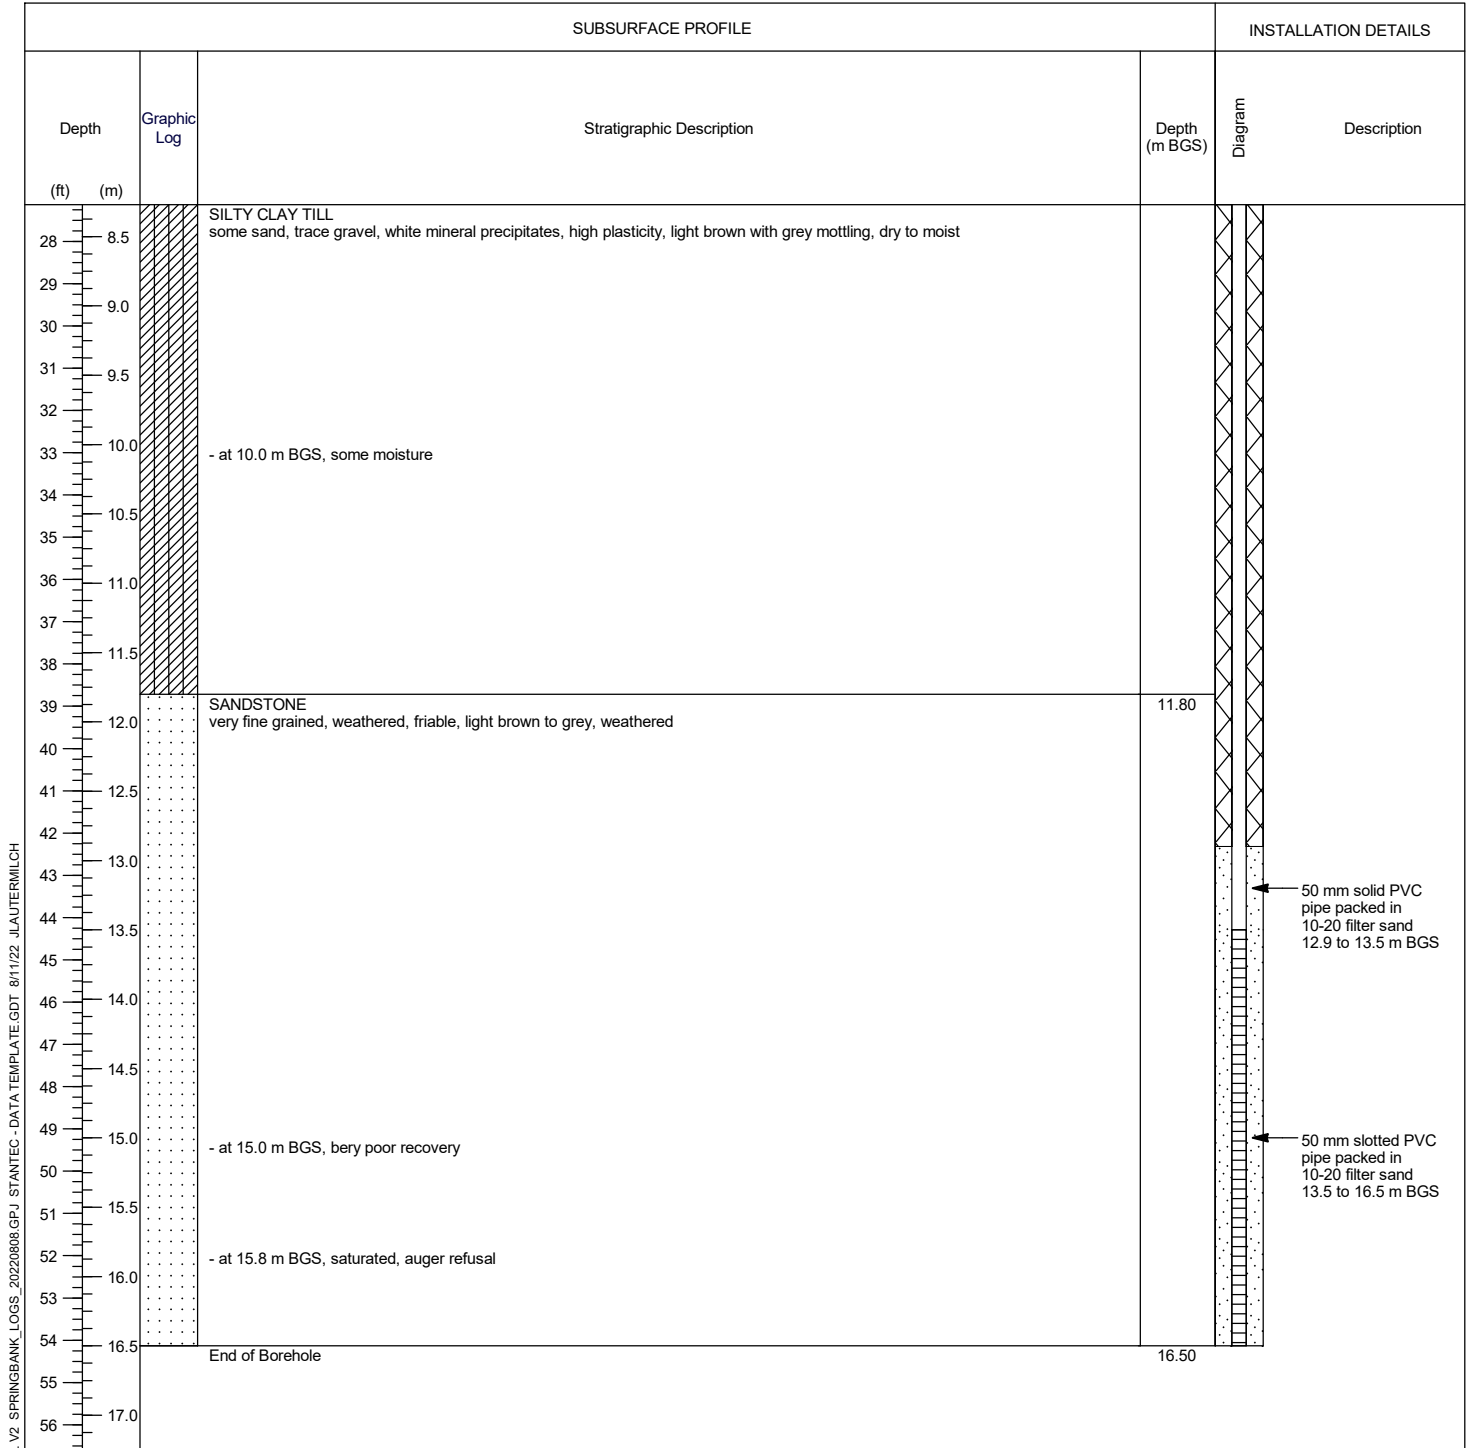
Method: Solid Stem Auger
Date started/completed: 25-Aug-2021
Ground surface elevation: n/a
Top of casing elevation: n/a
Easting: 677090
Northing: 565364

Screen Interval: 13.50 - 16.50 m BGS
 Sand Pack Interval: 12.90 - 16.50 m BGS
 Well Seal Interval: 0.30 - 12.90 m BGS

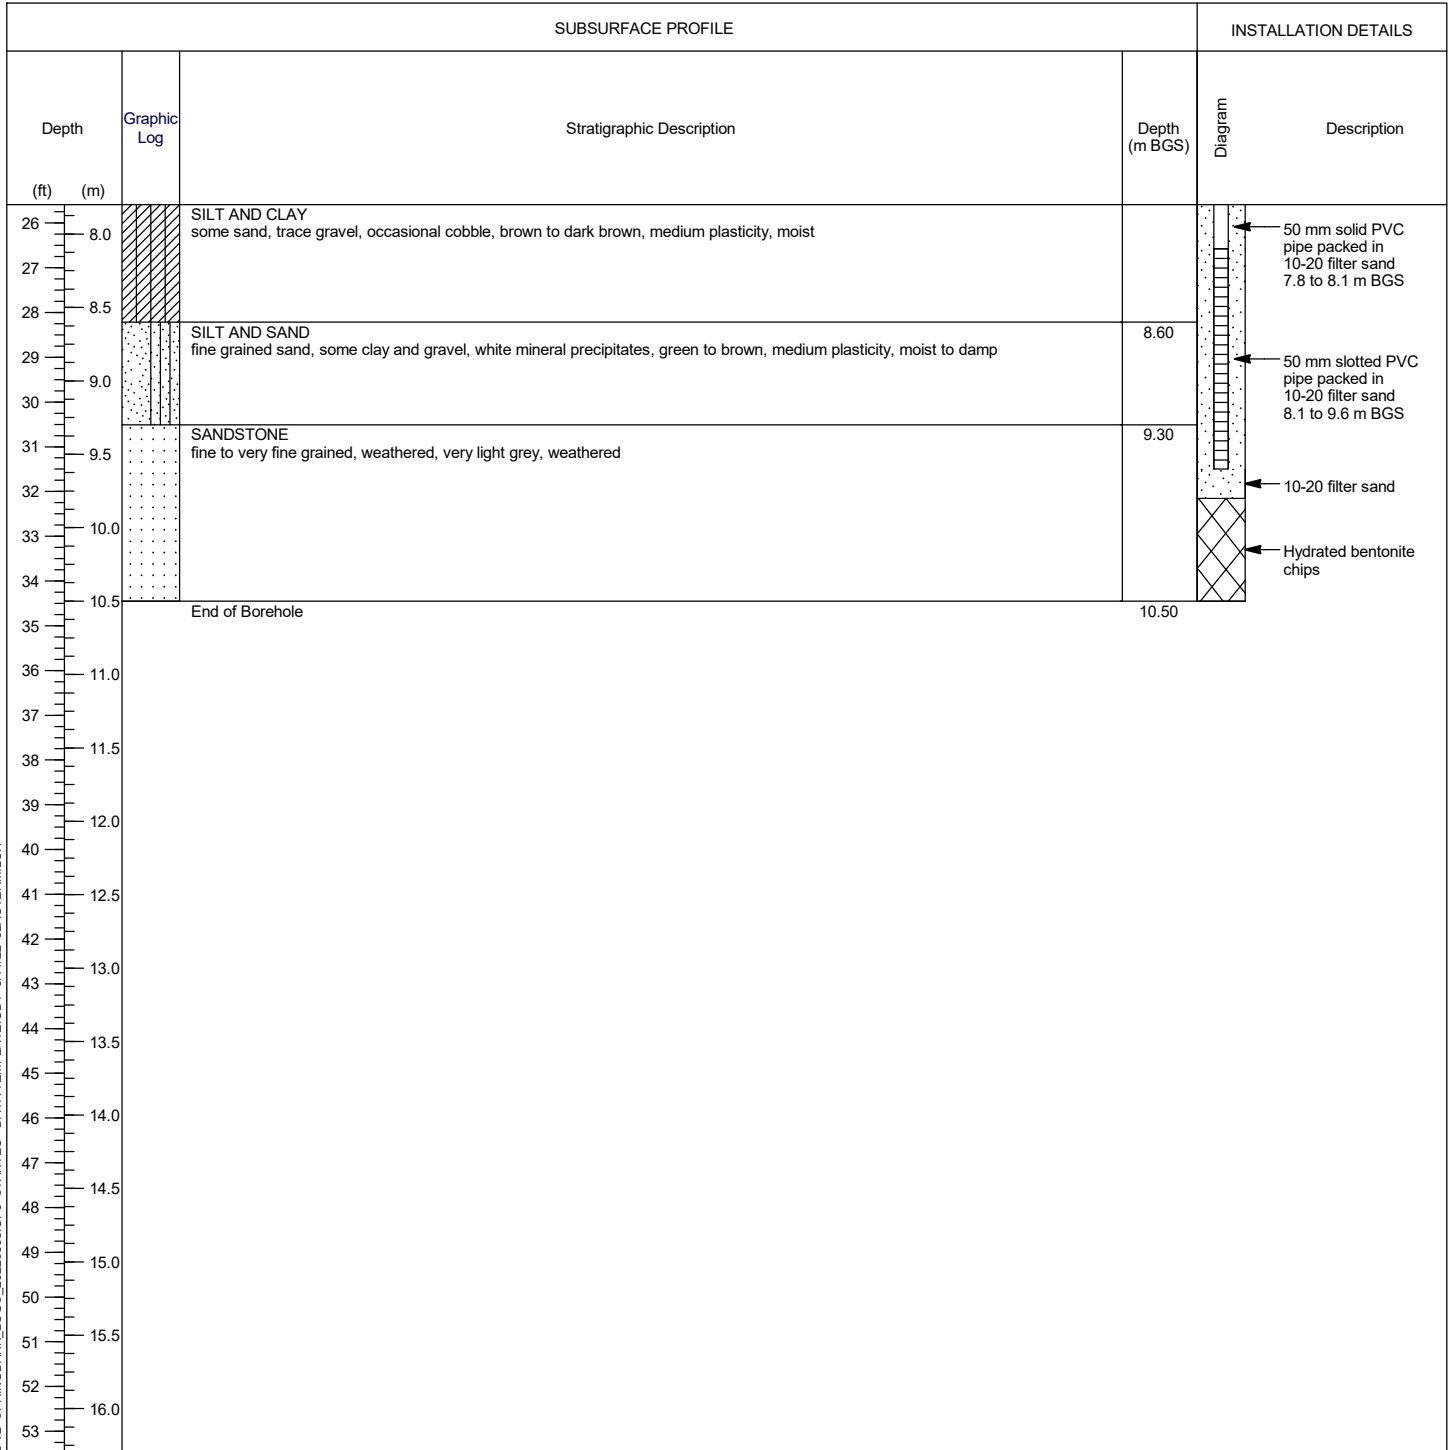
Method: Solid Stem Auger
Date started/completed: 25-Aug-2021
Ground surface elevation: n/a
Top of casing elevation: n/a
Easting: 677476
Northing: 5657319
