Springbank Off-stream Reservoir Project

Impact Assessment Agency
of Canada
Annual Report - 2021/2022
Reporting Year

Prepared for:
Alberta Transportation

Prepared by:
Stantec Consulting Ltd.

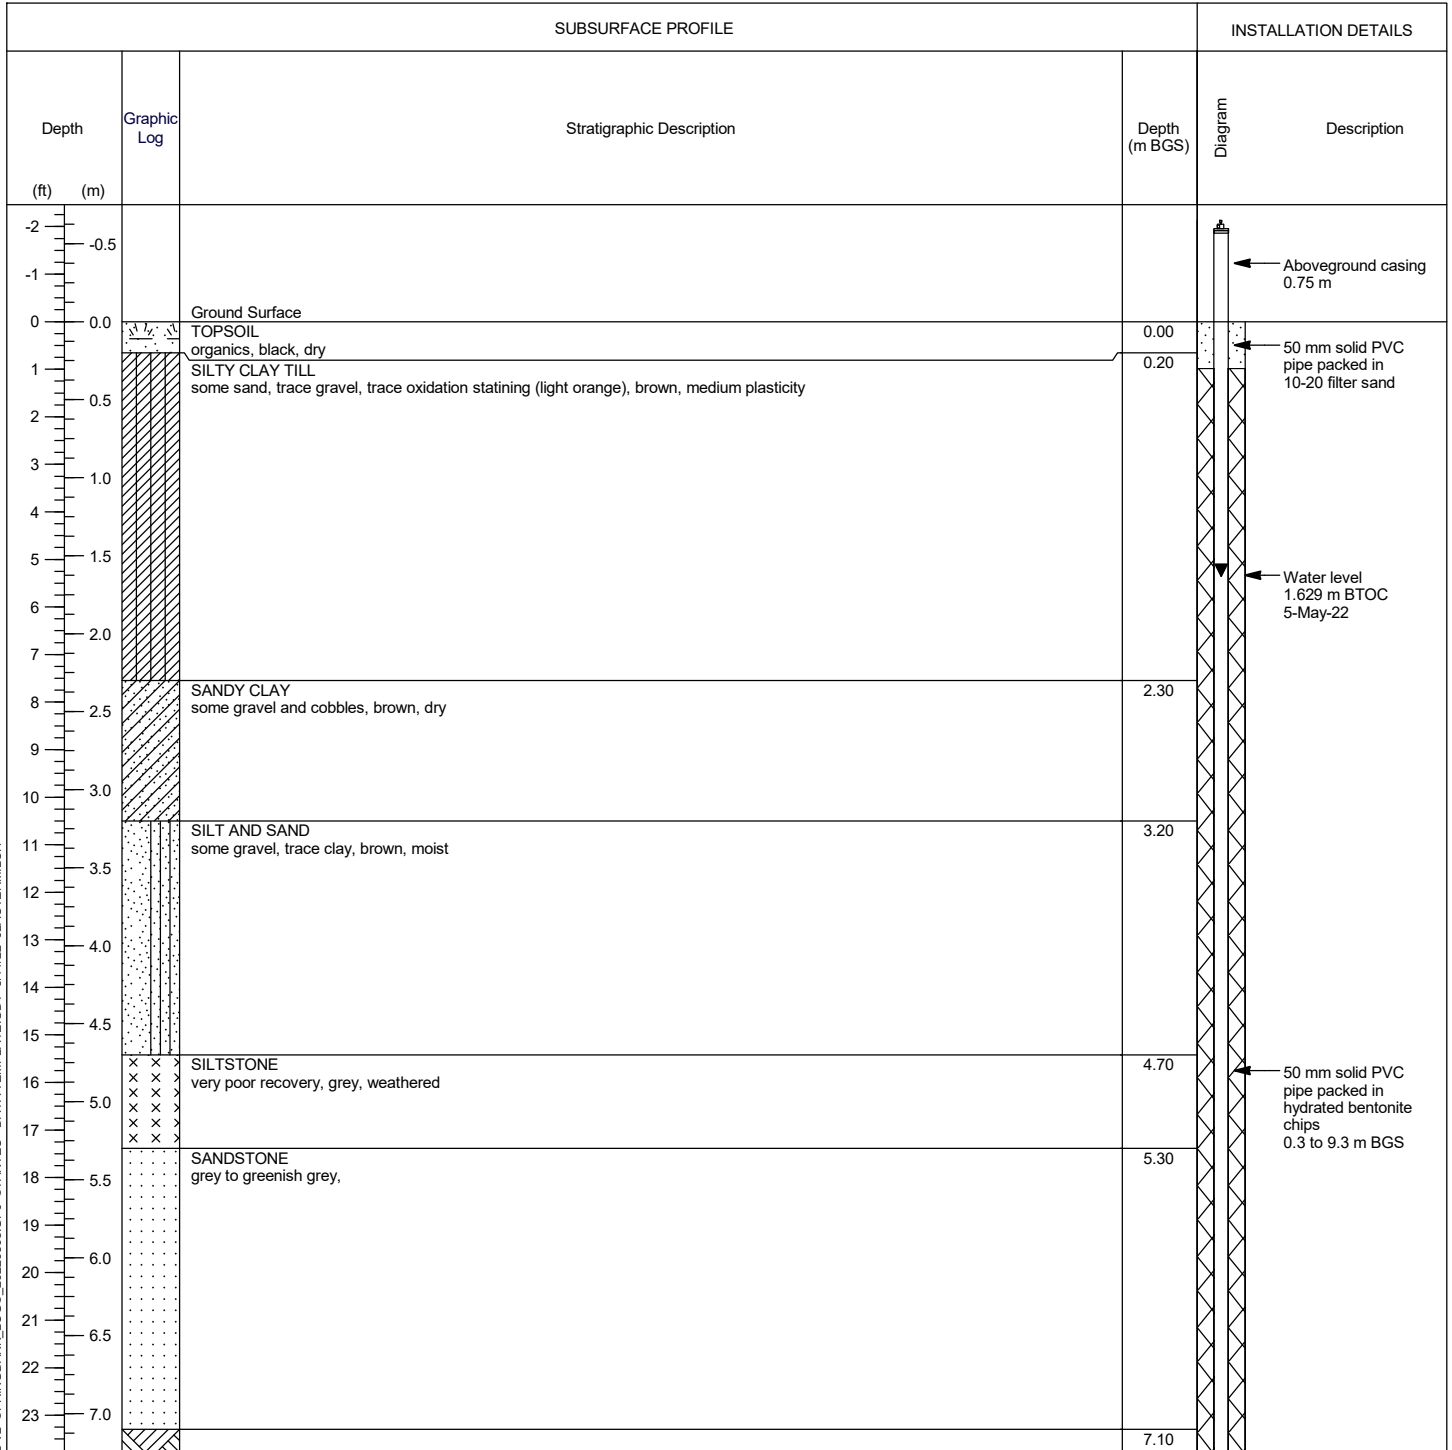
Method: Solid Stem Auger
Date started/completed: 26-Aug-2021
Ground surface elevation: n/a
Top of casing elevation: n/a
Easting: 678068
Northing: 5657928

Screen Interval: 9.60 - 12.60 m BGS
 Sand Pack Interval: 9.30 - 12.60 m BGS
 Well Seal Interval: 0.30 - 9.30 m BGS

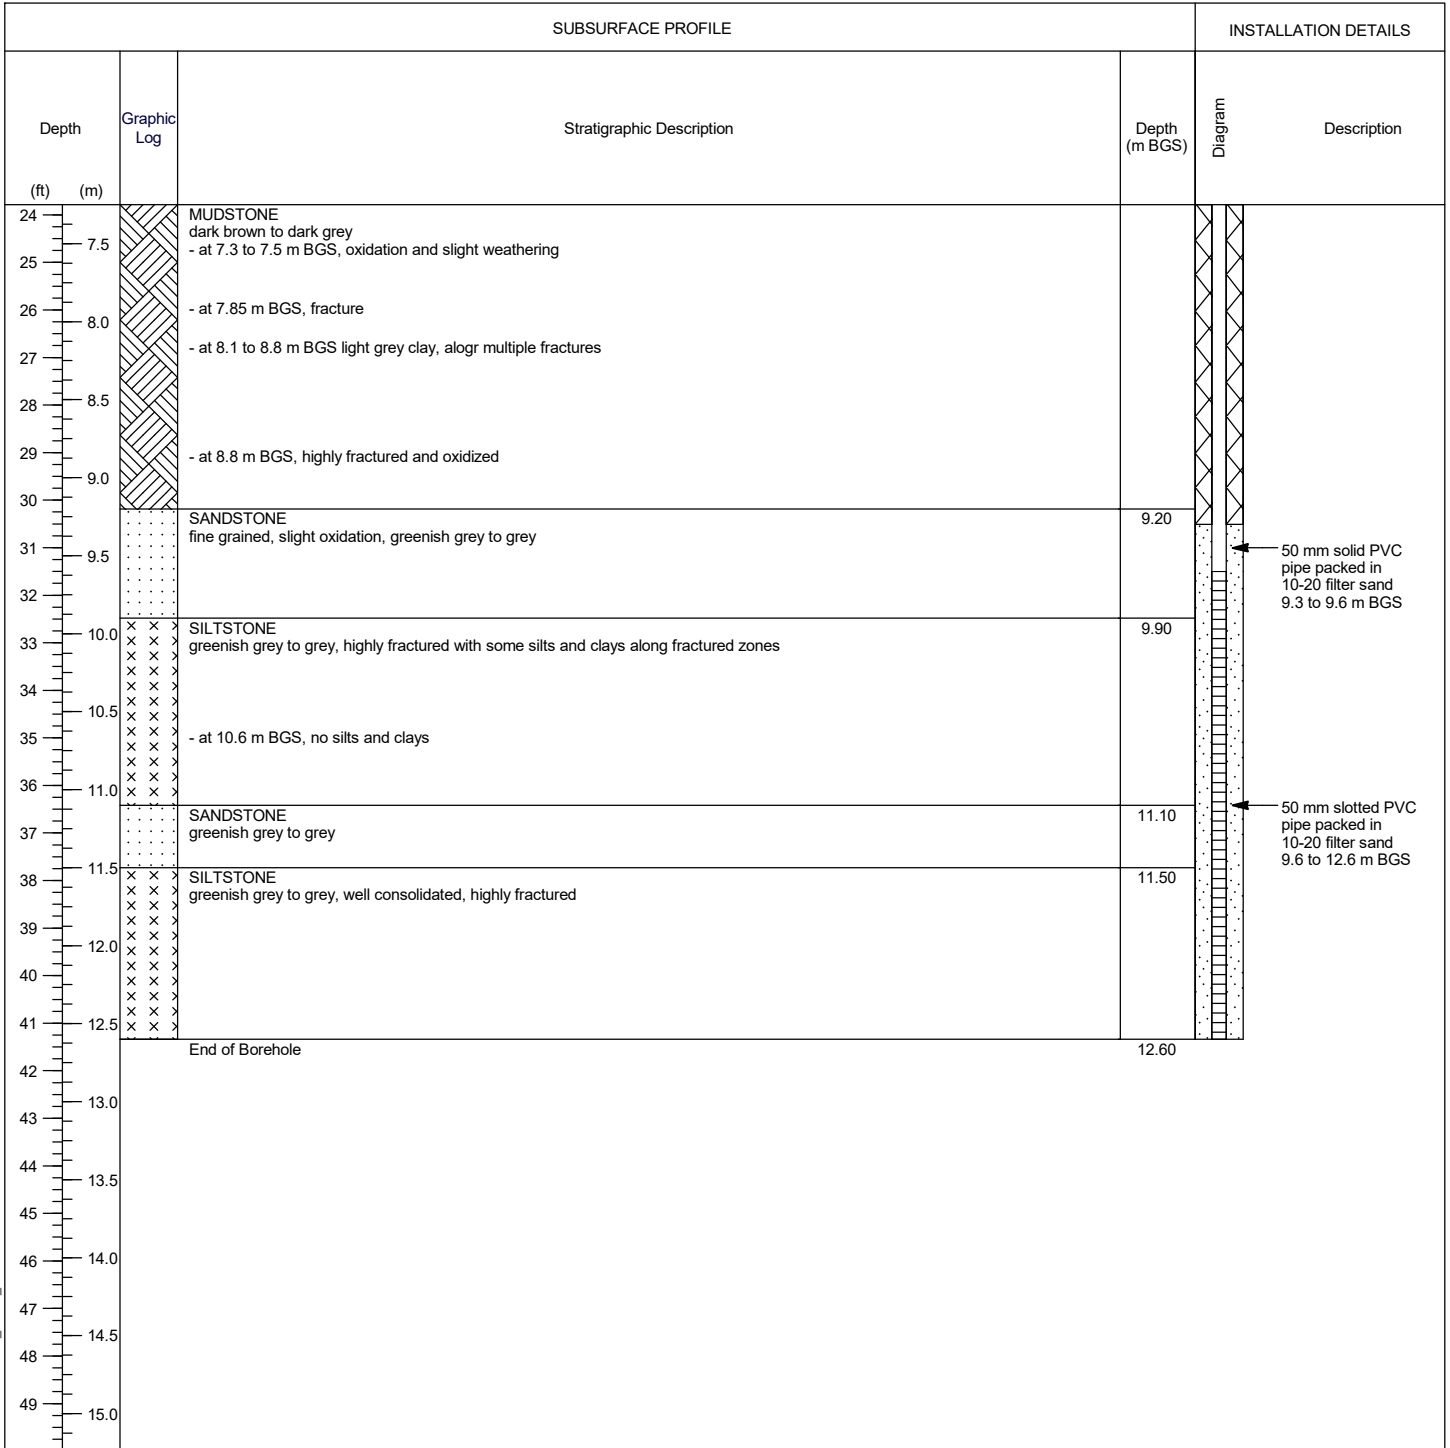
Project: SR1/Springank
Client: Alberta Transportaiton
Location: Rockyview County
Number: 10773396.5210.215
Field investigator: WT
Contractor: All Service Drilling

Method: Solid Stem Auger
Date started/completed: 26-Aug-2021
Ground surface elevation: n/a
Top of casing elevation: n/a
Easting: 678068
Northing: 5657928

Screen Interval: 9.60 - 12.60 m BGS
 Sand Pack Interval: 9.30 - 12.60 m BGS
 Well Seal Interval: 0.30 - 9.30 m BGS

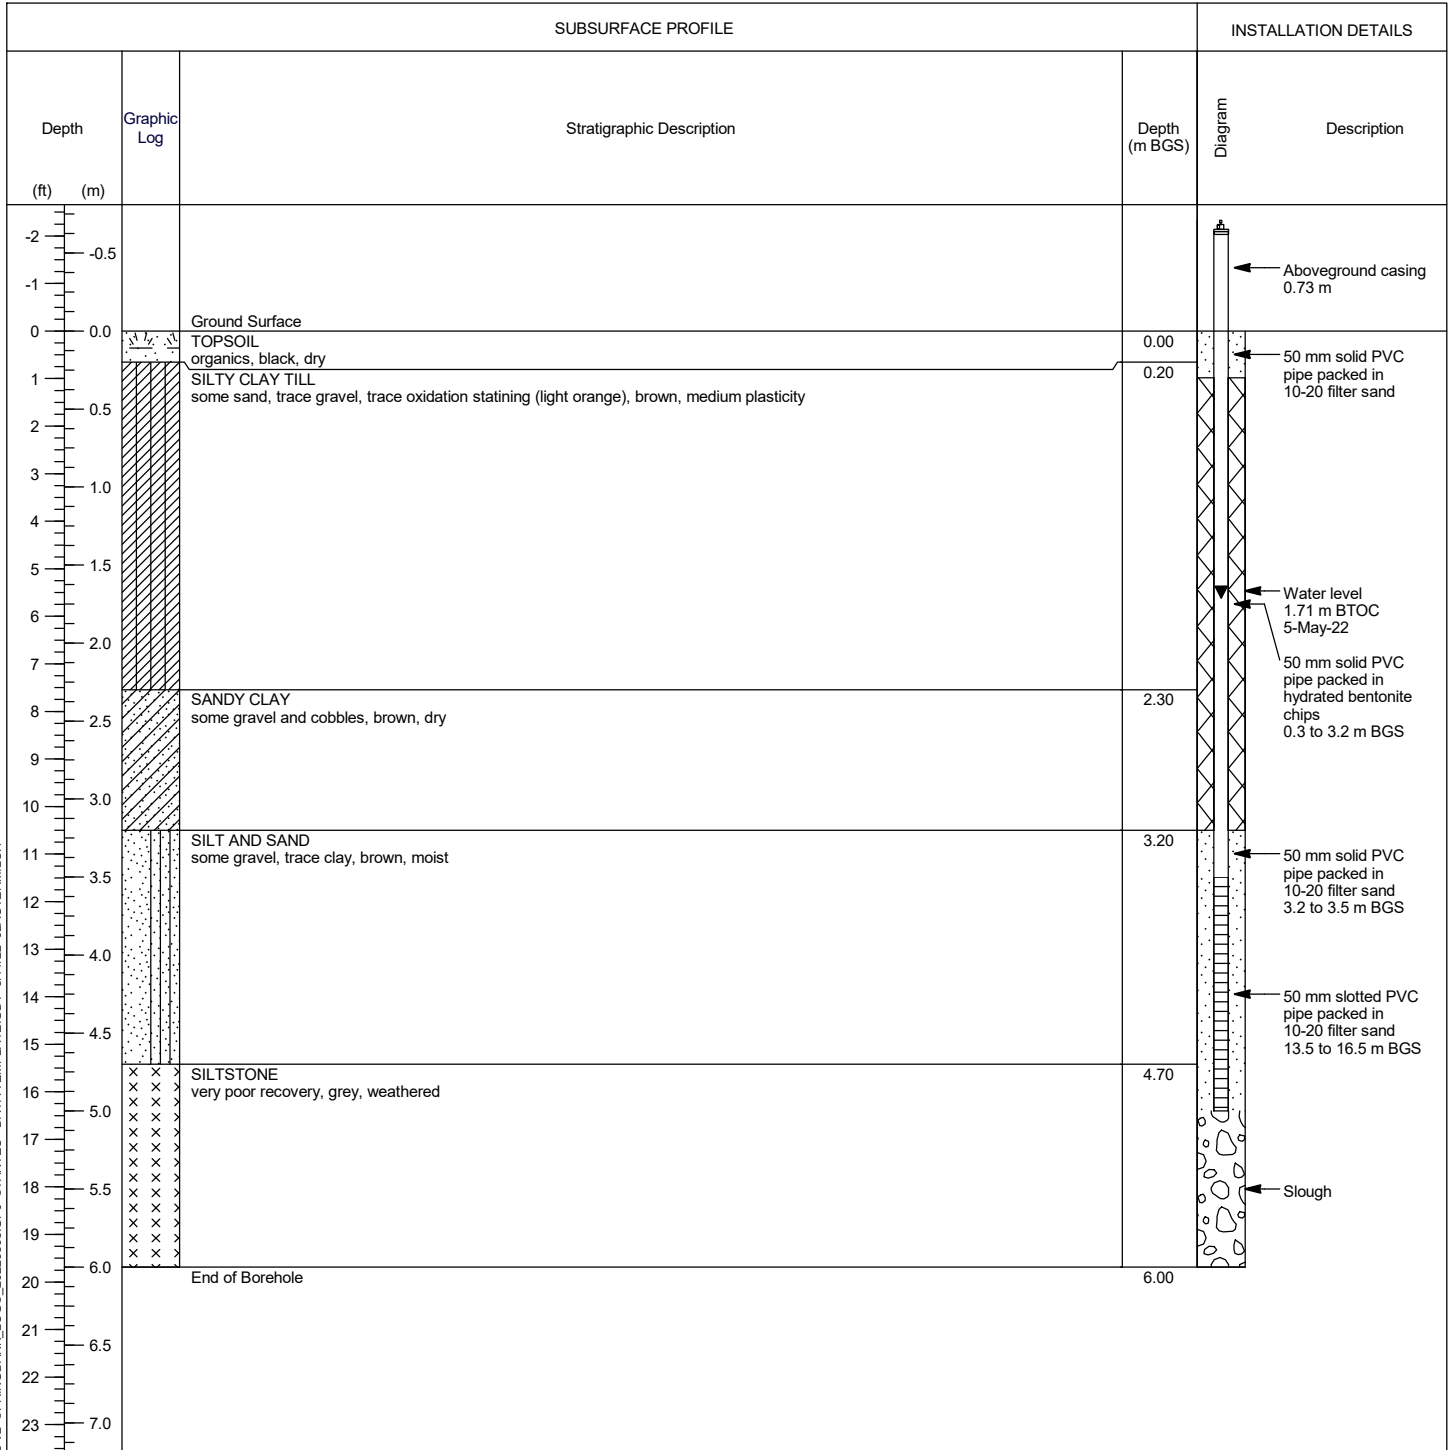
Method: Solid Stem Auger
Date started/completed: 23-Aug-2021
Ground surface elevation: n/a
Top of casing elevation: n/a
Easting: 678066
Northing: 5657928

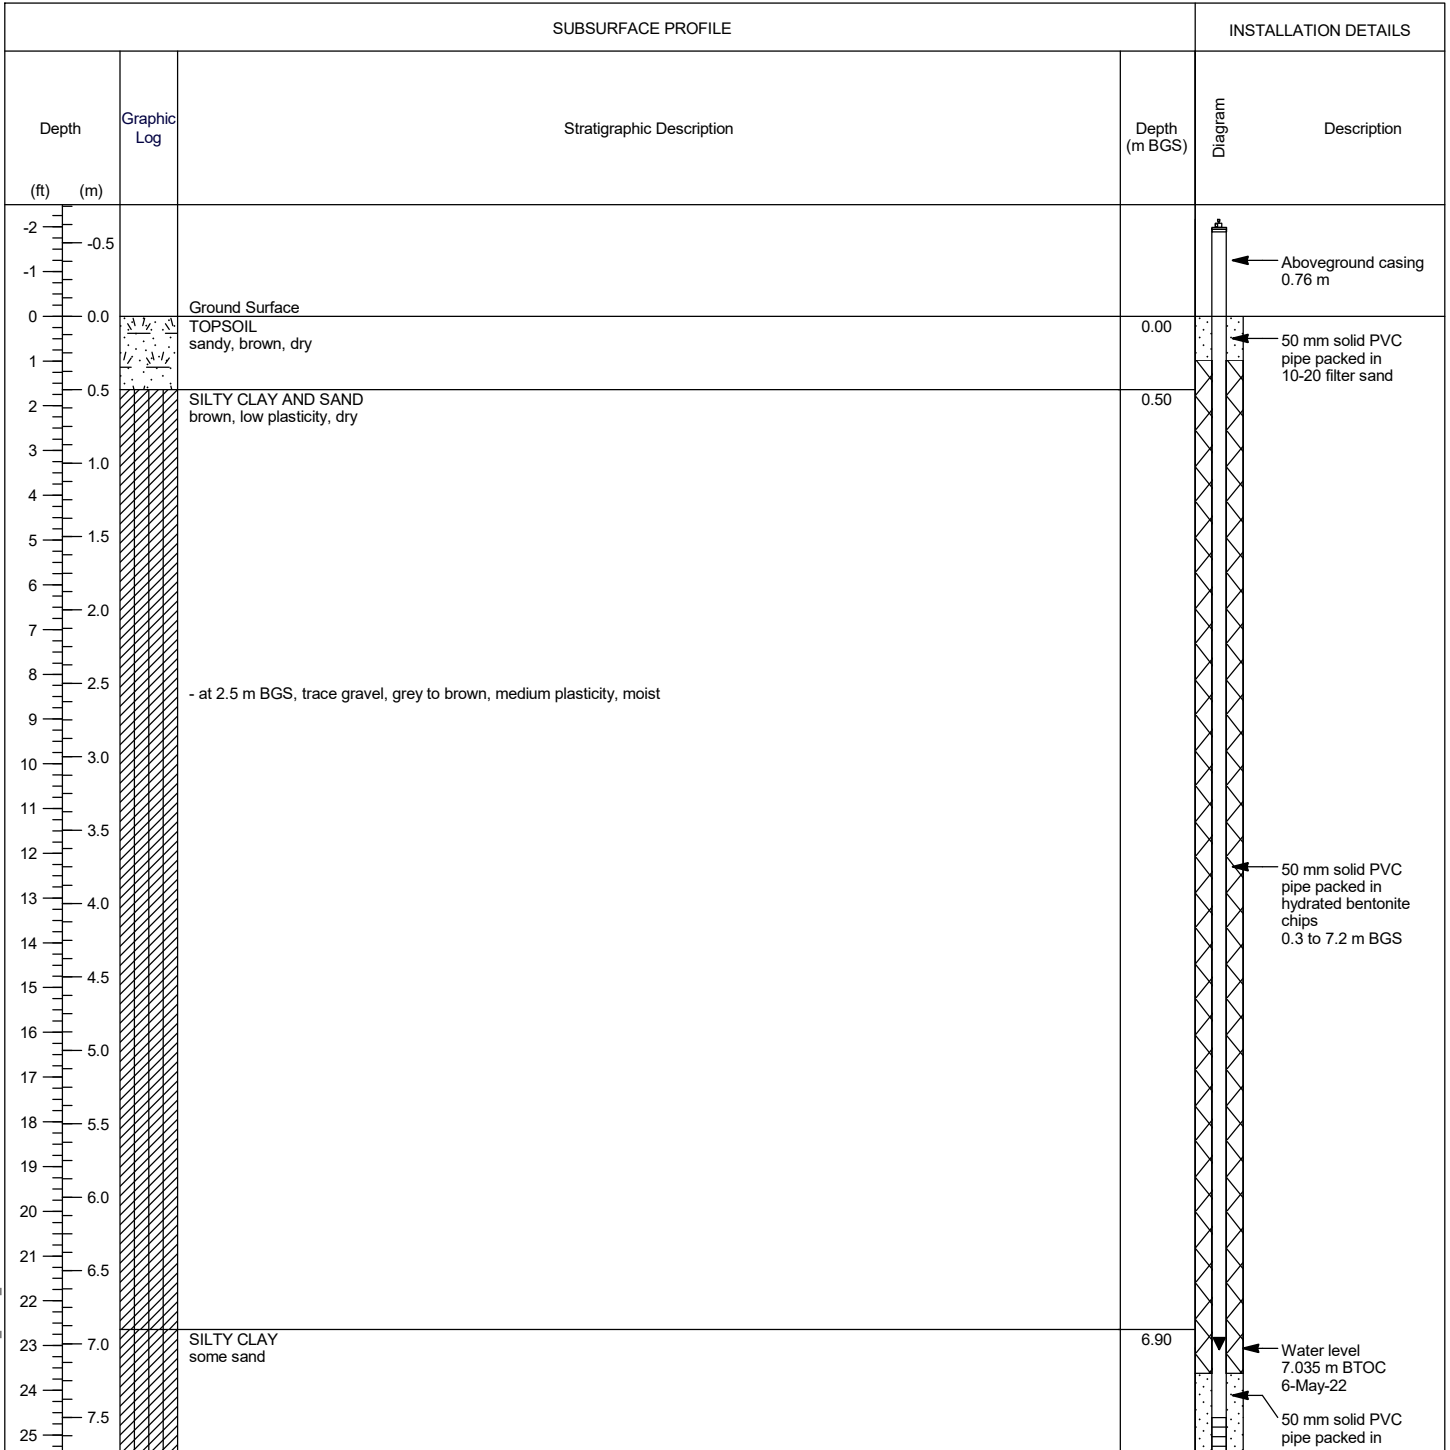
Monitoring Well: RMW16-19-10

Project: SR1/Springank	Method: Soid Stem Auger
Client: Alberta Transportaiton	Date started/completed: 29-Nov-2021
Location: Rockyview County	Ground surface elevation: n/a
Number: 10773396.5210.215	Top of casing elevation: n/a
Field investigator: WT/AK	Easting: n/a
Contractor: All Service Drilling	Northing: n/a

Screen Interval: 7.50 - 10.50 m BGS
 Sand Pack Interval: 7.20 - 10.50 m BGS
 Well Seal Interval: 0.30 - 7.20 m BGS

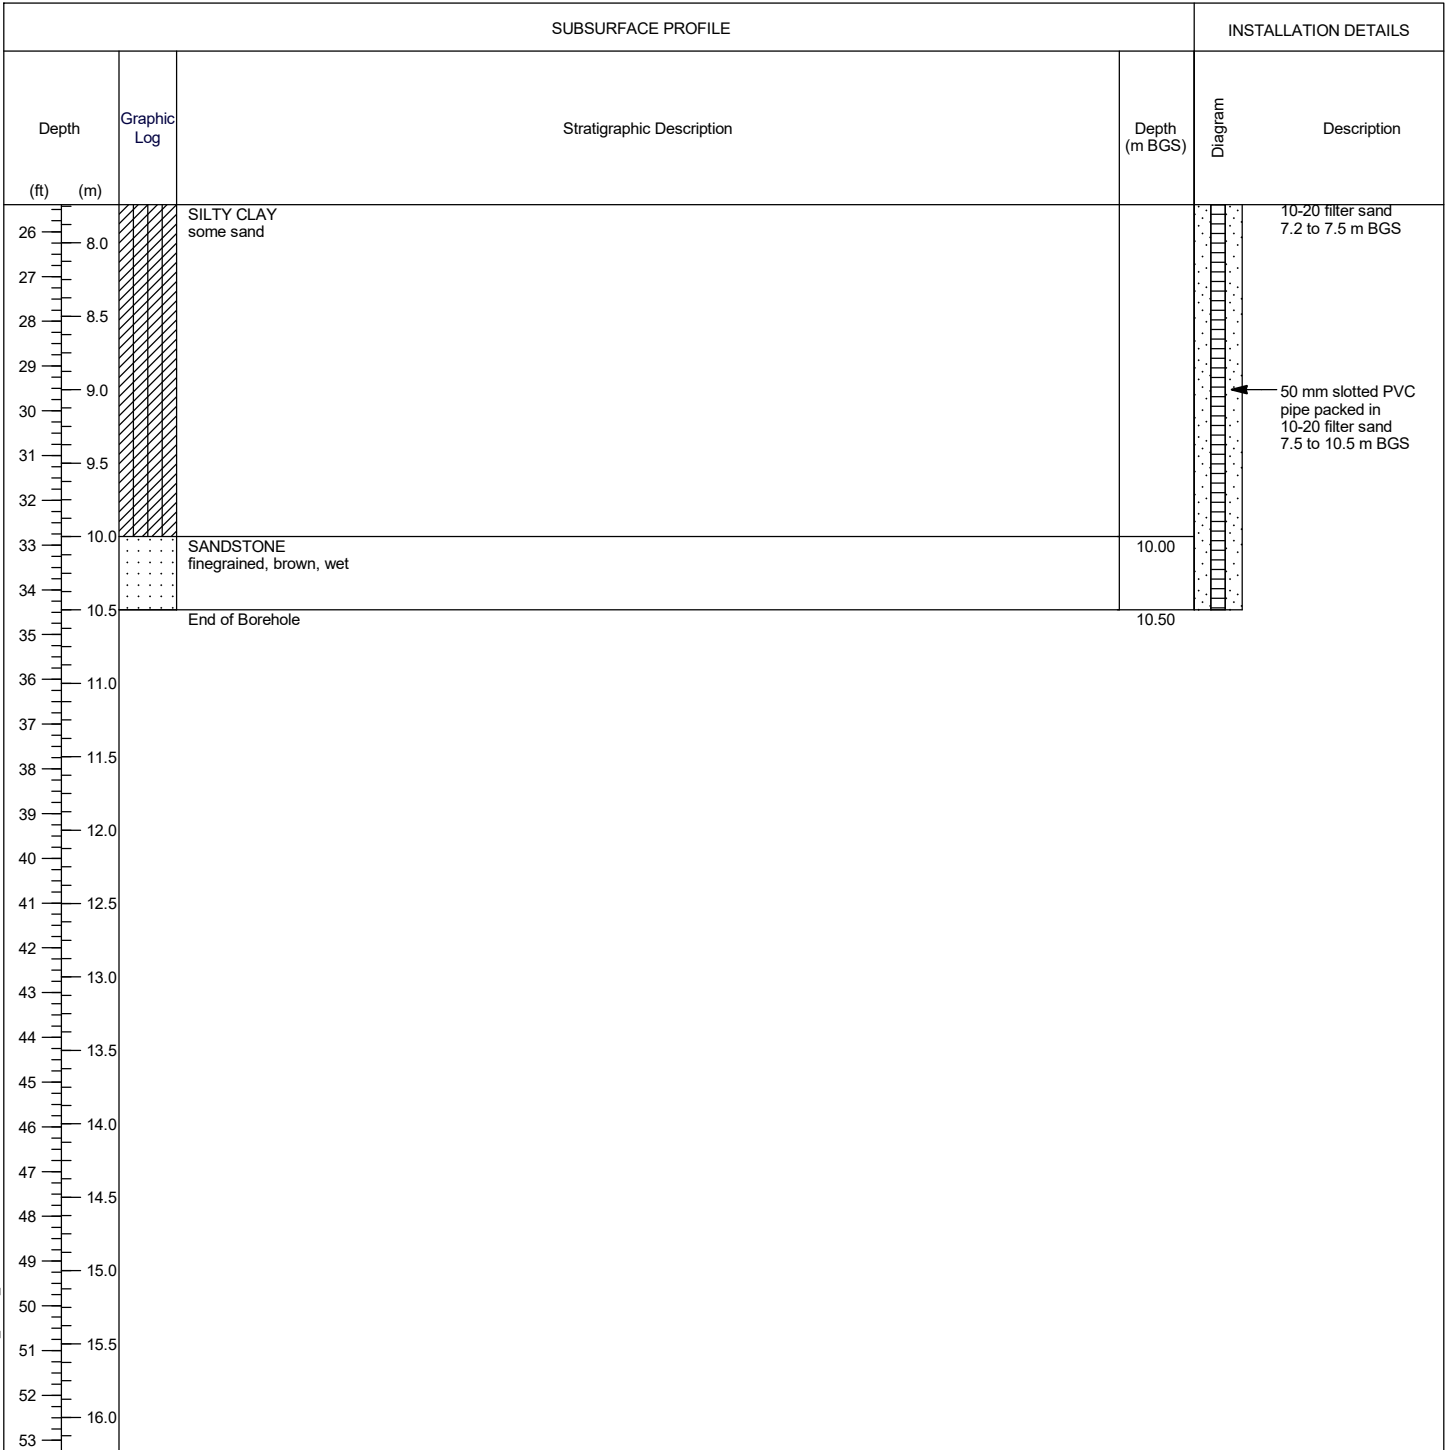
Project: SR1/Springank
Client: Alberta Transportaiton
Location: Rockyview County
Number: 10773396.5210.215
Field investigator: WT/AK
Contractor: All Service Drilling

Method: Soid Stem Auger
Date started/completed: 29-Nov-2021
Ground surface elevation: n/a
Top of casing elevation: n/a
Easting: n/a
Northing: n/a

Screen Interval: 7.50 - 10.50 m BGS
 Sand Pack Interval: 7.20 - 10.50 m BGS
 Well Seal Interval: 0.30 - 7.20 m BGS

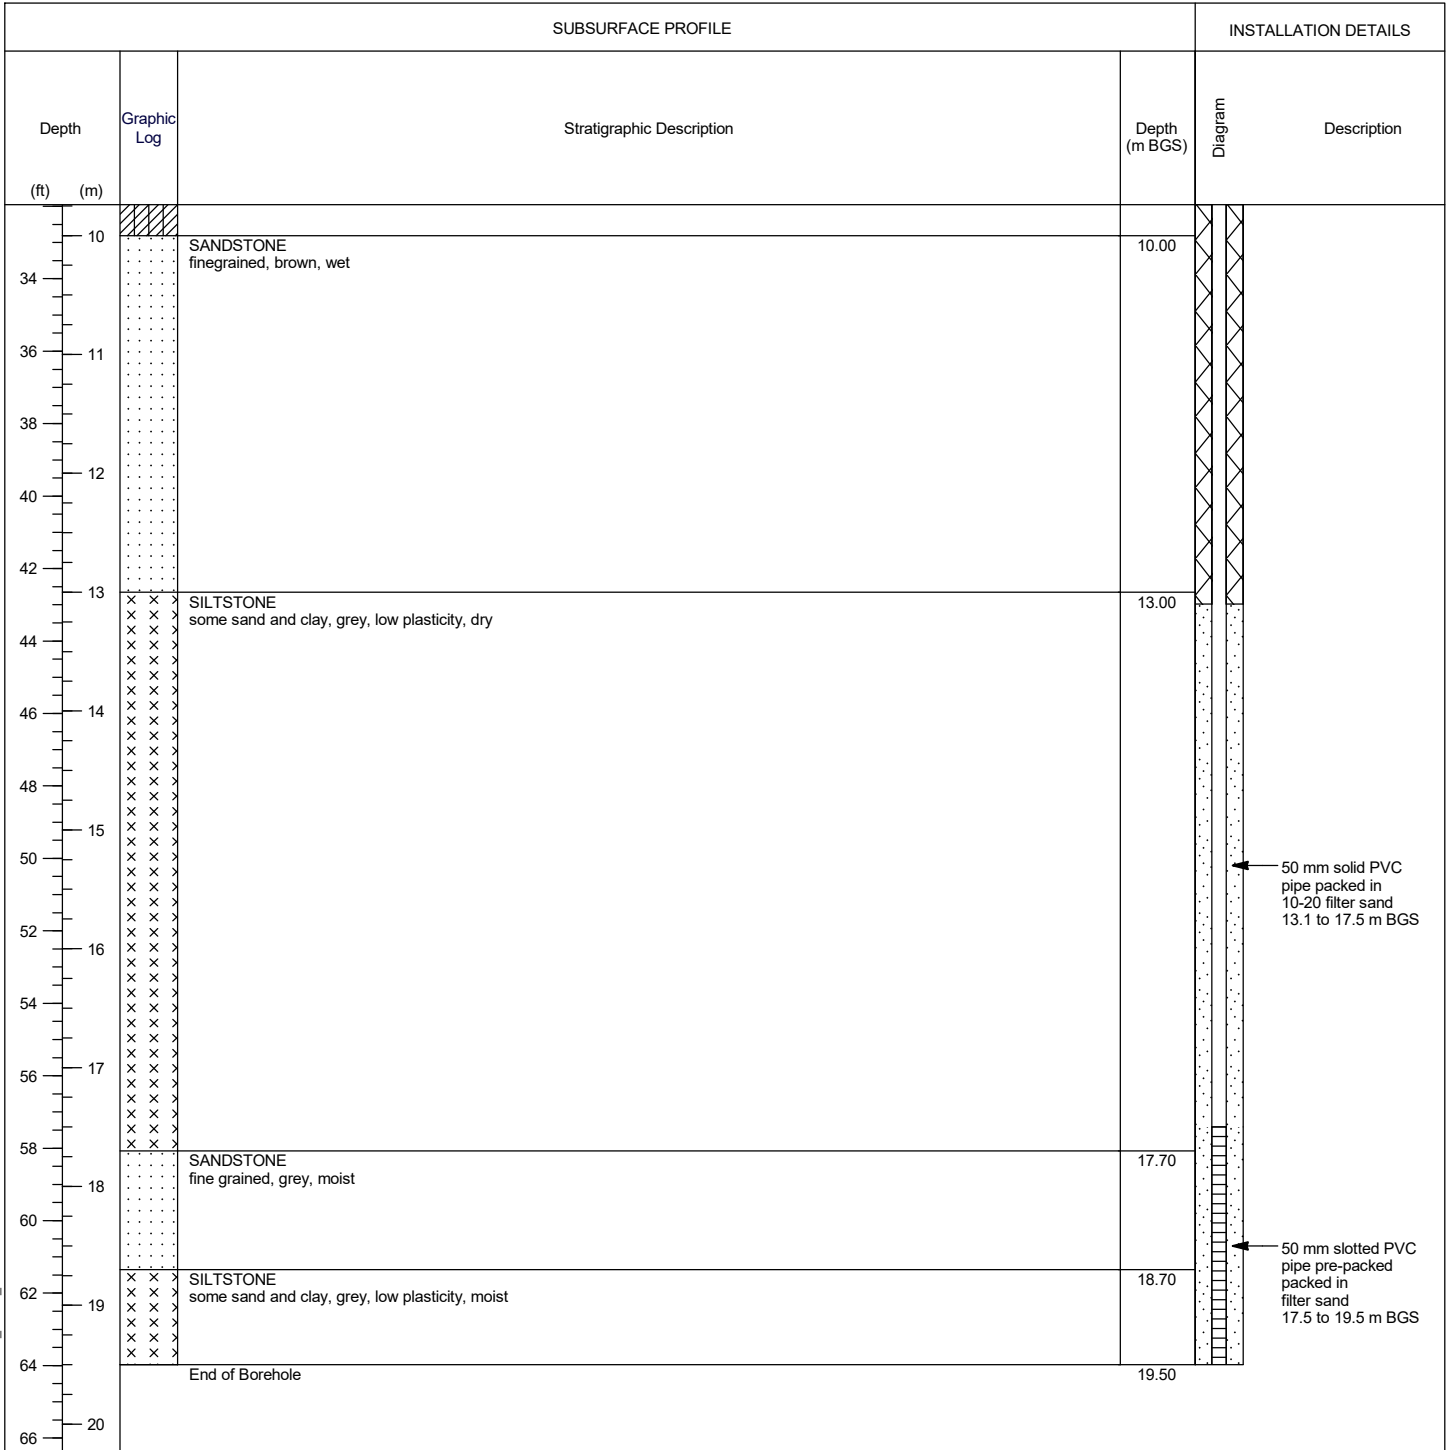
Project: SR1/Springank
Client: Alberta Transportaiton
Location: Rockyview County
Number: 10773396.5210.215
Field investigator: WT/AK
Contractor: All Service Drilling

Method: Soid Stem Auger
Date started/completed: 29-Nov-2021
Ground surface elevation: n/a
Top of casing elevation: n/a
Easting: n/a
Northing: n/a

Screen Interval: 17.50 - 19.50 m BGS
 Sand Pack Interval: 13.10 - 19.50 m BGS
 Well Seal Interval: 0.30 - 13.10 m BGS

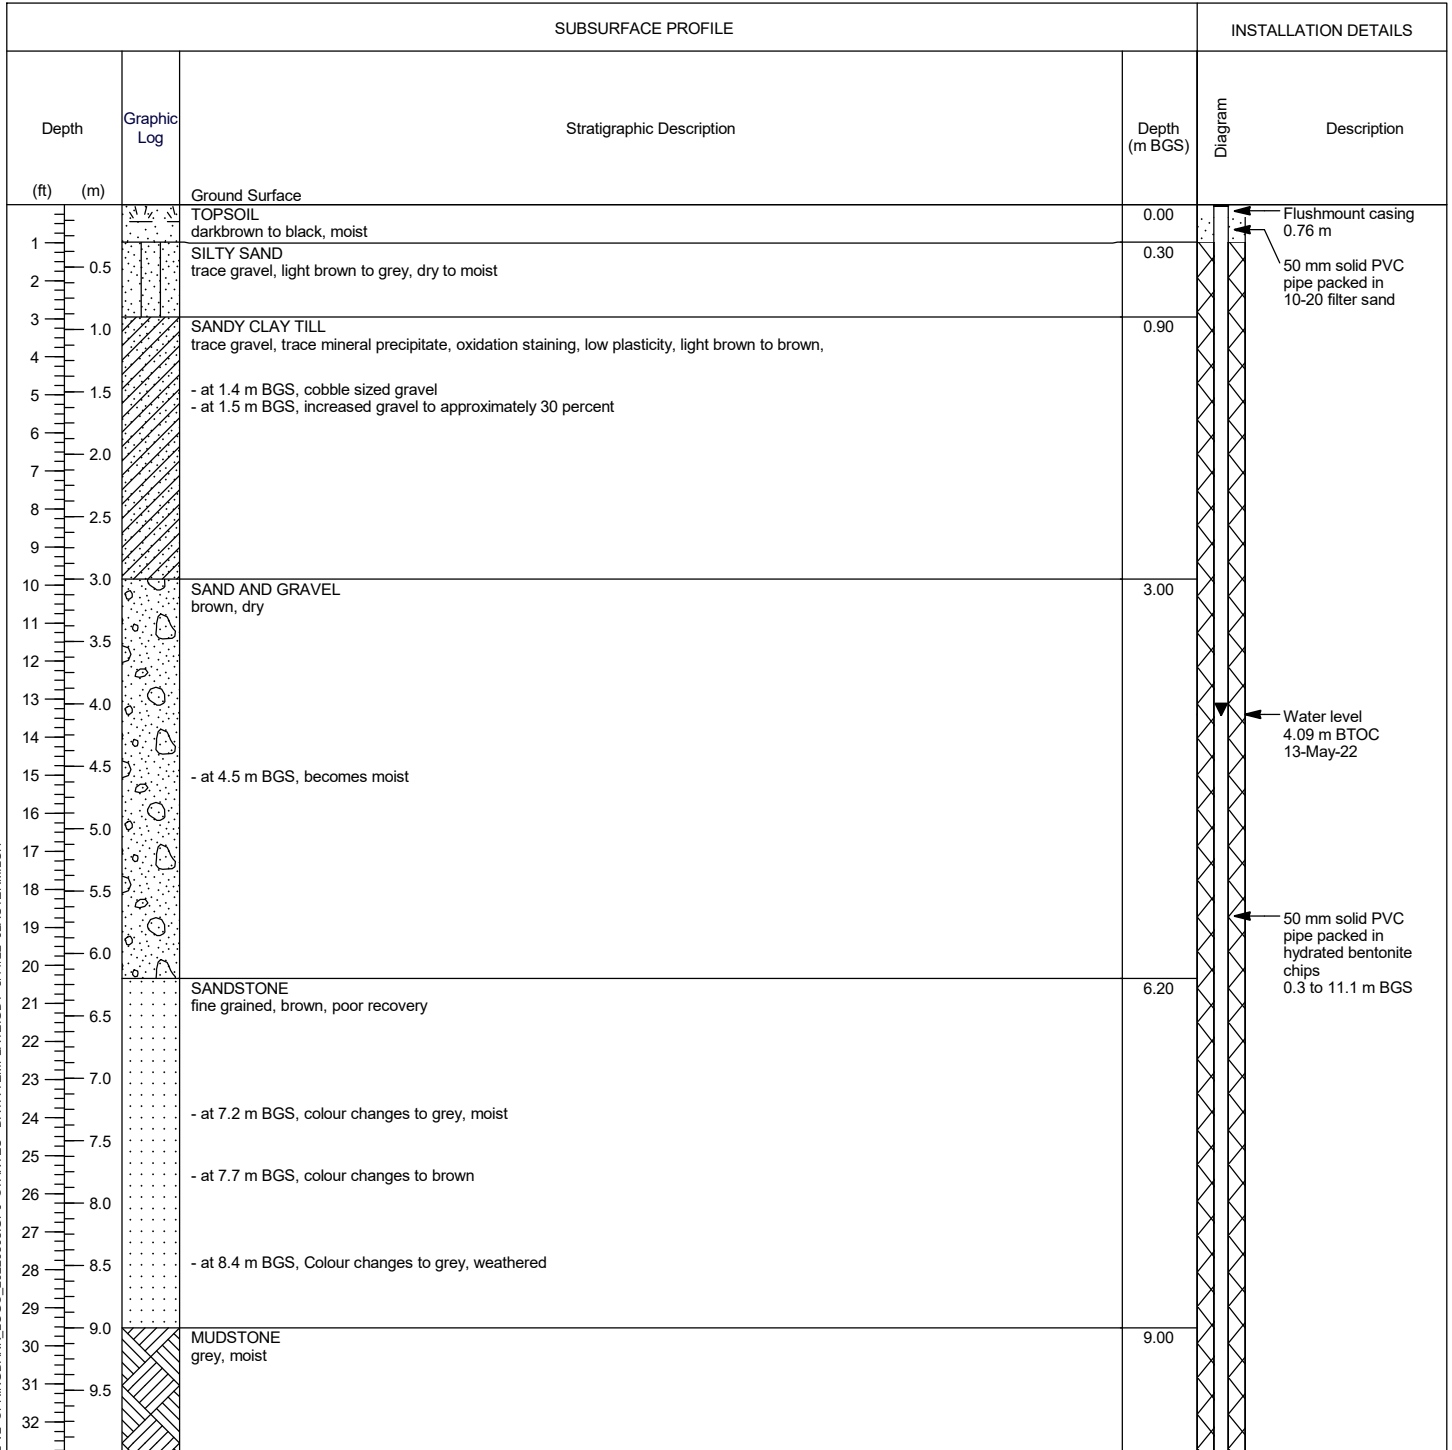
Method: Air Rotary
Date started/completed: 12-May-2022
Ground surface elevation: n/a
Top of casing elevation: n/a
Easting: n/a
Northing: n/a

Screen Interval: 11.40 - 12.90 m BGS
 Sand Pack Interval: 11.10 - 12.90 m BGS
 Well Seal Interval: 0.30 - 11.10 m BGS

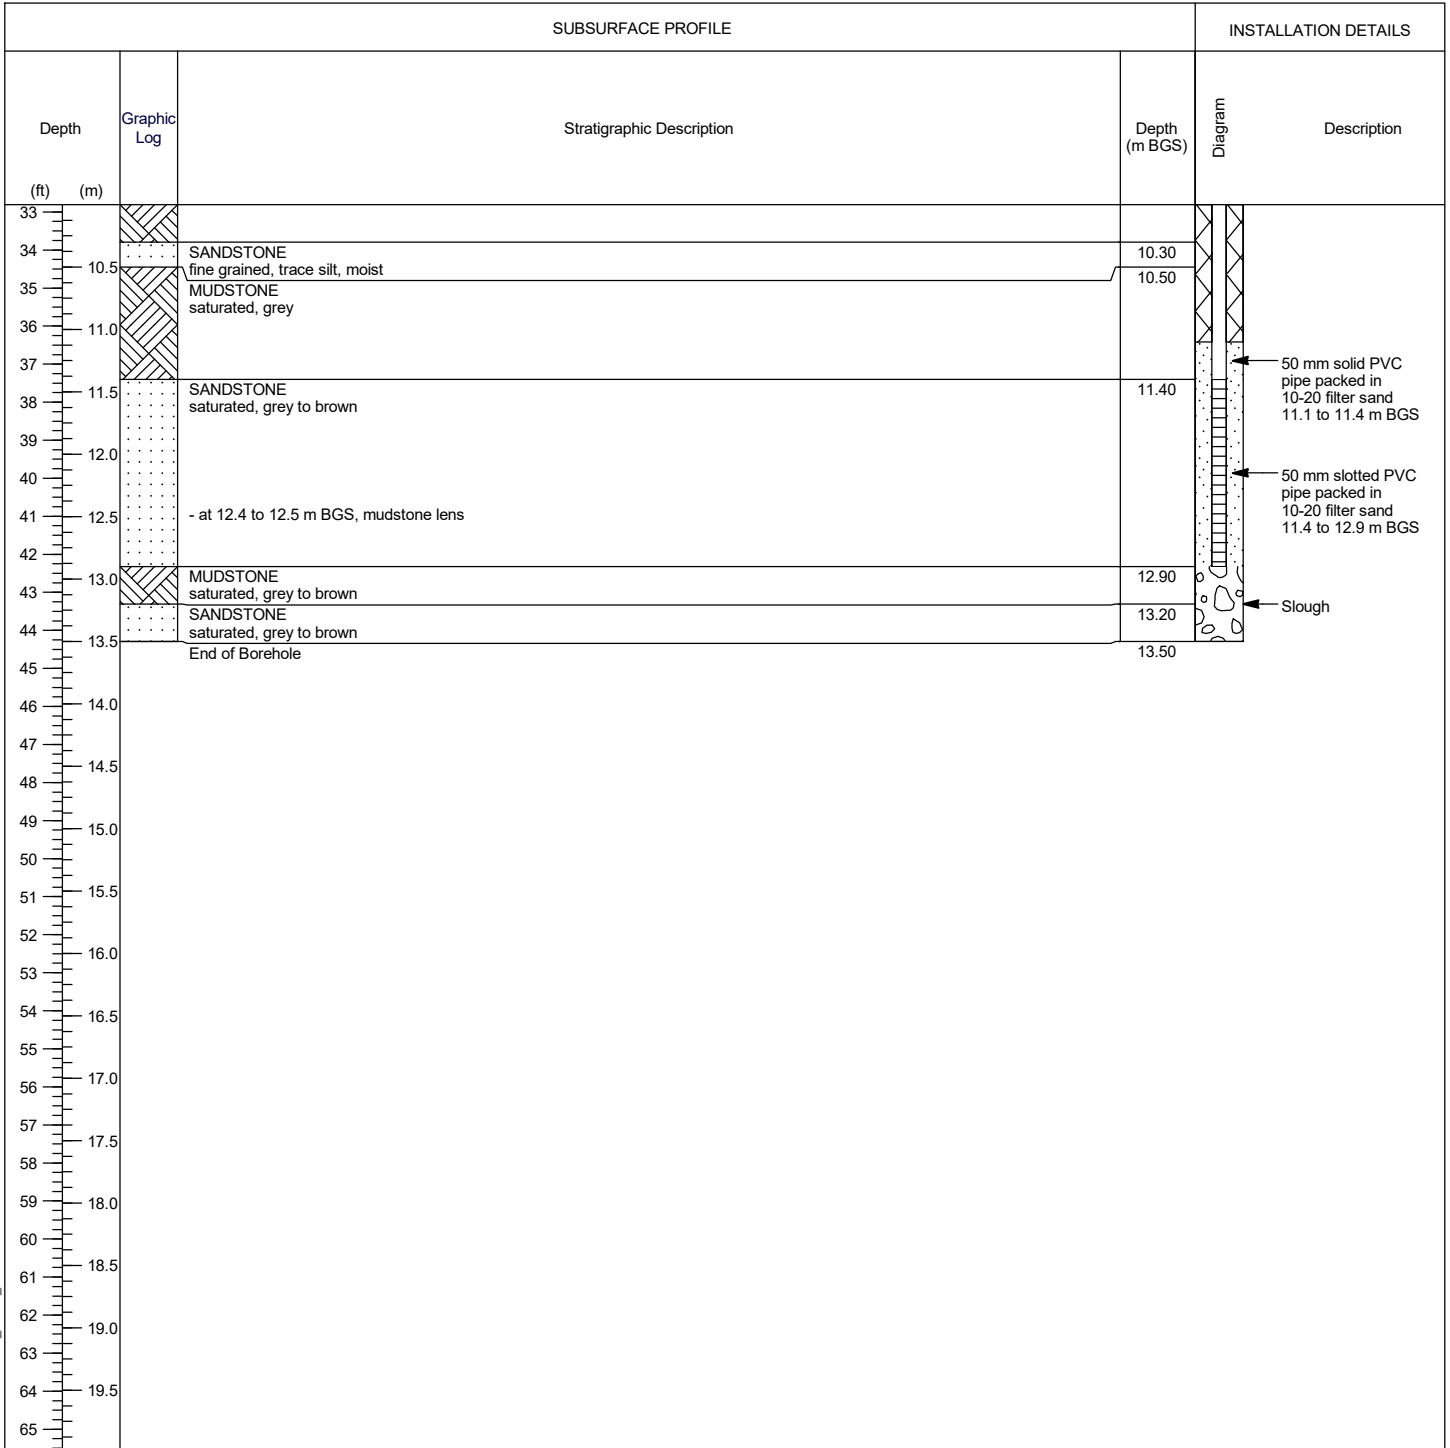
Project: SR1/Springank
Client: Alberta Transportaiton
Location: Rockyview County
Number: 10773396.5210.215
Field investigator: WT/IM
Contractor: All Service Drilling

Method: Air Rotary
Date started/completed: 12-May-2022
Ground surface elevation: n/a
Top of casing elevation: n/a
Easting: n/a
Northing: n/a

Screen Interval: 11.40 - 12.90 m BGS
 Sand Pack Interval: 11.10 - 12.90 m BGS
 Well Seal Interval: 0.30 - 11.10 m BGS

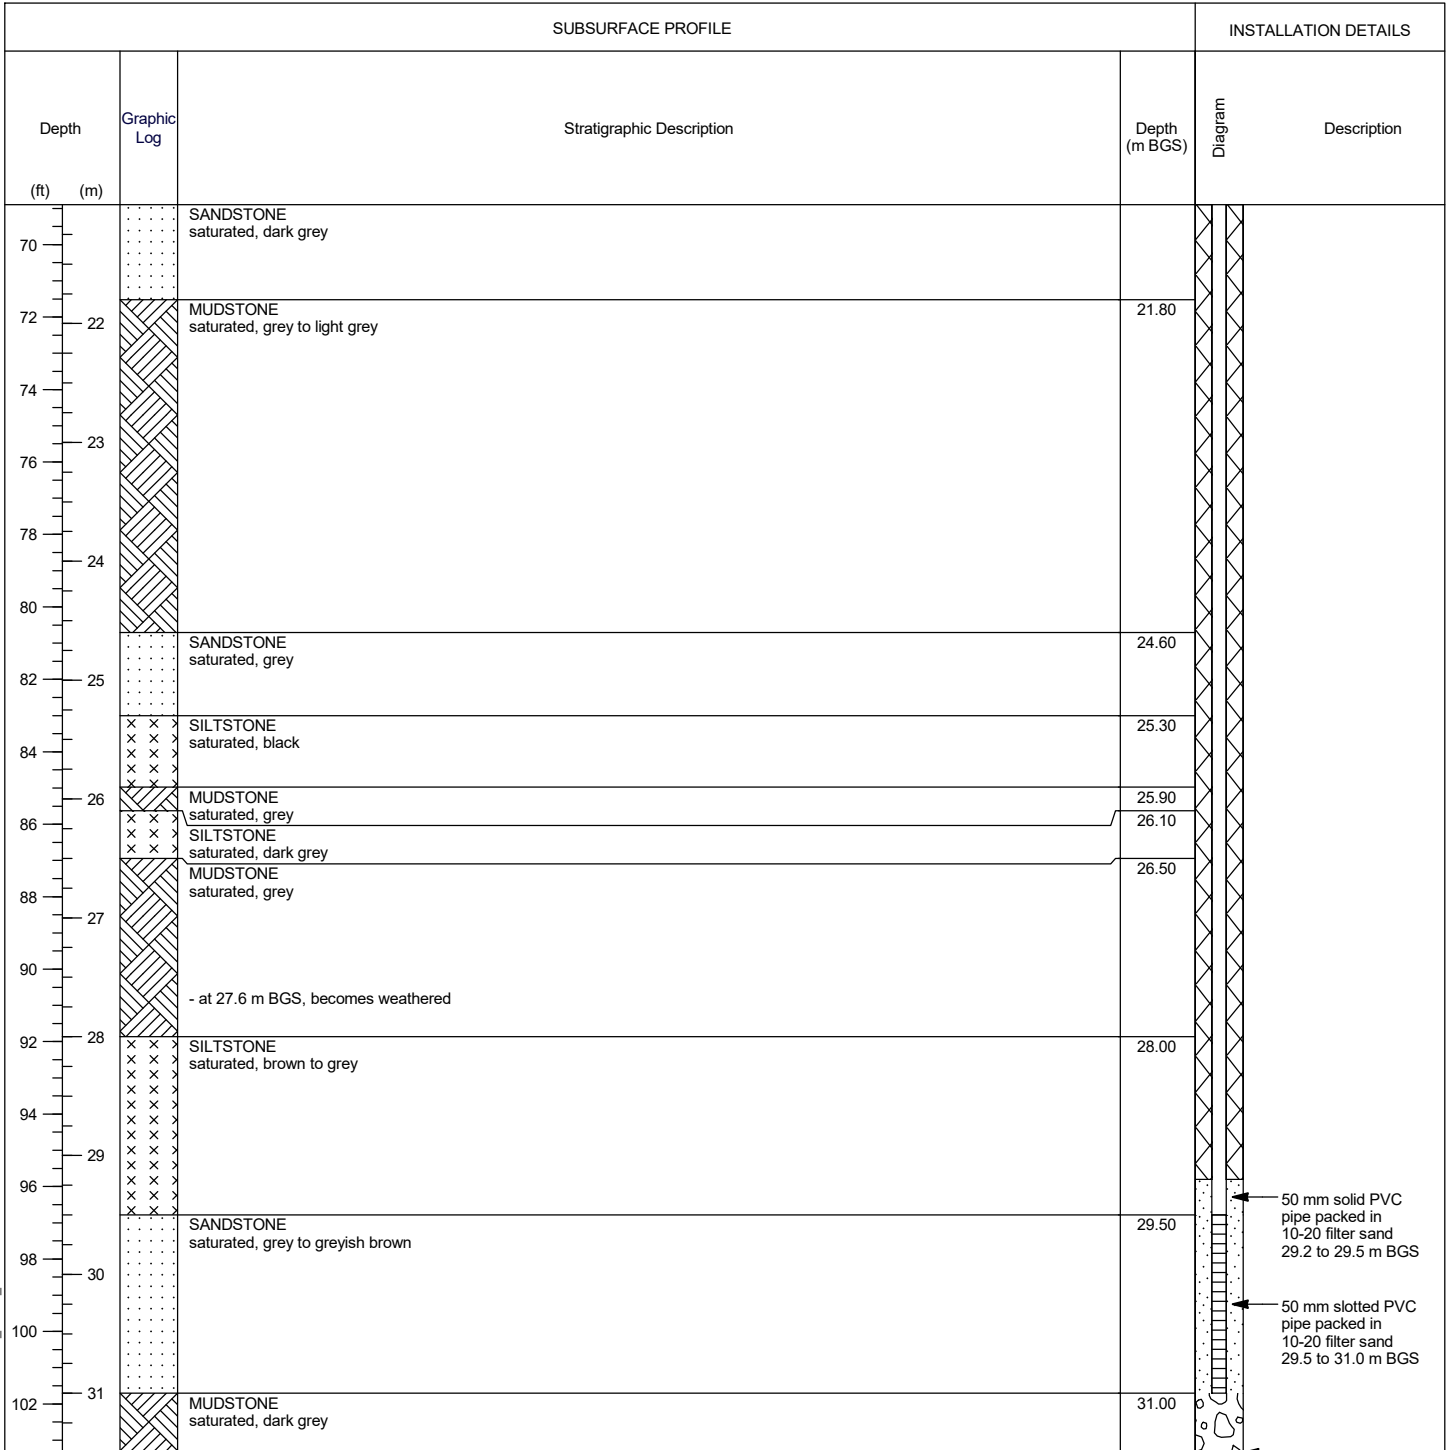
Project: SR1/Springank
Client: Alberta Transportaiton
Location: Rockyview County
Number: 10773396.5210.215
Field investigator: WT/IM
Contractor: All Service Drilling

Method: Air Rotary
Date started/completed: 13-May-2022
Ground surface elevation: n/a
Top of casing elevation: n/a
Easting: 681934
Northing: 5658853

Screen Interval: 29.50 - 31.00 m BGS
 Sand Pack Interval: 29.20 - 31.00 m BGS
 Well Seal Interval: 0.30 - 29.20 m BGS

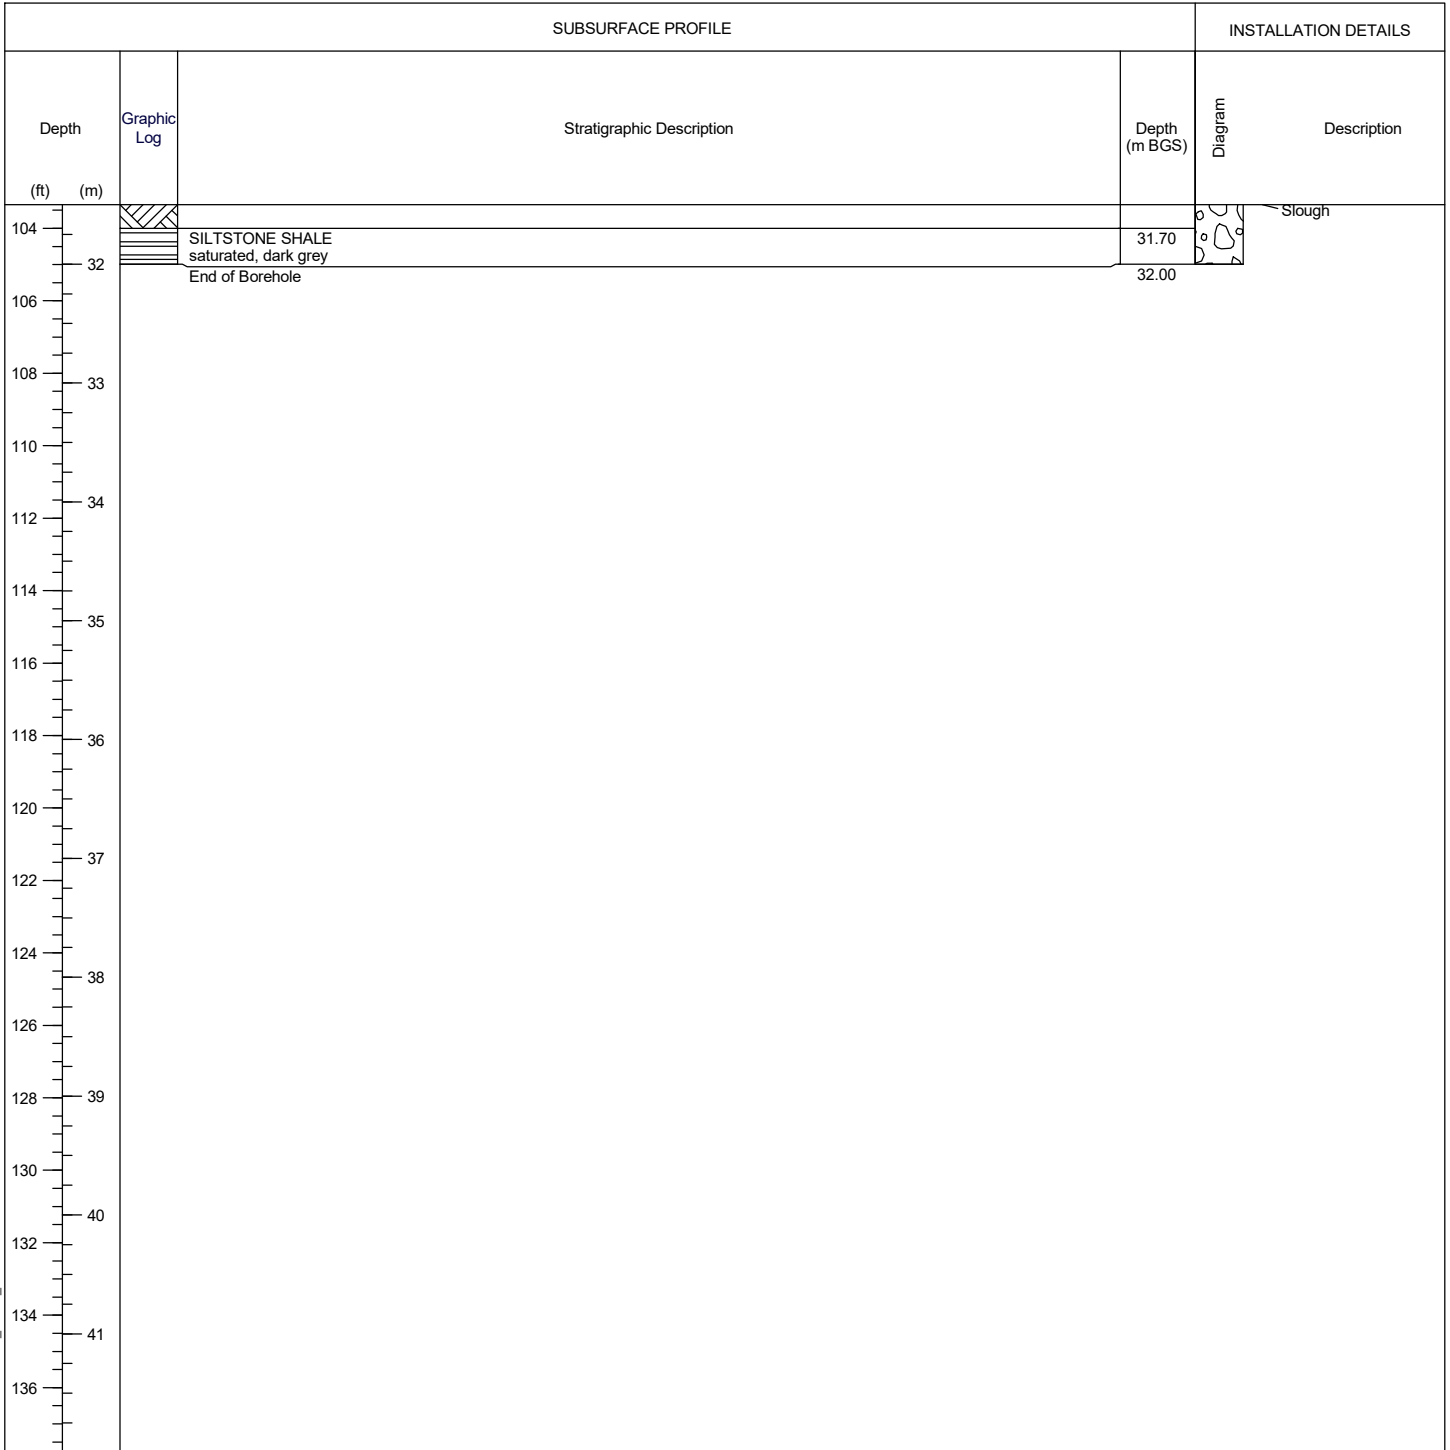
Project: SR1/Springank
Client: Alberta Transportaiton
Location: Rockyview County
Number: 10773396.5210.215
Field investigator: WT/IM
Contractor: All Service Drilling

Method: Air Rotary
Date started/completed: 13-May-2022
Ground surface elevation: n/a
Top of casing elevation: n/a
Easting: 681934
Northing: 5658853

Screen Interval: 29.50 - 31.00 m BGS
 Sand Pack Interval: 29.20 - 31.00 m BGS
 Well Seal Interval: 0.30 - 29.20 m BGS
