Springbank Off-stream Reservoir Project

Impact Assessment Agency
of Canada
Annual Report - 2021/2022
Reporting Year

Prepared for:
Alberta Transportation

Prepared by:
Stantec Consulting Ltd.

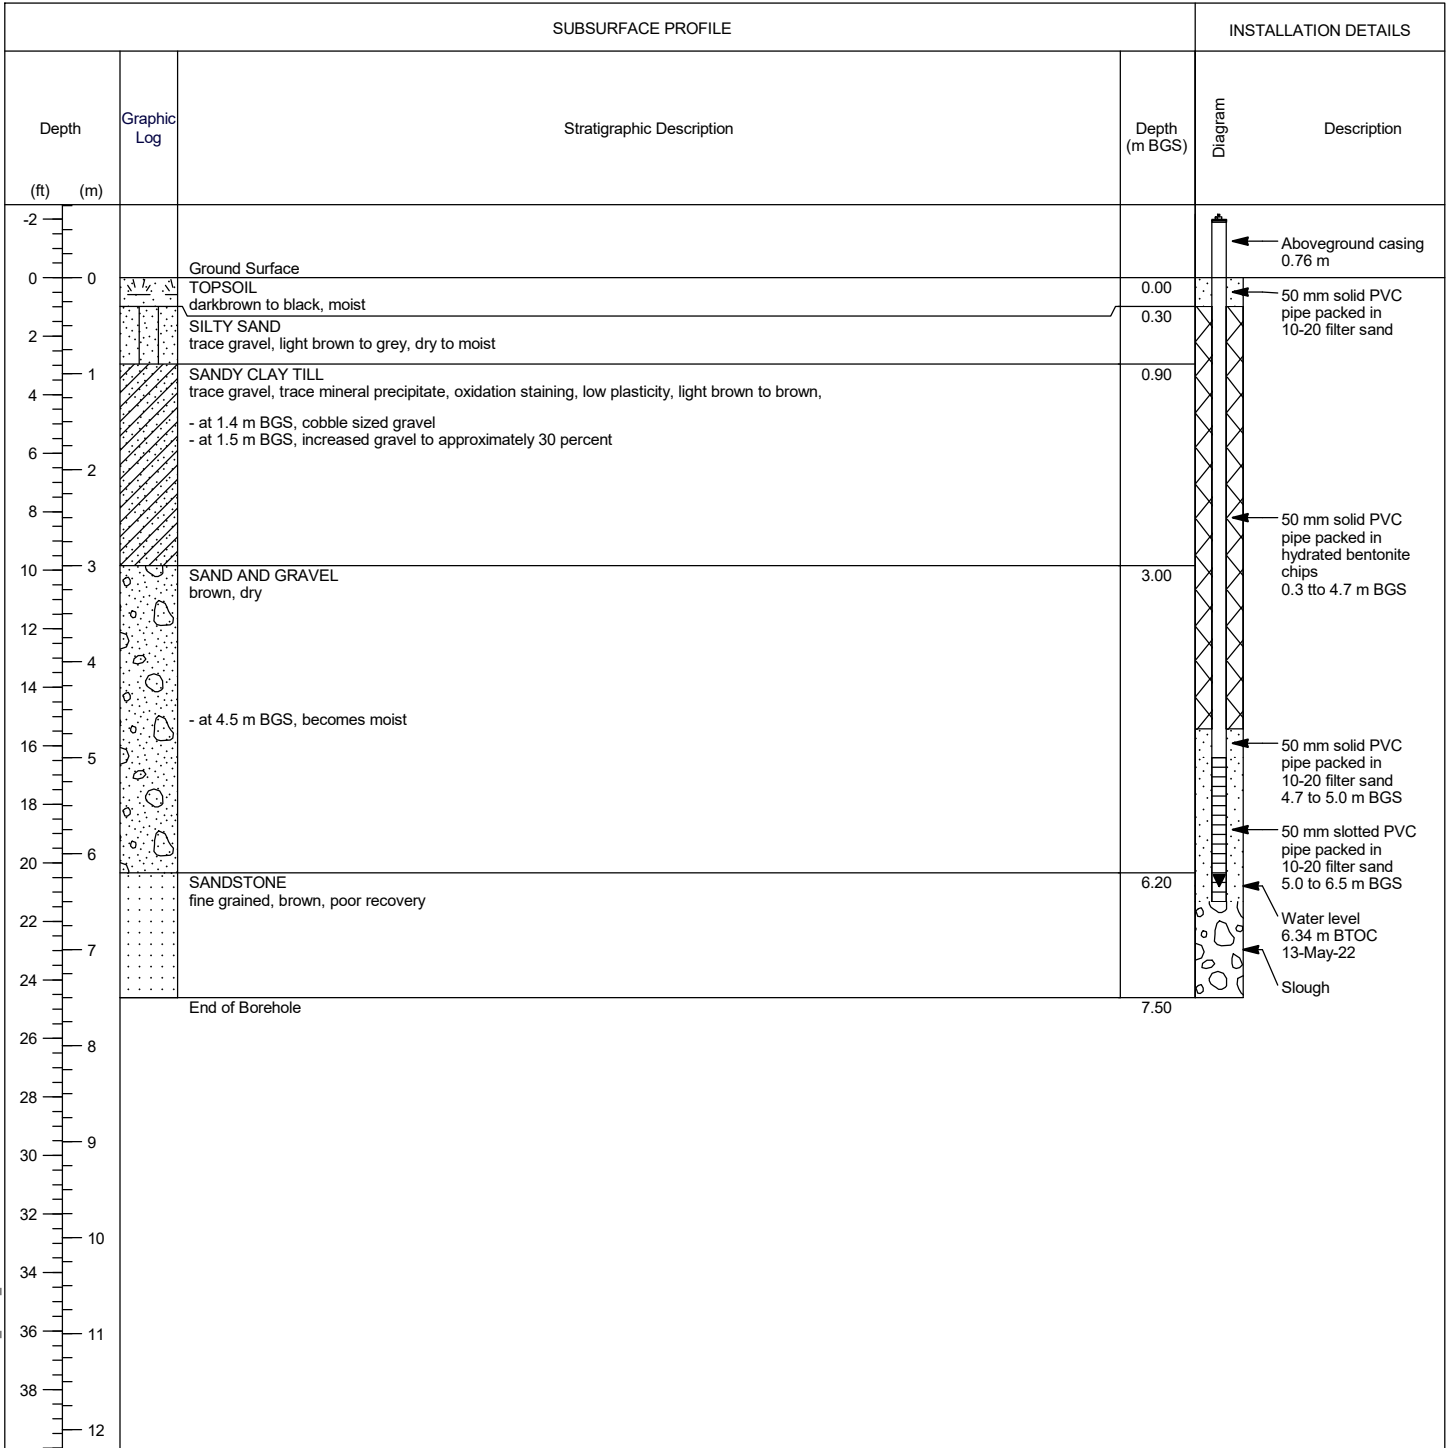
Project: SR1/Springank
Client: Alberta Transportaiton
Location: Rockyview County
Number: 10773396.5210.215
Field investigator: WT/IM
Contractor: All Service Drilling

Method: Solid Stem Auger
Date started/completed: 11-May-2022
Ground surface elevation: n/a
Top of casing elevation: n/a
Easting: n/a
Northing: n/a

Screen Interval: 5.00 - 6.50 m BGS
 Sand Pack Interval: 4.70 - 6.50 m BGS
 Well Seal Interval: 0.30 - 4.70 m BGS

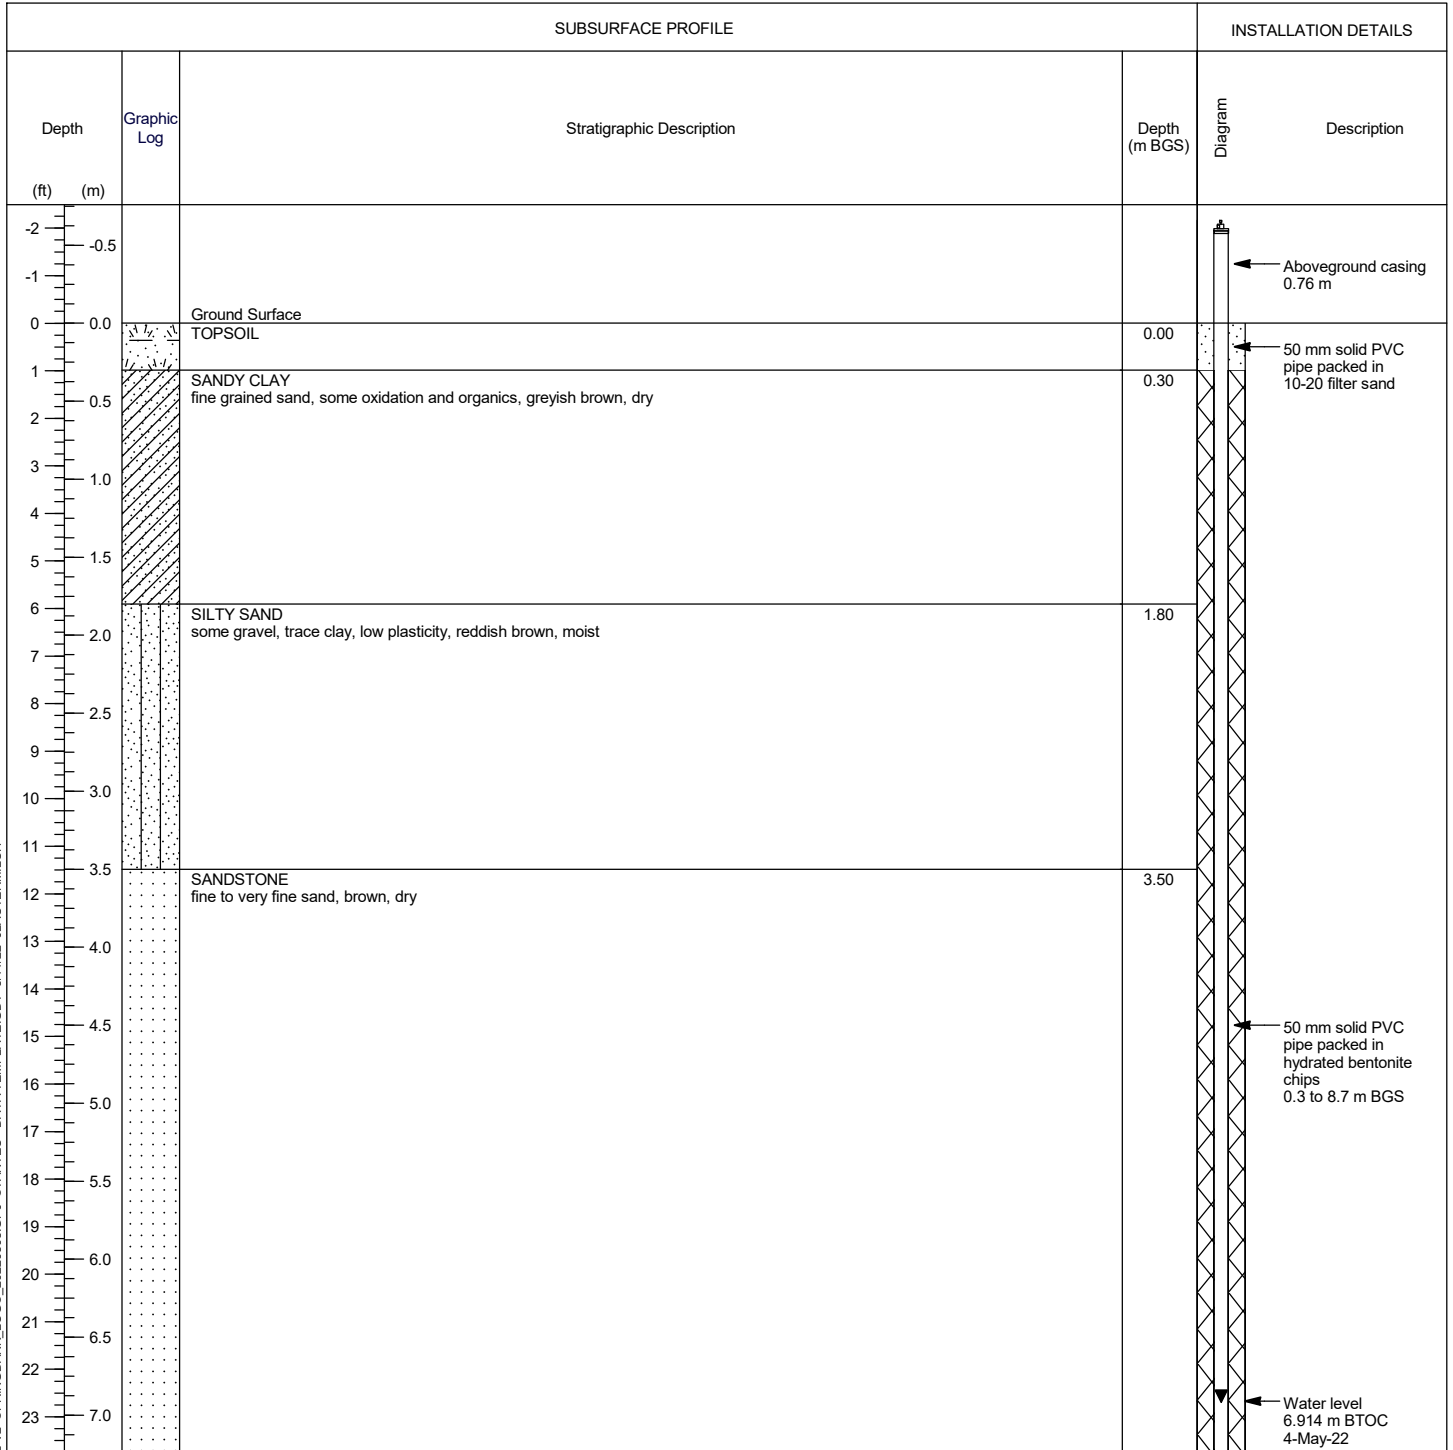
Method: Soid Stem Auger
Date started/completed: 30-Nov-2021
Ground surface elevation: n/a
Top of casing elevation: n/a
Easting: n/a
Northing: n/a

Screen Interval: 9.00 - 12.00 m BGS
 Sand Pack Interval: 8.70 - 12.00 m BGS
 Well Seal Interval: 0.30 - 8.70 m BGS

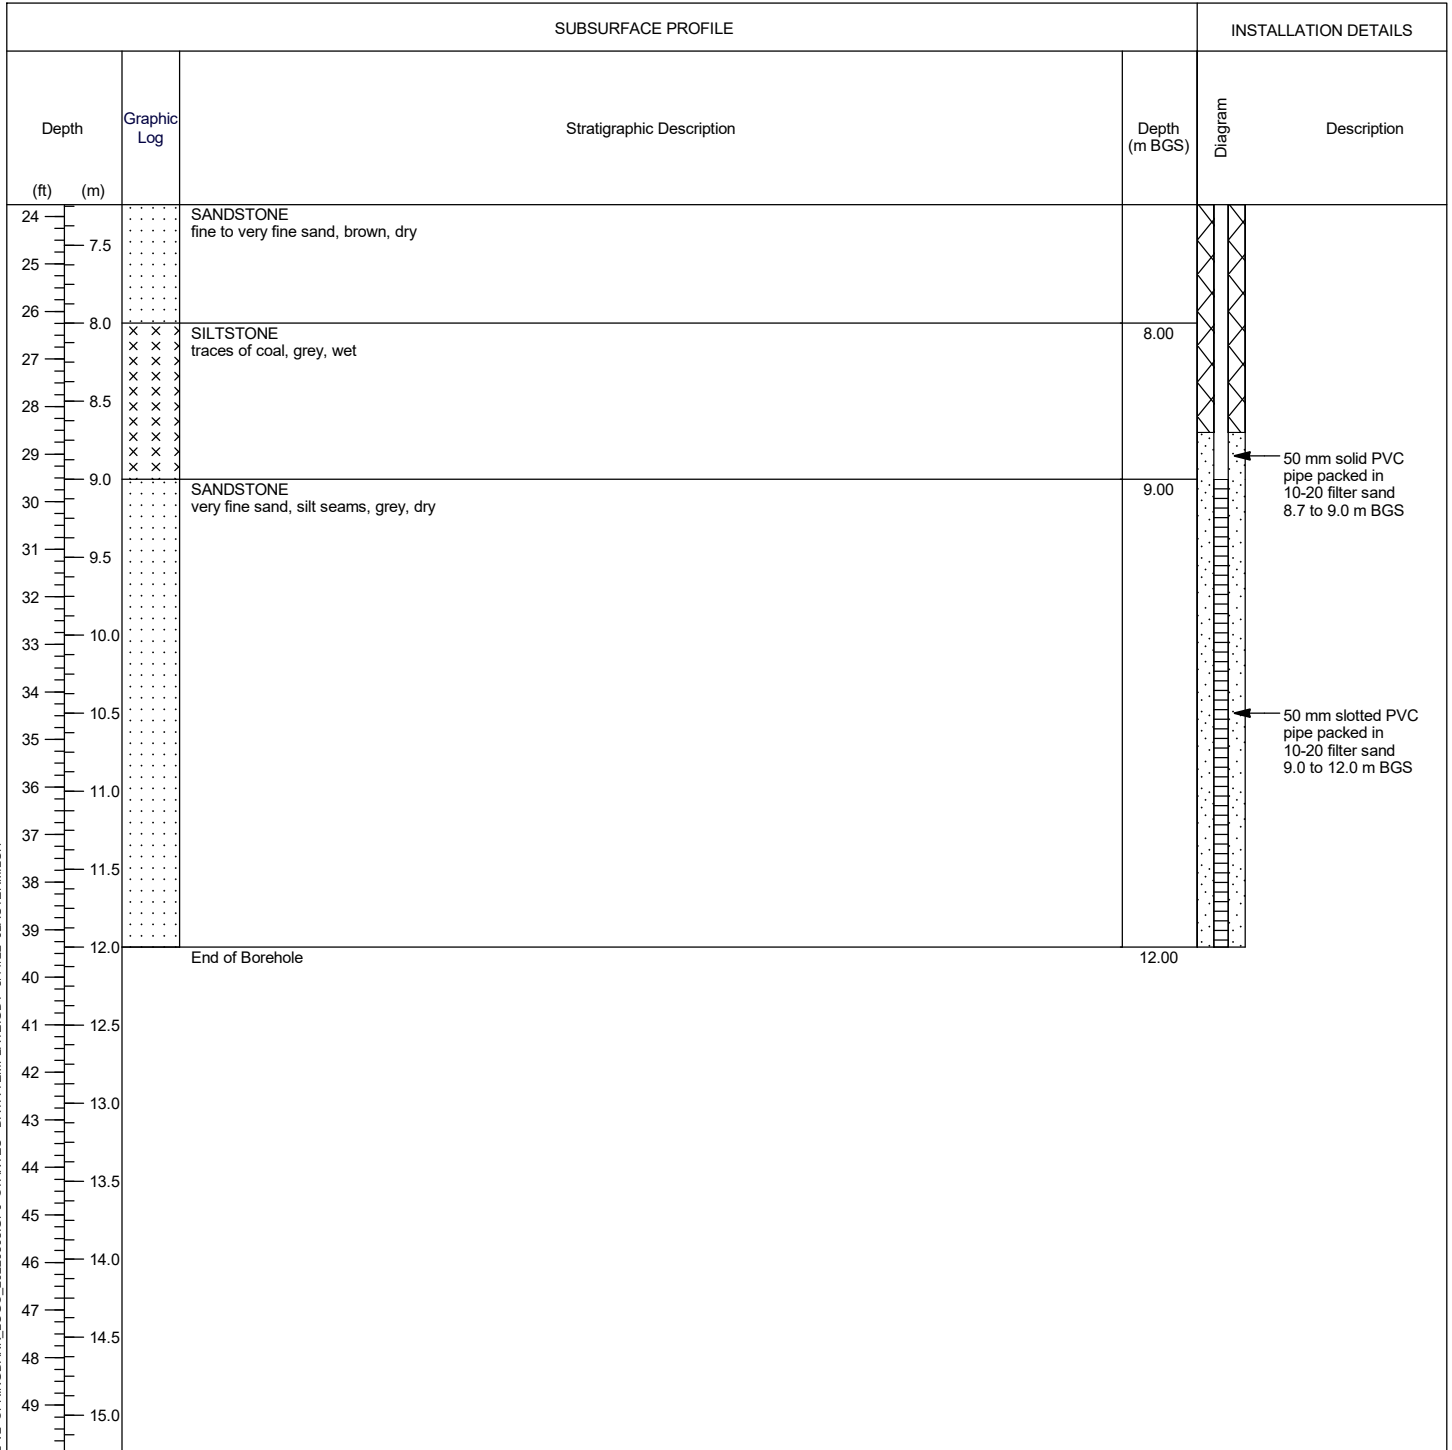
Screen Interval: 9.00 - 12.00 m BGS
 Sand Pack Interval: 8.70 - 12.00 m BGS
 Well Seal Interval: 0.30 - 8.70 m BGS

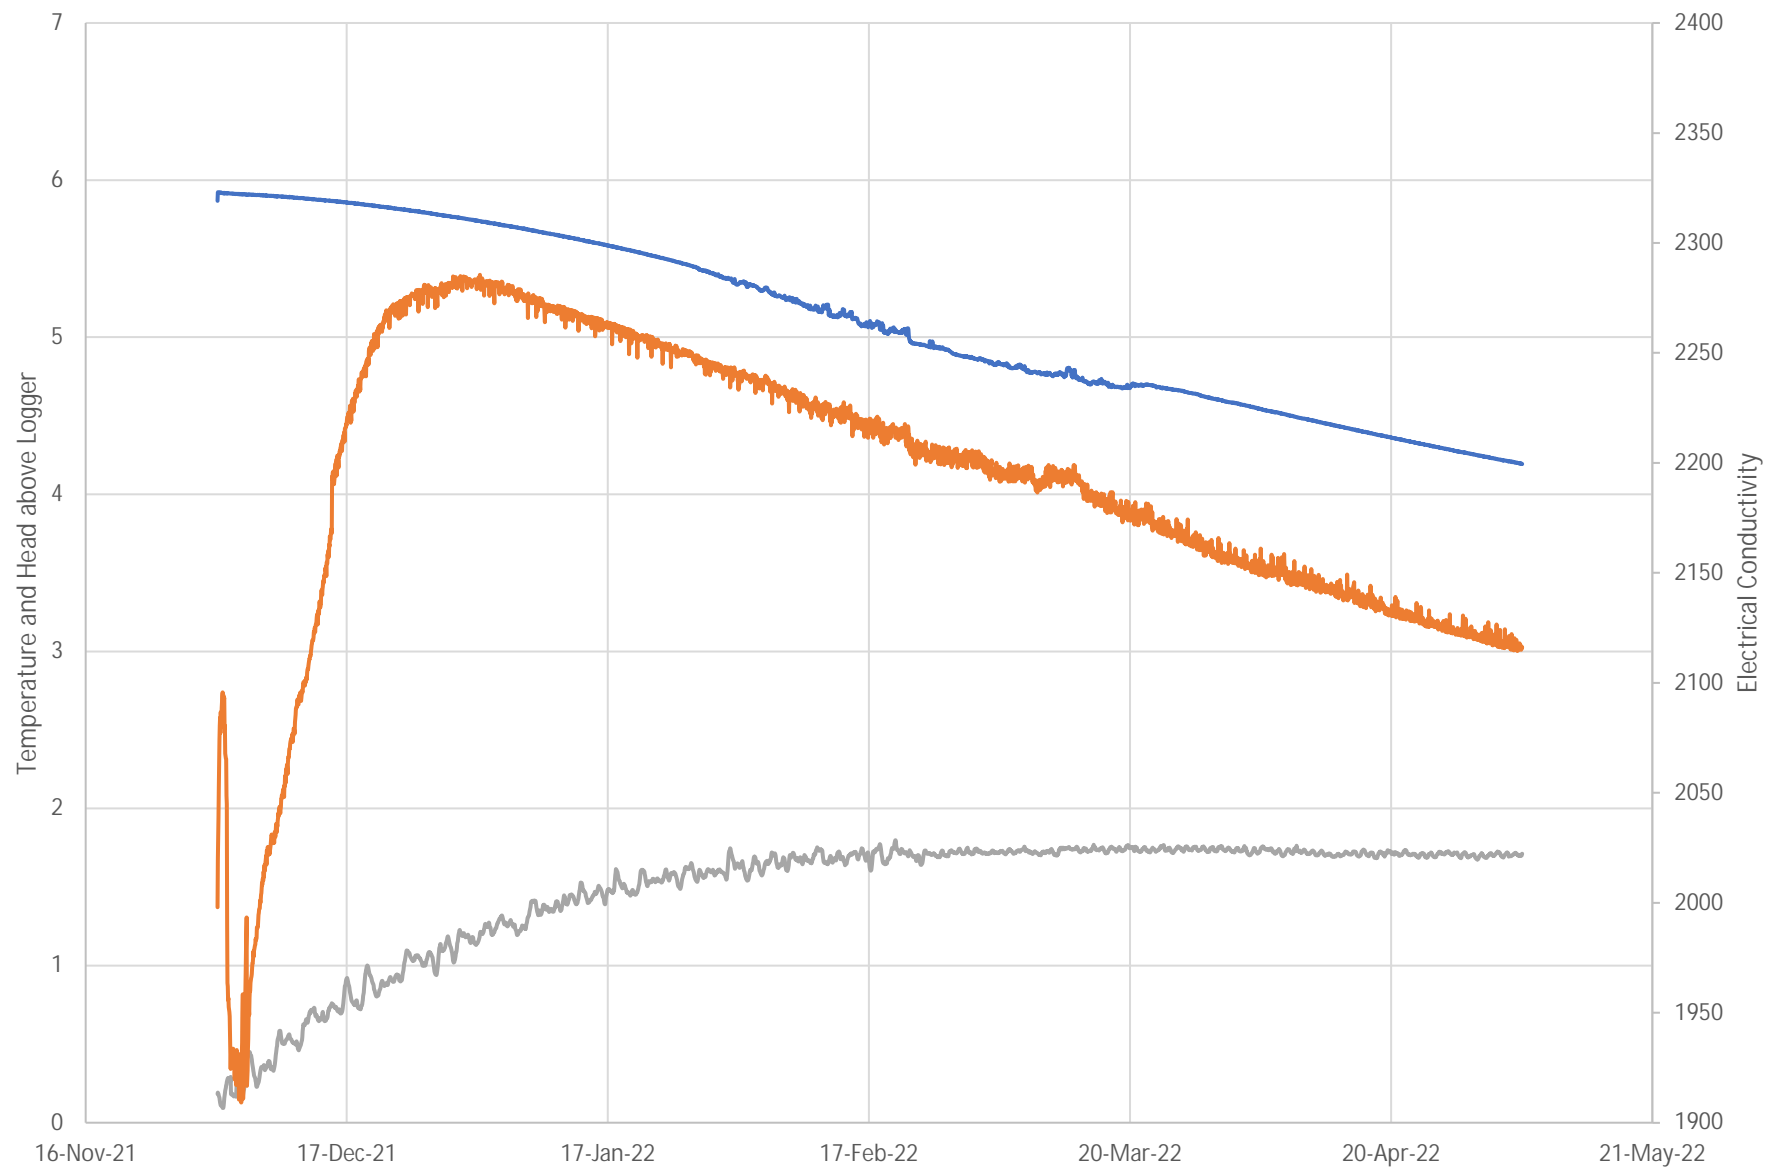
MW16-7-5

— Temperature (°C) — Head above Logger (m) — Electrical Conductivity (uS/cm)
