Condition 3.14 Follow-Up Program - March 2024 Results

Blackwater Gold Ltd.

Revision History			
Project Name		Blackwater Gold Ltd. Fisheries Support	
Project Number		12009	
Report Title		Condition 3.14 Follow-Up Program – March 2024 Results	
Document #		P5868	
Report Author(s)		Jessica Courtier, RP Bio	
Version	Date	Document Stage	Description/Notes
a	May 8, 2024	Draft	
1	May 27, 2024	Internal Review	
2	June 27, 2024	Final	Updated after client review
		Choose an item.	
		Choose an item.

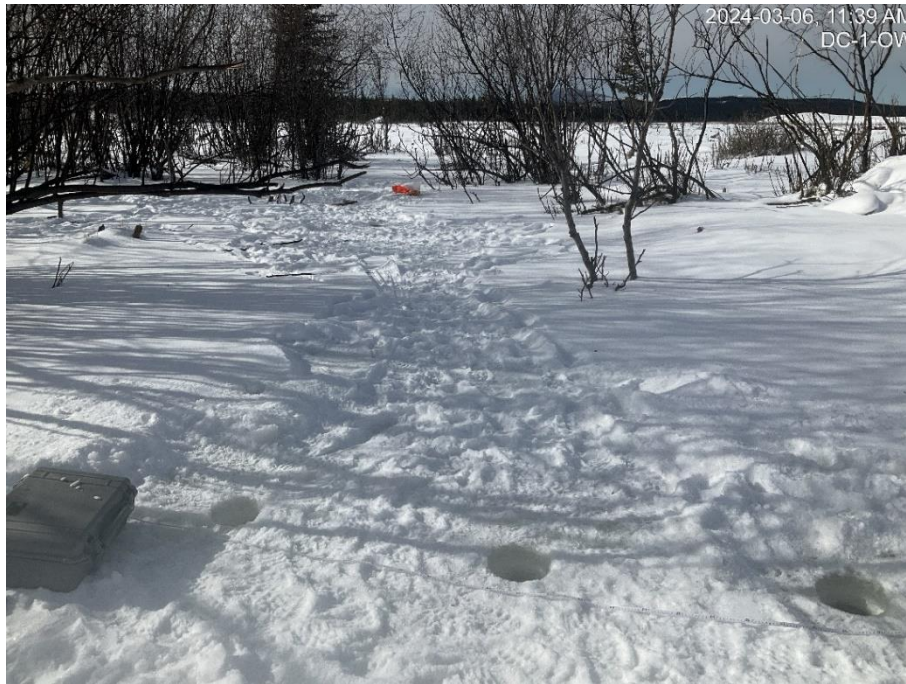
Photo 1. DC-1-OW - View looking upstream towards overwintering pool location. Velocity measurement locations visible in foreground.

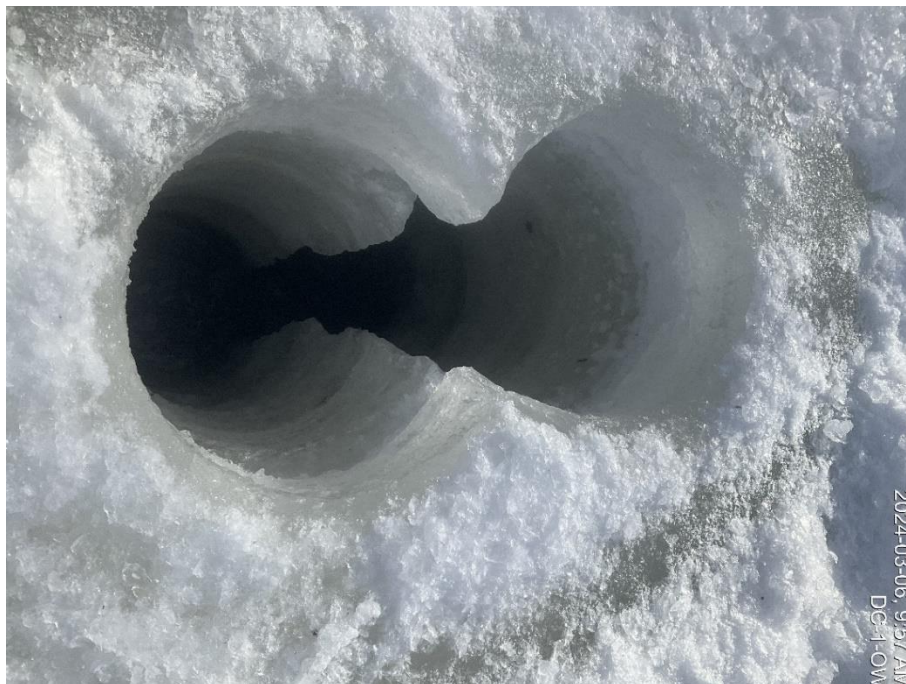
Photo 2. DC-1-OW – View showing ice thickness (>0.7 m).

Waterbody	Site Name	Pool Depth (m)	Ice Depth (m)	Snow Depth (m)	Wetted Width (m)	Ice Condition	Comments
Davidson Creek	DC-1-OW	0.47	0.77	0.08	NC	Multiple layers of flood ice. Surface layer has hollow underneath.	Total depth 1.55 m
Davidson Creek	DC-2-OW	0.25	0.34	0.15	NC	Ice condition variable. Where there is flowing water, there is layers of ice (~5cm) between snow layers. In other areas ice continuous to substrate.	Wetted width approx 1-2 m
Davidson Creek	DC-3-OW	0.39	0.06	0.4	2	Ice is highly unstable and soft. Very weak layer. Slush on top with some patches of open water	Unable to determine exact wetted width. Approximately 2 m.
Davidson Creek	DC-4-OW	0.47	0.37	0.11	4.8	Pockets of thin ice on riffles with air gaps, thick ice on pools.	Gravels and cobbles in riffles. Abundant LWD and SWD instream.
Davidson Creek	DC-5-OW	0.3	0.42	0.41	2	Ice depth varies across site (20-40cm). Clear hard ice then dark near substrate. Other areas are thin and easily chipped out.	Channel not fully wetted. Water identified over approx 2 m width. Bankfull width at least 5 m but difficult to determine exact width under thick snow.

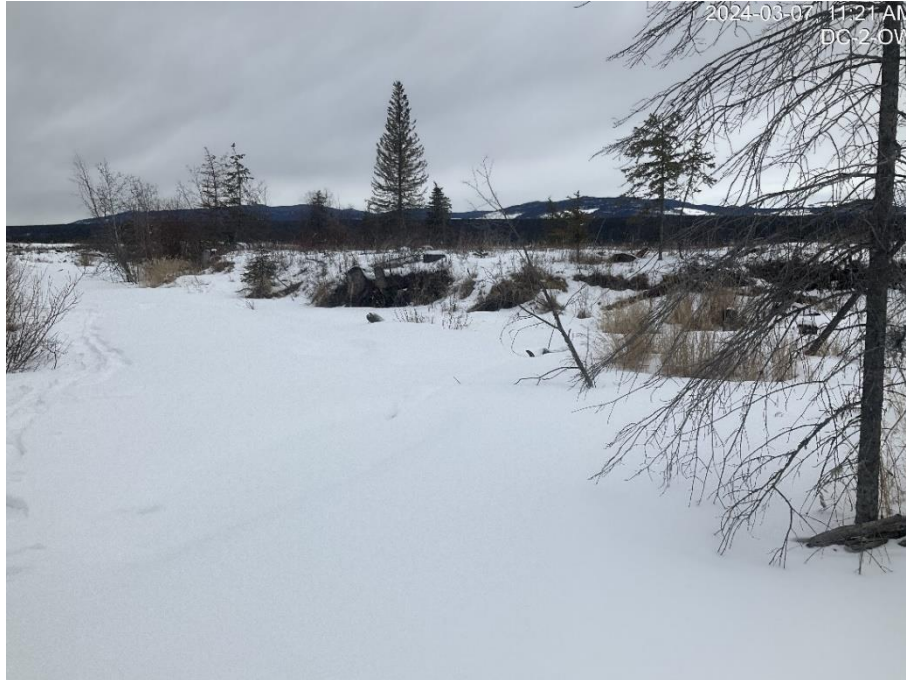
Photo 3. DC-2-OW - View looking downstream towards historic overwintering pool location. Overwintering pool habitat with depth to deploy underwater cameras was not found.

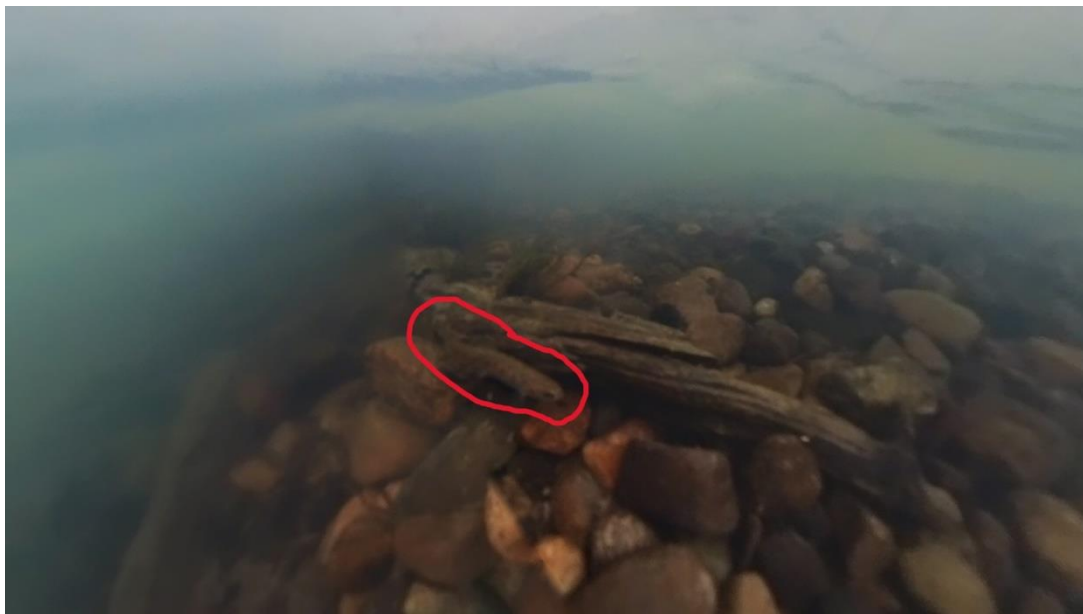
Photo 6. DC-4-OW – Video frame capture, with observed fish circled in red.

The effective field of view of the cameras was affected by moderate to high turbidity at all sites except DC-4-OW. Fish were observed from footage at three sites which included all turbidity conditions (DC-4-OW, DC-8-OW, DC-9-OW); MaxN value at these sites was one. Camera deployment information and MaxN values are provided in Table 1.

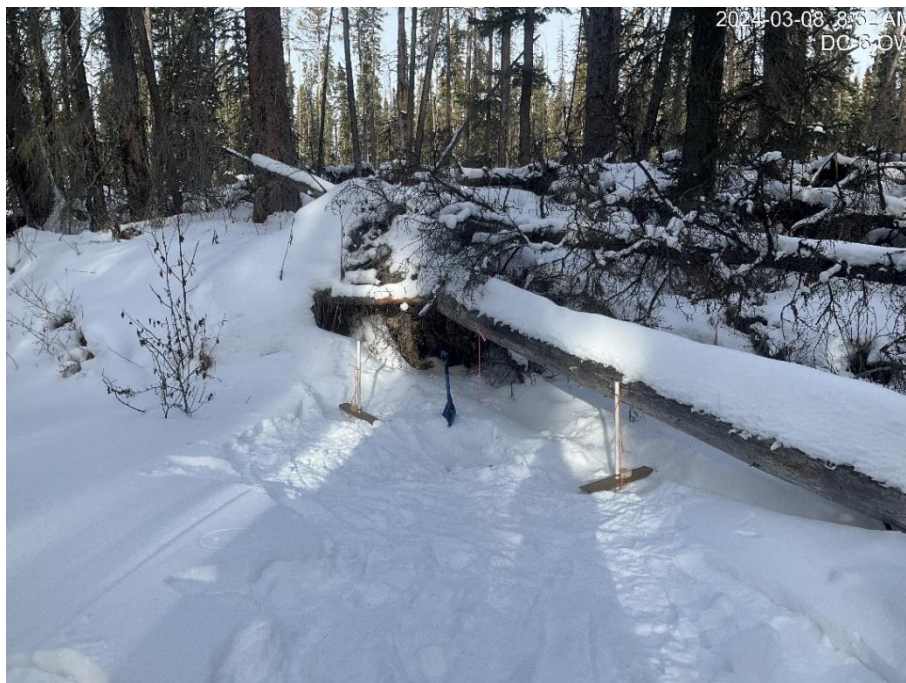
Photo 8. DC-6-OW - View looking towards left bank at overwintering pool location with underwater camera setup visible.

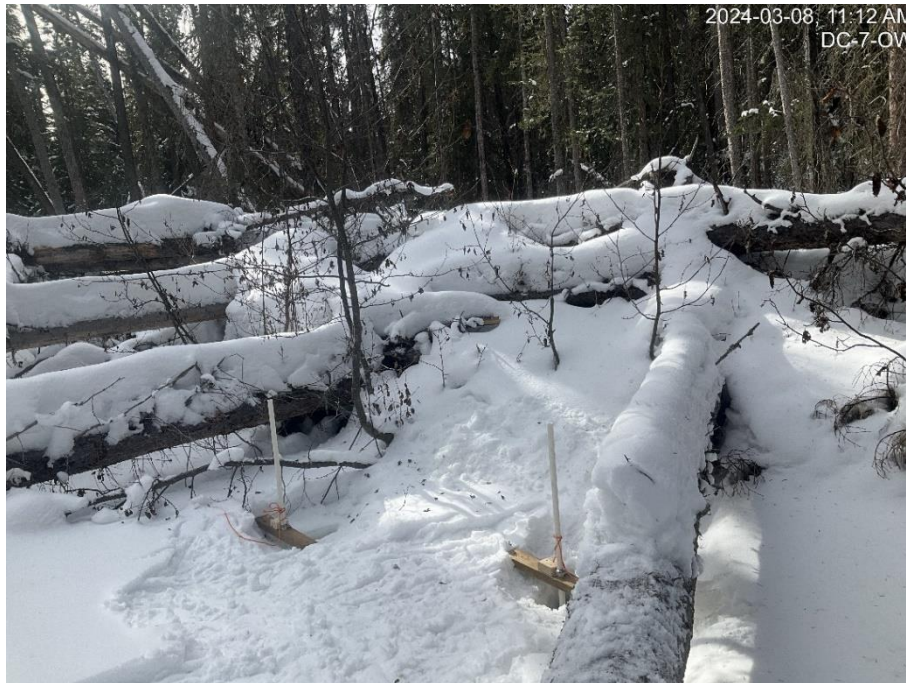
Photo 9. DC-7-OW - View looking towards left bank at overwintering pool location with underwater camera setup visible.

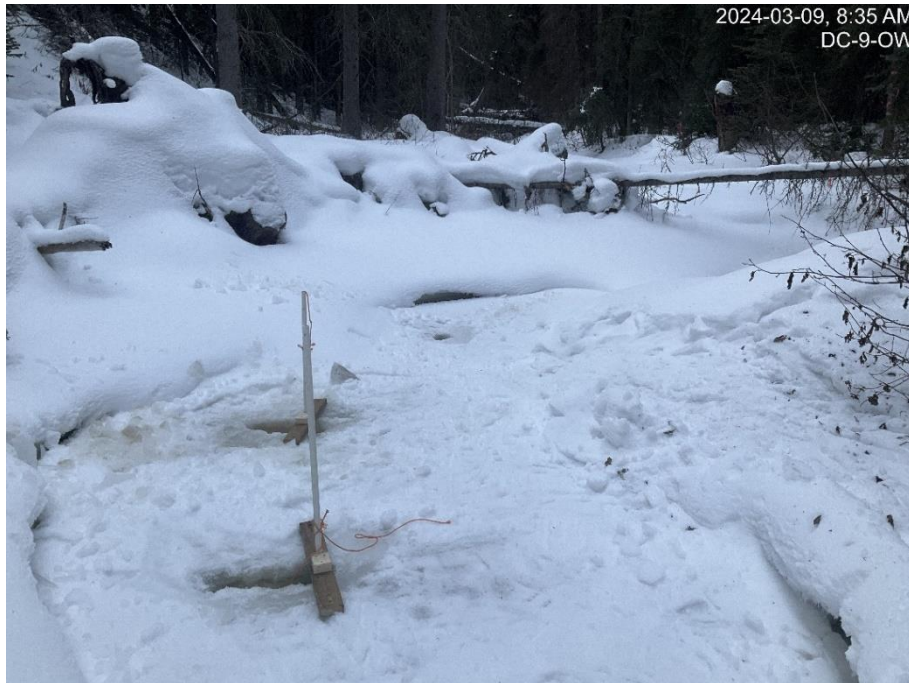
Photo 11. DC-9-OW - View looking upstream at overwintering pool location with underwater camera setup visible.
